## WETLAND DETERMINATION DATA FORM - North Central and Northeast Region

Project/Site: SPP	City/County: Aitkin		Sampling Date: 2016-08-22
Applicant/Owner: Enbridge		State: Minnesota	Sampling Point: w-50n26w18-l1
Investigator(s): ZCW, MGH	Section, Townshi	ip, Range: S18, T50, R26W	
Landform (hillslope, terrace, etc.): Depression		Local Relief (concave, conve	x, none): CC Slope (%): 0-2%
Subregion (LRR or MLRA):		•	de: -93.67771835 Datum: NAD83
Soil Map Unit Name: 928C			NWI Classification: N/A
Are climatic/hydrologic conditions on the site	typical for this time of year	? (if no explain in Remarks):	No
Are Vegetation No , Soil No , or Hydrolo	gy No significantly distur	bed? Are "Normal Circumstar	nces" present? Yes
Are Vegetation No , Soil No , or Hydrology	No naturally problemati	c? (If needed, explain any an	swers in Remarks)
<del></del>			
SUMMARY OF FINDINGS - Attach site map	showing sampling point lo	ocations, transects, important	t features, etc.
Hydrophytic Vegetation Present?	Yes	Is the Sampled Area

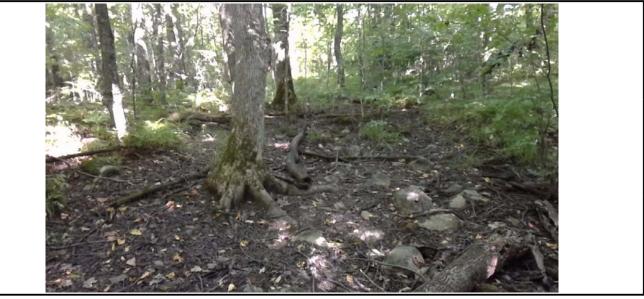
Site Photograph 1 Sampling Point: w-50n26w18-l1

Latitude:	46.8197081610996	Cowardin Classification: PFO
Longitude:	: -93.6777304206916	Circular 39: 1
Direction: We	st	Eggers & Reed: Seasonally Flooded Basin
Remarks:		
1
