WETLAND DETERMINATION DATA FORM - North Central and Northeast Region

Project/Site: SPP	_ c	City/County: Aitkin		Sampling Date: 2016-08-22		
Applicant/Owner: Enbridge		State: Minnesota		Sampling Point: w-50n26w18-m1		
Investigator(s): ZCW, MGH		Section, Townshi	p, Range: S18, T50N, R26	5W		
Landform (hillslope, terrace, etc.): Depress	sion		Local Relief (concave, co		Slope (%): 0-2%	
Subregion (LRR or MLRA):		 Latitude: 46	•	gitude: -93.67959899	Datum: NAD83	
Soil Map Unit Name: 928D					ssification: N/A	
Are climatic/hydrologic conditions on the	sita tynic	cal for this time of year	2 (if no evalain in Remarl		No

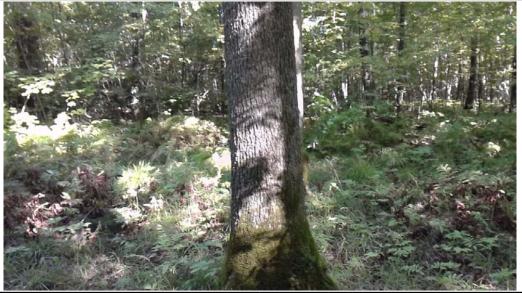
Site Photograph 1 Sampling Point: w-50n26w18-m1

Latitude: 46.8192923348833	Cowardin Classification: PFO
Longitude: -93.6795805581786	Circular 39: 1
Direction: North	Eggers & Reed: Seasonally Flooded Basin
Pomarke

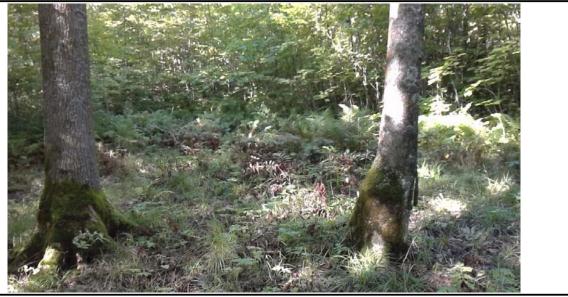
Site Photograph 2 Sampling Point: w-50n26w18-m1

Latitude: 46.8192924606118	Cowardin Classification: PFO			
Longitude: -93.6795806419977	Circular 39: 1			
Direction: West	Eggers & Reed: Seasonally Flooded Basin			
Remarks:
