## WETLAND DETERMINATION DATA FORM - North Central and Northeast Region

Project/Site: SPP	City/County: Aitkin		Sampling Date: 2016-08-22		
Applicant/Owner: Enbridge		State: Minnesota	Sampling Point: w-50n26	iw18-o1	
Investigator(s): ZCW, MGH	Section, Townsh	ip, Range: S26, T50N, R26	N		
Landform (hillslope, terrace, etc.): Depression		Local Relief (concave, co	nvex, none): CC Slope (%	_ .): 0-2%	
Subregion (LRR or MLRA):	 Latitude: 4	•	itude: -93.68169615 Datum: NAD	83	
Soil Map Unit Name: 928C			NWI Classification: N/A		
·	typical for this time of year	? (if no. explain in Remark			
Are climatic/hydrologic conditions on the site typical for this time of year? (if no, explain in Remarks):  Are Vegetation No_, Soil No_, or Hydrology No_ significantly disturbed? Are "Normal Circumstances" present? Yes					
Are Vegetation No , Soil No , or Hydrology	No naturally problemati	c? (If needed, explain an	answers in Remarks)		
SUMMARY OF FINDINGS - Attach site map	showing sampling point lo	ocations, transects, impor	ant features, etc.

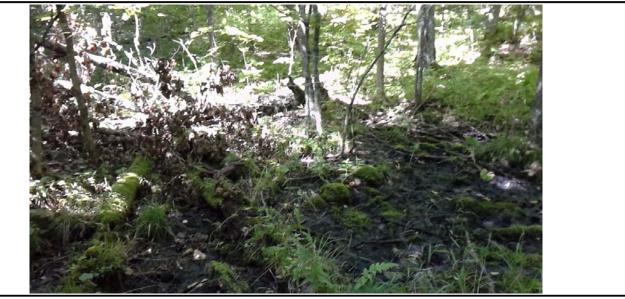
Site Photograph 1 Sampling Point: w-50n26w18-o1

Latitude: 46.8190006027434	Cowardin Classification: PFO
Longitude: -93.681695731444	Circular 39: 1
Direction: West	Eggers & Reed: Seasonally Flooded Basin
Remarks:

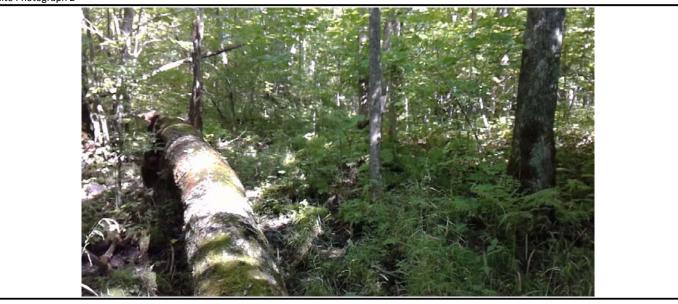
Site Photograph 2 Sampling Point: w-50n26w18-o1

Latitude: 46.8190001836483	Cowardin Classification: PFO	
Longitude: -93.6816954799869	Circular 39: 1	
Direction: North	Eggers & Reed: Seasonally Flooded Basin	
Remarks:
