WETL		MINATION DATA F	ORM - North Cent	tral and Northe	-			
Project/Site: SPP	Cit	City/County: Aitkin			Sampling Date: 2016-08-22			
Applicant/Owner: Enbridge			State: Minnesota		Sampling	Point: w-50n2	6w18-p1	
Investigator(s): ZCW, MGH		Section, Townshi	p, Range: <u>S18, T50N</u>	, R26W				
Landform (hillslope, terrace, etc.): Depre	ession		Local Relief (concav	e, convex, none)	: CC	Slope (%	%): <u>0-2%</u>	
Subregion (LRR or MLRA):		Latitude: 46	5.8189524068	Longitude: -93.	68379145	Datum: NAD	083	
Soil Map Unit Name: 928C					NWI Class	ification: N/A		
Are climatic/hydrologic conditions on th	ne site typica	l for this time of year	? (if no, explain in Re	emarks):		No		
Are Vegetation <u>No</u> , Soil <u>No</u> , or Hy	ydrology <u>No</u>	_ significantly disturb	oed? Are "Normal Ci	rcumstances" pr	esent? Yes			
Are Vegetation <u>No</u> , Soil <u>No</u> , or Hyd	rology <u>No</u>	naturally problemation	c? (If needed, explai	in any answers ir	n Remarks)

Sampling Point: w-50n26w...

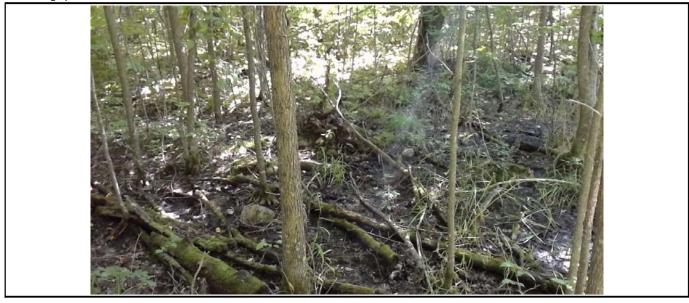
Site Photograph 1

Cowardin Classification: PFO

Direction: East

Circular 39: 7 Eggers & Reed: <u>Hardwood Swamp/Coniferous Swamp</u>

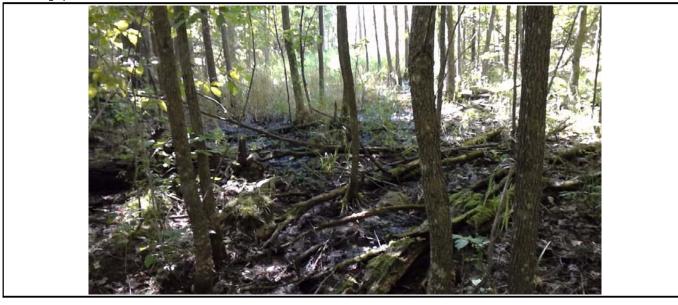
Site Photograph 2

Cowardin Classification: PFO

Direction: South

Eggers & Reed: Hardwood Swamp/Coniferous Swamp

Circular 39: 7
