**WETLAND DETERMINATION DATA FORM - North Central and Northeast Region**

Project/Site: SPP City/County: Aitkin Sampling Date: 2016-08-22  
 Applicant/Owner: Enbridge State: Minnesota Sampling Point: w-50n26w18-r1  
 Investigator(s): ZCW, MGH Section, Township, Range: S18, T50N, R26W  
 Landform (hillslope, terrace, etc.): Depression Local Relief (concave, convex, none): CC Slope (%): 0-2%  
 Subregion (LRR or MLRA): \_\_\_\_\_ Latitude: 46.8181566708... Longitude: -93.68450886... Datum: NAD83  
 Soil Map Unit Name: 928C NWI Classification: N/A  
 Are climatic/hydrologic conditions on the site typical for this time of year? (if no, explain in Remarks): No  
 Are Vegetation No, Soil No, or Hydrology No significantly disturbed? Are "Normal Circumstances" present? Yes  
 Are Vegetation No, Soil No, or Hydrology No naturally problematic? (If needed, explain any answers in Remarks)

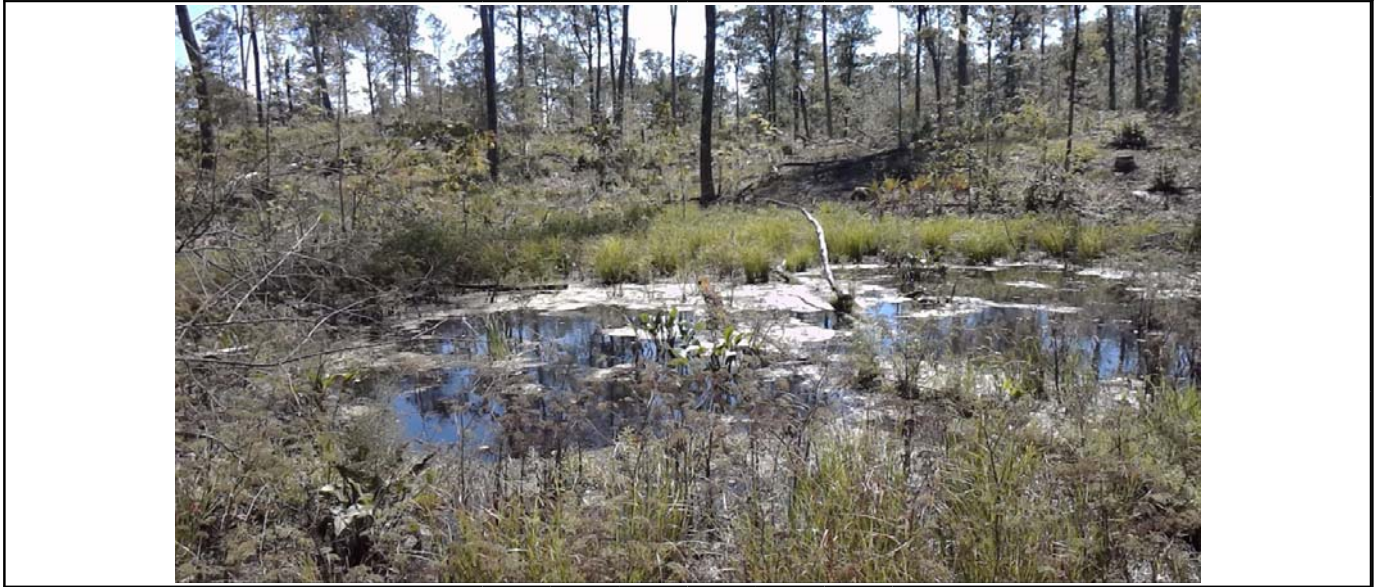
Site Photograph 1

Cowardin Classification: PEM

Circular 39: 1

Direction: Southeast

Eggers & Reed: Seasonally Flooded Basin

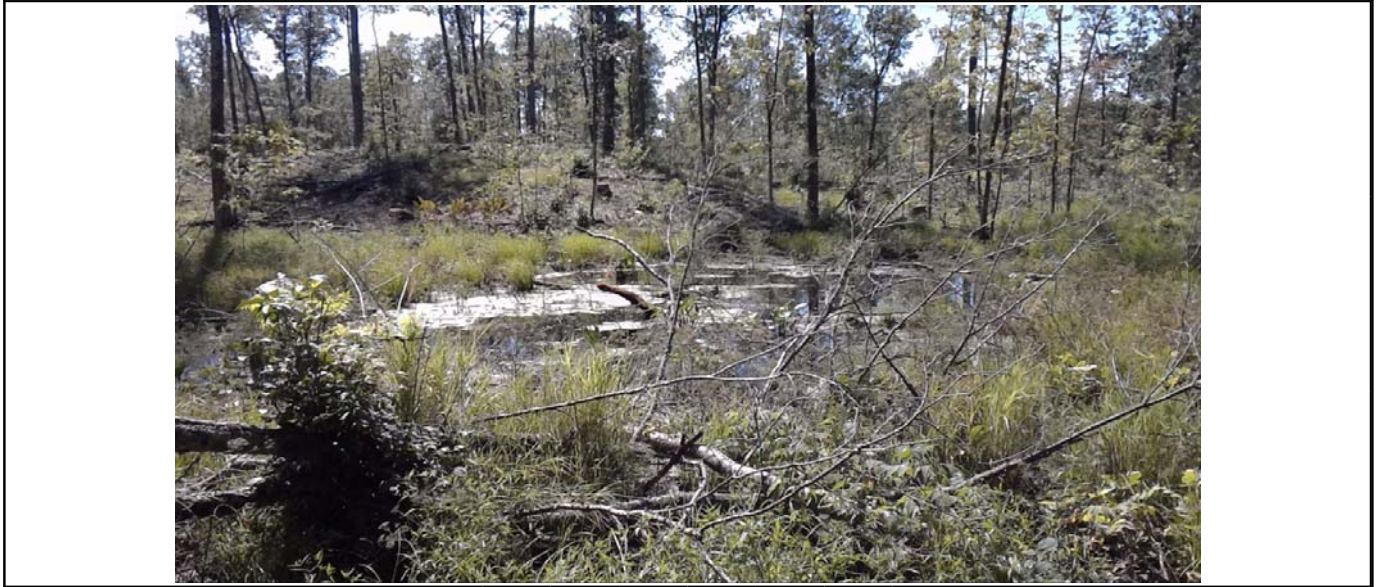
Site Photograph 2

Cowardin Classification: PEM

Circular 39: 1

Direction: South

Eggers & Reed: Seasonally Flooded Basin
