WETLAND DETERMINATION DATA FORM - North Central and Northeast Region

Project/Site: SPP City/County: Aitkin Sampling Date: 2016-08-22
 Applicant/Owner: Enbridge State: Minnesota Sampling Point: w-50n26w18-s1
 Investigator(s): ZCW, MGH Section, Township, Range: S18, T50N, R26W
 Landform (hillslope, terrace, etc.): Depression Local Relief (concave, convex, none): CC Slope (%): 0-2%
 Subregion (LRR or MLRA): _____ Latitude: 46.8181106122... Longitude: -93.68379841... Datum: NAD83
 Soil Map Unit Name: 928C NWI Classification: N/A
 Are climatic/hydrologic conditions on the site typical for this time of year? (if no, explain in Remarks): No
 Are Vegetation No, Soil No, or Hydrology No significantly disturbed? Are "Normal Circumstances" present? Yes
 Are Vegetation No, Soil No, or Hydrology No naturally problematic? (If needed, explain any answers in Remarks)

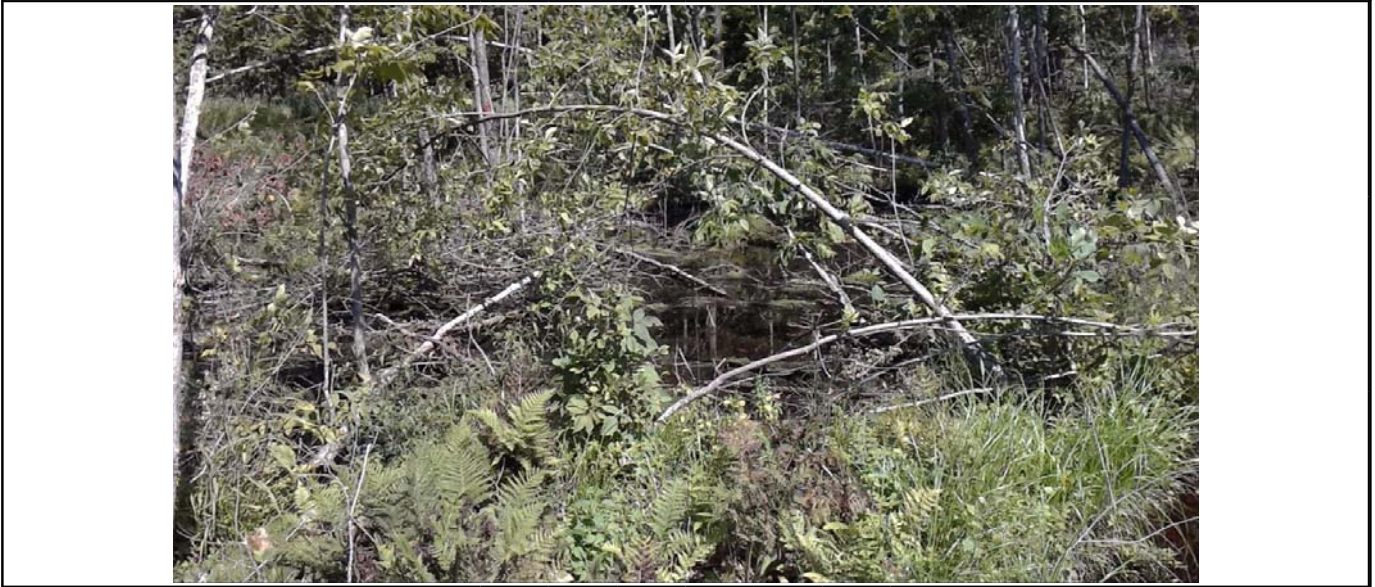
Site Photograph 1

Cowardin Classification: PSS

Circular 39: 6

Direction: Northeast

Eggers & Reed: Shrub-Carr/Alder Thicket

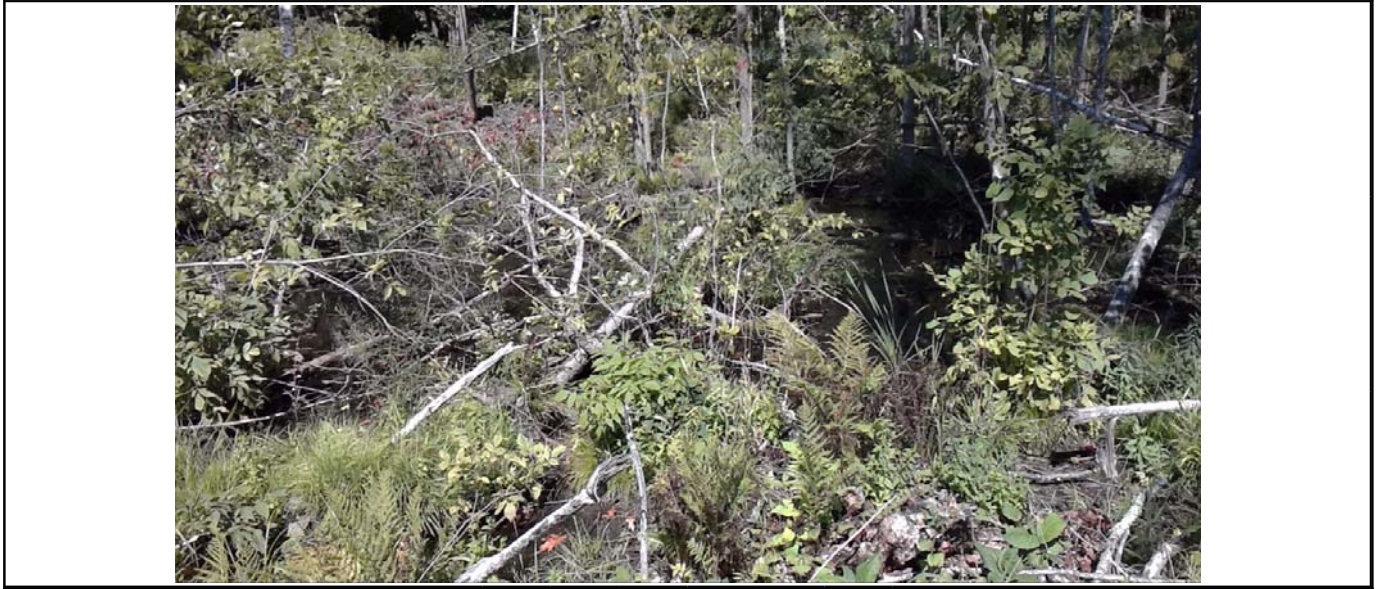
Site Photograph 2

Cowardin Classification: PSS

Circular 39: 6

Direction: North

Eggers & Reed: Shrub-Carr/Alder Thicket
