WETLAND DETERMINATION DATA FORM - North Central and Northeast Region

Project/Site: SPP	Ci	ity/County: Aitkin		Samplii	ng Date: 2016-08-22	
Applicant/Owner: Enbridge			State: Minnesota	Samplir	ng Point: <u>w-50n26w18-v1</u>	
Investigator(s): ZCW, MGH		Section, Townshi	p, Range: S18, T50N, R26	W		
Landform (hillslope, terrace, etc.): D	epression		Local Relief (concave, co	nvex, none): CC	Slope (%): 0-2%	
Subregion (LRR or MLRA):		 Latitude: 46	5.8176354840 Long	gitude: -93.68329315	Datum: NAD83	
Soil Map Unit Name: 928D				NWI Cla	ssification: N/A	
Are climatic/hydrologic conditions o	n the site typic	al for this time of year	? (if no. explain in Remark		No	
Are Vegetation No , Soil No , o						
SUMMARY OF FINDINGS - Attack	ı site map shov	wing sampling point lo	cations, transects, impor	tant features, etc.		
Hydrophytic Vegetation Present?		Yes	Is the Sampled Area			
Hydric Soil Present?		Yes	within a Wetland?		Yes	
Wetland Hydrology Present?		Yes	If yes, optional Wetland	Site ID:	w-50n26w18-v

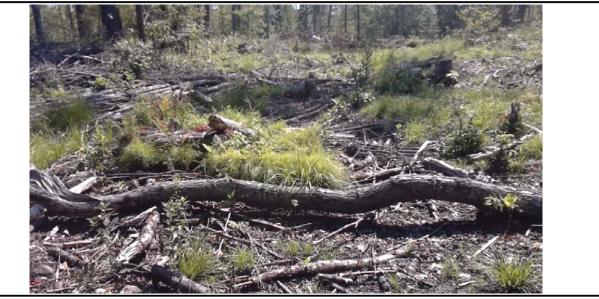
Site Photograph 1 Sampling Point: w-50n26w18-v1

Cowardin Classification: PEM
Circular 39: 1
Eggers & Reed: Seasonally Flooded Basin

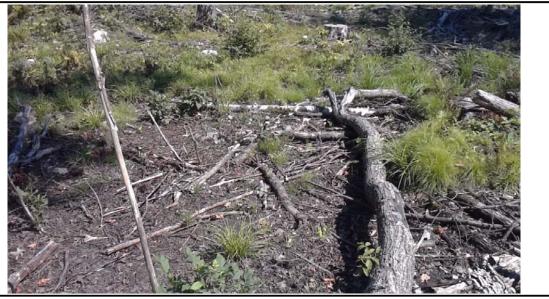
Site Photograph 2 Sampling Point: w-50n26w18-v1

Latitude: 46.8176359450881 Cowardin Classification: PEM					
Longitude: -93.6832890474179	Circular 39: 1				
rection: East	Eggers & Reed: Seasonally Flooded Basin				
emarks:
