## WETLAND DETERMINATION DATA FORM - North Central and Northeast Region

Project/Site: SPP	City/County: Aitkin		Sampling Date: 2016-08-22	
Applicant/Owner: Enbridge		State: Minnesota	Sampling Point: w-50n26w18-w1	
Investigator(s): ZCW, MGH	Section, Townsh	ip, Range: S18, T50N, R28W		
Landform (hillslope, terrace, etc.): Depre		Local Relief (concave, convex,	none): CC Slope (%): 0-2%	
Subregion (LRR or MLRA):		, , , , ,	: -93.68252310 Datum: NAD83	
Soil Map Unit Name: 928C			NWI Classification: N/A	
Are climatic/hydrologic conditions on the	e site typical for this time of year	? (if no explain in Remarks):	No	
Are Vegetation No , Soil No , or Hy	drology No significantly disturb	bed? Are "Normal Circumstance	es" present? Yes	
Are Vegetation No , Soil No , or Hydr	rology No naturally problemati	c? (If needed, explain any answ	vers in Remarks)	
· — — ·	- · · · · · · · · · · · · · · · · · · ·	, , , ,	,	
SUMMARY OF FINDINGS - Attach site	e map showing sampling point lo	ocations, transects, important fo	eatures, etc.

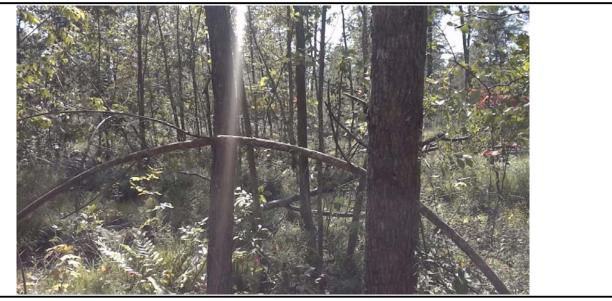
Site Photograph 1 Sampling Point: w-50n26w18-w1

Latitude: 46.8173578754503	Cowardin Classification: PFO
Longitude: -93.6824998912343	Circular 39: 7
Direction: Southwest	Eggers & Reed: Hardwood Swamp/Coniferous Swamp
Remarks:

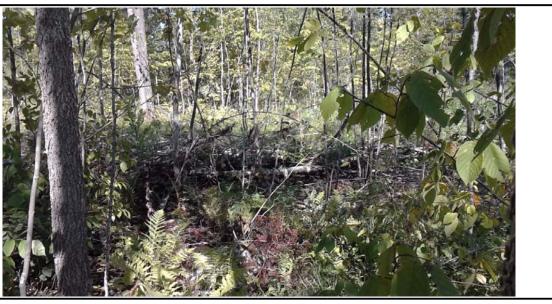
Site Photograph 2 Sampling Point: w-50n26w18-w1

Latitude:	46.8173524691228	Cowardin Classification: PFO
Longitude:	-93.6825010647007	Circular 39: 7
Direction: Nor	theast	Eggers & Reed: Hardwood Swamp/Coniferous Swamp
Remarks:
