## WETLAND DETERMINATION DATA FORM - North Central and Northeast Region

Project/Site: SPP	City/County: Aitkin		Sampling Date: 2016-08-09			
Applicant/Owner: Enbridge		State: Minnesota	Sampling Point: w-50n26w6-a1			
Investigator(s): ZCW	Section, Townshi	p, Range: S6, T50N, R26W				
Landform (hillslope, terrace, etc.): Depression		Local Relief (concave, conver	x, none): CC Slope (%): 0-2%			
Subregion (LRR or MLRA):		•	de: -93.67854463 Datum: NAD83			
Soil Map Unit Name: 544			NWI Classification: N/A			
·	e typical for this time of year	? (if no. explain in Remarks):	No			
Are Vegetation No , Soil No , or Hydrolo	ogy <u>NO</u> significantly distur	bed? Are "Normal Circumstar	ices" present? Yes			
Are Vegetation No , Soil No , or Hydrolog	y No naturally problemati	c? (If needed, explain any an	swers in Remarks)			
SUMMARY OF FINDINGS - Attach site ma	p showing sampling point lo	ocations, transects, important	t features, etc.			
Hydrophytic Vegetation Present?	Yes	Is the Sampled Area

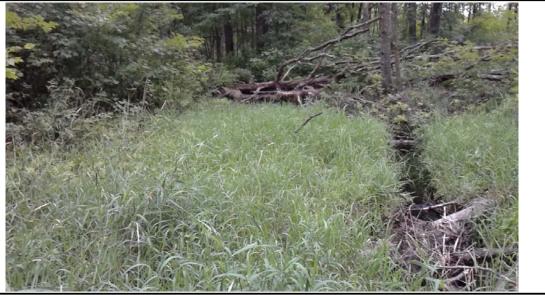
Site Photograph 1 Sampling Point: w-50n26w6-a1

Latitude: 46.8542371178482	Cowardin Classification: PEM	
Longitude: -93.6785906554141	Circular 39: 2	
Direction: North	Eggers & Reed: Fresh (Wet) Meadow	
Pomarke:

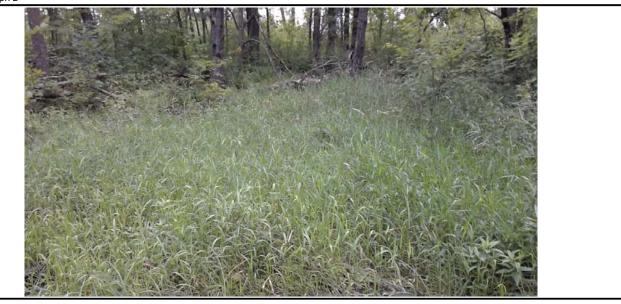
Site Photograph 2 Sampling Point: w-50n26w6-a1

Latitude: 46.8542369083006	Cowardin Classification: PEM	
Longitude: -93.6785902363189	Circular 39: 2	
Direction: East	Eggers & Reed: Fresh (Wet) Meadow	
Remarks:
