WETLAND DETERMINATION DATA FORM - North Central and Northeast Region

Project/Site: SPP	City/County: Aitkin		Sampling Date: 2016-08-09			
Applicant/Owner: Enbridge		State: Minnesota	Sampling Point: w-50n26w6-a2			
Investigator(s): ZCW, MGH	Section, Townsh	nip, Range: S6, T50N, R26W	· · · · · · · · · · · · · · · · · · ·			
Landform (hillslope, terrace, etc.): Depr		Local Relief (concave, convex	, none): CC Slope (%): 0-2%			
Subregion (LRR or MLRA):		•	e: -93.67873205 Datum: NAD83			
Soil Map Unit Name: 544			NWI Classification: PEM5B

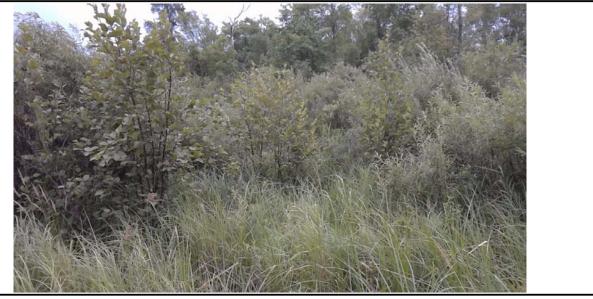
Site Photograph 1 Sampling Point: w-50n26w6-a2

Latitude: 46.8530596280907	Cowardin Classification: PSS	
Longitude: -93.6787395180144	Circular 39: 6	
Direction: West	Eggers & Reed: Shrub-Carr/Alder Thicket	
Remarks:

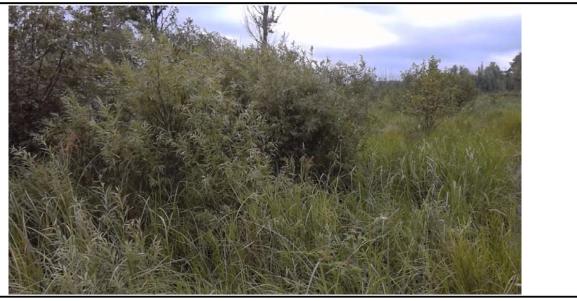
Site Photograph 2 Sampling Point: w-50n26w6-a2

Latitude: 46.8530346081097	Cowardin Classification: PSS	
Longitude: -93.6787116900959	Circular 39: 6	
Direction: South	Eggers & Reed: Shrub-Carr/Alder Thicket	
Remarks:
