**WETLAND DETERMINATION DATA FORM - North Central and Northeast Region**

Project/Site: SPP City/County: Aitkin Sampling Date: 2016-08-11  
 Applicant/Owner: Enbridge State: Minnesota Sampling Point: w-50n26w6-a6  
 Investigator(s): ZCW, MGH Section, Township, Range: S6, T50N, R26W  
 Landform (hillslope, terrace, etc.): Depression Local Relief (concave, convex, none): CC Slope (%): 0-2%  
 Subregion (LRR or MLRA): \_\_\_\_\_ Latitude: 46.8465943308... Longitude: -93.67875896... Datum: NAD83  
 Soil Map Unit Name: 544 NWI Classification: PEM5B  
 Are climatic/hydrologic conditions on the site typical for this time of year? (if no, explain in Remarks): No  
 Are Vegetation No, Soil No, or Hydrology No significantly disturbed? Are "Normal Circumstances" present? Yes  
 Are Vegetation No, Soil No, or Hydrology No naturally problematic? (If needed, explain any answers in Remarks)

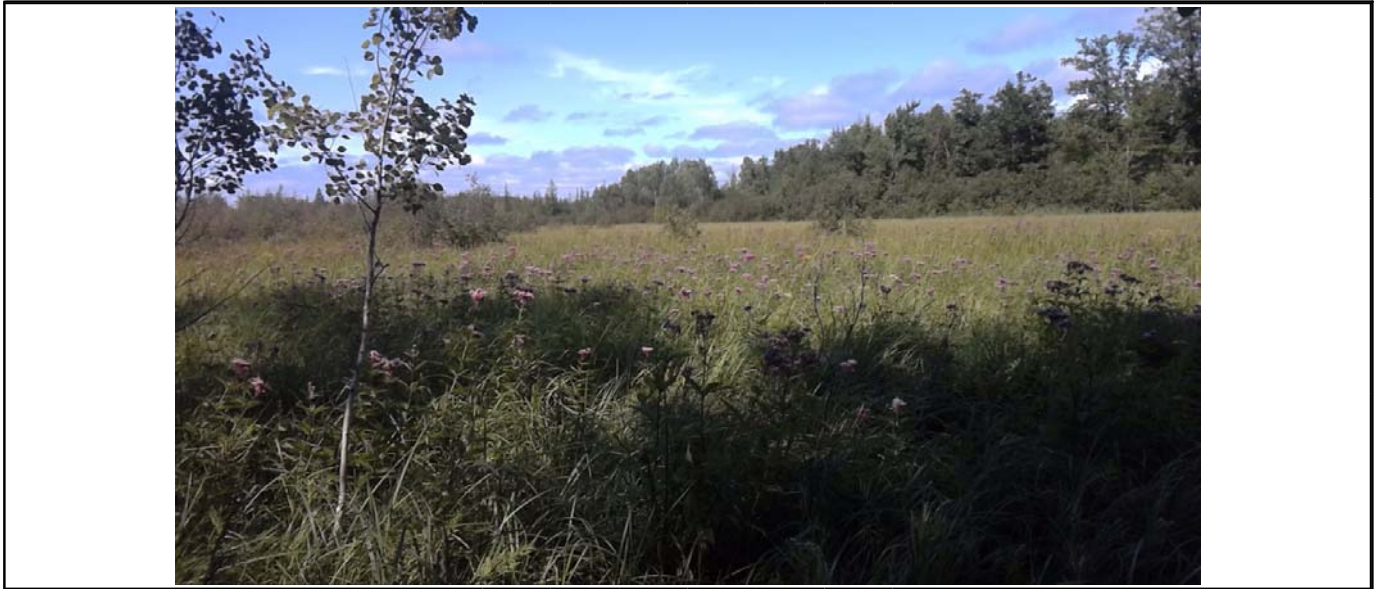
Site Photograph 1

Sampling Point: w-50n26w6-a6

Cowardin Classification: PEM

Direction: North

Eggers & Reed: Fresh (Wet) Meadow

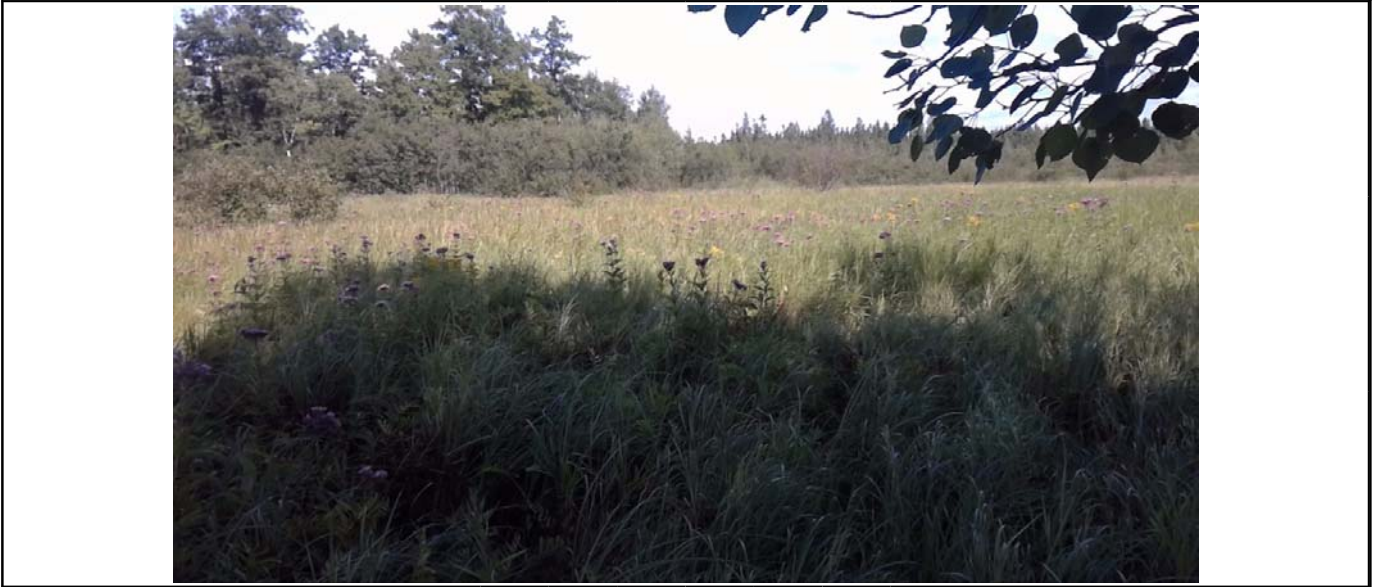
Site Photograph 2

Sampling Point: w-50n26w6-a6

Cowardin Classification: PEM

Direction: East

Eggers & Reed: Fresh (Wet) Meadow
