WETLAND DETERMINATION DATA FORM - North Central and Northeast Region

Project/Site: SPP	City/County: A	City/County: Aitkin		Sampling Date: 2016-08-10		
Applicant/Owner: Enbridge		State: Minnesota	Sampli	ng Point: <u>w-50n26w6-b1</u>		
Investigator(s): ZCW, MGH	Section,	Township, Range: S6, T50N,	R26W			
Landform (hillslope, terrace, etc.): Dep	ression	Local Relief (concav	ve, convex, none): CC	Slope (%): 0-2%		
Subregion (LRR or MLRA):	La [†]	titude: 46.8539713696	Longitude: -93.68324303	Datum: NAD83		
Soil Map Unit Name: 504B			NWI Cla	ssification: N/A		
Are climatic/hydrologic conditions on	the site typical for this tim	ne of year? (if no, explain in R	emarks):	No		
Are Vegetation No , Soil No , or Hy	Hydrology <u>No</u> significan	tly disturbed? Are "Normal C	ircumstances" present? Yes	-		
SUMMARY OF FINDINGS - Attach s	ite map showing samplin	g point locations, transects, i	mportant features, etc.			
Hydrophytic Vegetation Present?	Yes	Is the Sampled Are	a			
Hydric Soil Present?	Yes	within a Wetland?		Yes

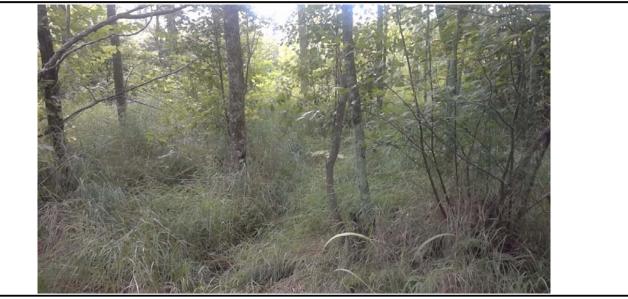
Site Photograph 1 Sampling Point: w-50n26w6-b1

Latitude: 46.854036916091	Cowardin Classification: PFO			
Longitude: -93.6831844412663	Circular 39: 7			
Direction: West	Eggers & Reed: Hardwood Swamp/Coniferous Swamp			
Remarks:
