**WETLAND DETERMINATION DATA FORM - North Central and Northeast Region**

Project/Site: SPP City/County: Aitkin Sampling Date: 2016-08-11  
 Applicant/Owner: Enbridge State: Minnesota Sampling Point: w-50n26w6-e1  
 Investigator(s): ZCW, MGH Section, Township, Range: S6, T50N, R26W  
 Landform (hillslope, terrace, etc.): Depression Local Relief (concave, convex, none): CC Slope (%): 0-2%  
 Subregion (LRR or MLRA): \_\_\_\_\_ Latitude: 46.8558256561... Longitude: -93.67959732... Datum: NAD83  
 Soil Map Unit Name: 504B NWI Classification: N/A  
 Are climatic/hydrologic conditions on the site typical for this time of year? (if no, explain in Remarks): No  
 Are Vegetation No, Soil No, or Hydrology No significantly disturbed? Are "Normal Circumstances" present? Yes  
 Are Vegetation No, Soil No, or Hydrology No naturally problematic? (If needed, explain any answers in Remarks)

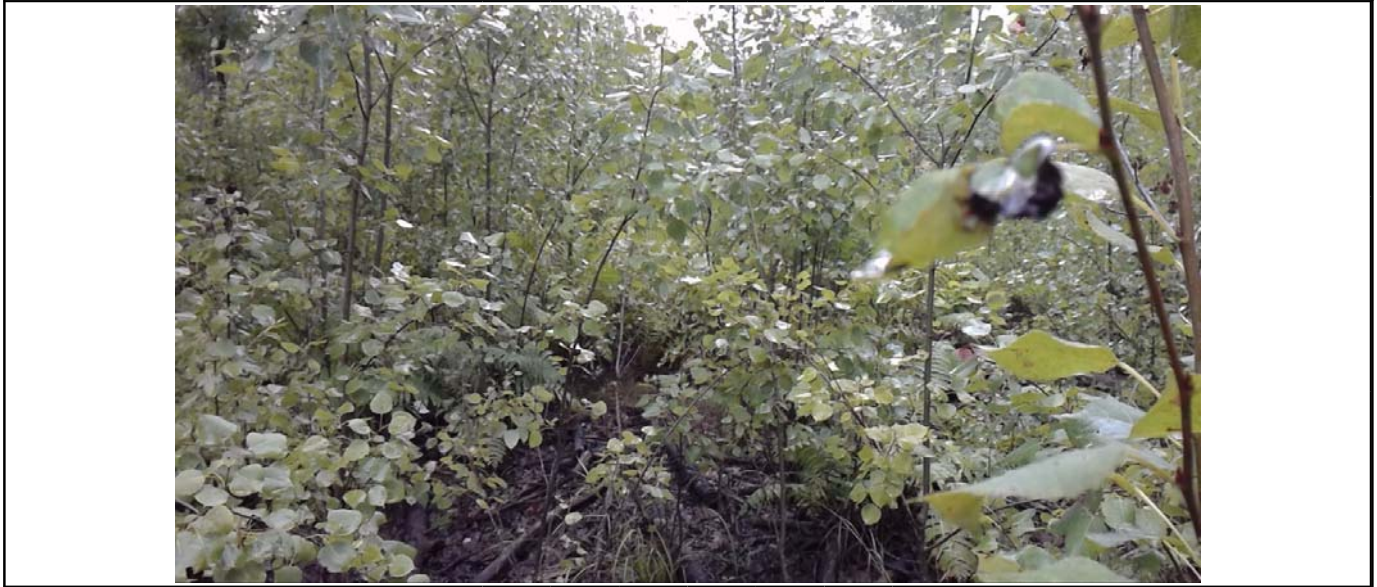
Site Photograph 1

Sampling Point: w-50n26w6-e1

Cowardin Classification: PSS

Direction: Southeast

Eggers & Reed: Seasonally Flooded Basin

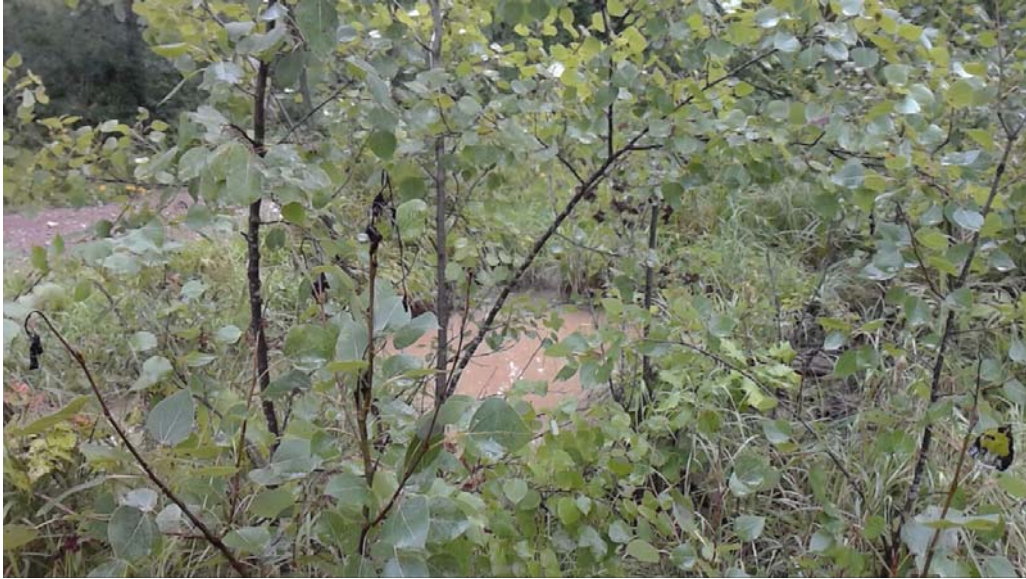
Site Photograph 2

Sampling Point: w-50n26w6-e1

Cowardin Classification: PSS

Direction: Northeast

Eggers & Reed: Seasonally Flooded Basin
