## WETLAND DETERMINATION DATA FORM - North Central and Northeast Region

Project/Site: SPP	Cit	y/County: Aitkin		Sampling Date: 2016-08-11		
Applicant/Owner: Enbridge			State: Minnesota	Sampli	ng Point: w-50n26w6-g1	
Investigator(s): ZCW, MGH		Section, Township	p, Range: <u>S6, T50N, R26</u>	SW .		
Landform (hillslope, terrace, etc.): Depre	ssion		Local Relief (concave, c	onvex, none): CC	Slope (%): 0-2%	
Subregion (LRR or MLRA):		 Latitude: 46	5.848276914141 Loi	ngitude: -93.68272637	Datum: NAD83	
Soil Map Unit Name: 292				NWI Cla	assification: N/A	
Are climatic/hydrologic conditions on the	e site typica	I for this time of year	? (if no, explain in Rema	-	No	
. , .		,		,		
Are Vegetation No_, Soil No_, or Hydrology No_ significantly disturbed? Are "Normal Circumstances" present? Yes_						
Are Vegetation No_, Soil No_, or Hydrology No_ naturally problematic? (If needed, explain any answers in Remarks)						
SUMMARY OF FINDINGS - Attach site	map show	ing sampling point lo	cations, transects, impo	ortant features, etc.

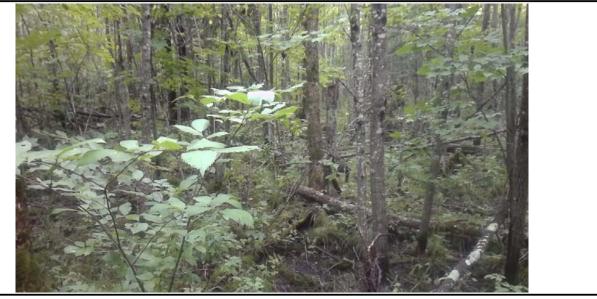
Site Photograph 1 Sampling Point: w-50n26w6-g1

Latitude: 46.8482559593831	Cowardin Classification: PFO
Longitude: -93.6827431340643	Circular 39: 7
Direction: West	Eggers & Reed: Hardwood Swamp/Coniferous Swamp
Damanika

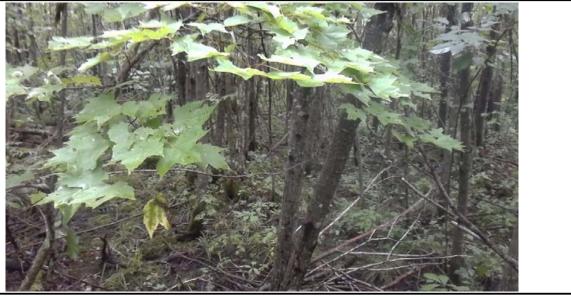
Site Photograph 2 Sampling Point: w-50n26w6-g1

Latitude: 46.848255707926	Cowardin Classification: PFO			
Longitude: -93.6827430502453	Circular 39: 7			
Direction: North	Eggers & Reed: Hardwood Swamp/Coniferous Swamp			
Remarks:
