WETLAND DETERMINATION DATA FORM - North Central and Northeast Region

Project/Site: SPP	City/County: Aitkin		Sampling Date: 2016-08-11			
Applicant/Owner: Enbridge		State: Minnesota	Sampling Point: w-50n26w6-h1			
Investigator(s): ZCW, MGH	Section, Townsh	nip, Range: S6, T50N, R26W				
Landform (hillslope, terrace, etc.): Dep	<u></u>	Local Relief (concave, convex, r	none): CC Slope (%): 0-2%			
Subregion (LRR or MLRA):		•	: -93.68322366 Datum: NAD83			
Soil Map Unit Name: 292			NWI Classification: N\A			
Are climatic/hydrologic conditions on	the site typical for this time of yea	r? (if no explain in Remarks):	No			
Are Vegetation No , Soil No , or I	Are Vegetation No_, Soil No_, or Hydrology No_ significantly disturbed? Are "Normal Circumstances" present? Yes_					
Are Vegetation No , Soil No , or Hy	drology No naturally problemat	ic? (If needed, explain any answ	vers in Remarks)			
· — — ·		, , ,	,			
SUMMARY OF FINDINGS - Attach s	ite map showing sampling point l	ocations, transects, important fe	eatures, etc.

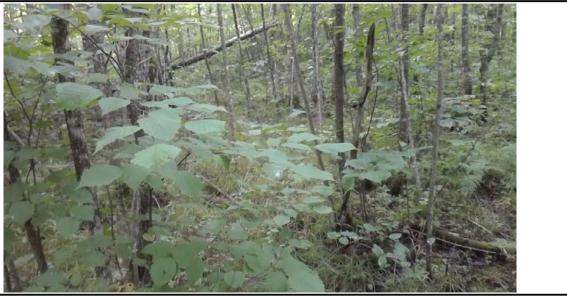
Site Photograph 1 Sampling Point: w-50n26w6-h1

Latitude: 46.8477227865223	Cowardin Classification: PFO
Longitude: -93.6832692661264	Circular 39: 7
Direction: South	Eggers & Reed: Hardwood Swamp/Coniferous Swamp
Remarks:

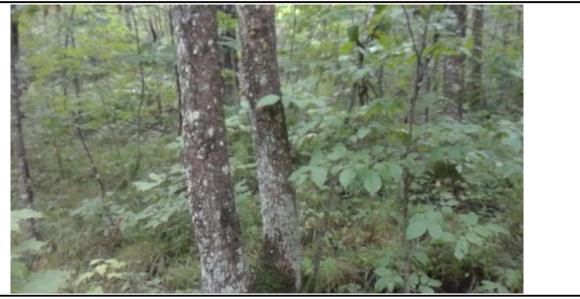
Site Photograph 2 Sampling Point: w-50n26w6-h1

Cowardin Classification: PFO		
Circular 39: 7		
Eggers & Reed: Hardwood Swamp/Coniferous Swamp
