WETLAND DETERMINATION DATA FORM - North Central and Northeast Region

Project/Site: SPP	City/County: Aitkin		Sampling Date: 2016-08-12	
Applicant/Owner: Enbridge		State: Minnesota	Sampling Point: w-50n26w6-k1	
Investigator(s): ZCW, MGH	Section, Townsh	ip, Range: S6, T50N, R26W		
Landform (hillslope, terrace, etc.): Depre		Local Relief (concave, convex, n	one): CC Slope (%): 0-2%	
Subregion (LRR or MLRA):		•	-93.68155592 Datum: NAD83	
Soil Map Unit Name: 504B			NWI Classification: PSSB	
Are climatic/hydrologic conditions on the	e site typical for this time of year	r? (if no explain in Remarks):	No	
_				
Are Vegetation No , Soil No , or Hy	drology No significantly disturb	bed? Are "Normal Circumstance:	s" present? <u>Yes</u>	
Are Vegetation No _, Soil No _, or Hydro	ology No naturally problemati	c? (If needed, explain any answe	ers in Remarks)	
· — — ·	··	, , , , ,	,	
SUMMARY OF FINDINGS - Attach site	e map showing sampling point lo	ocations, transects, important fe	atures, etc.

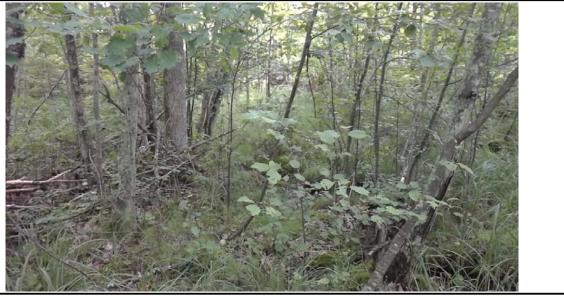
Site Photograph 1 Sampling Point: w-50n26w6-k1

Latitude: 46.8428334547643	Cowardin Classification: PFO	
Longitude: -93.681555669842	Circular 39: 7	
Direction: East	Eggers & Reed: Hardwood Swamp/Coniferous Swamp	
Remarks:

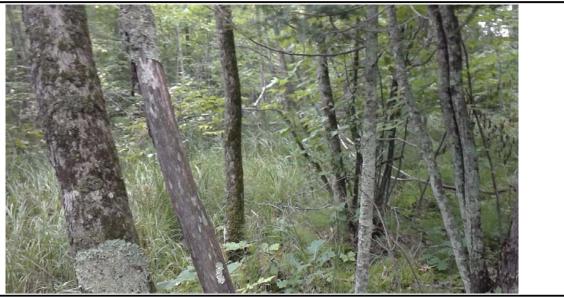
Site Photograph 2 Sampling Point: w-50n26w6-k1

Latitude: 46.8428928824578	Cowardin Classification: PFO	
Longitude: -93.6814721860864	Circular 39: 7	
Direction: West	Eggers & Reed: Hardwood Swamp/Coniferous Swamp	
Remarks:
