WETLAND D	ETERMINATION DATA I	FORM - North Cent	tral and Northeast Regior	1		
Project/Site: SPP	City/County: <u>Aitkin</u>		Sampli	Sampling Date: 2016-08-12		
Applicant/Owner: Enbridge		State: Minnesota	Sampli	ng Point: <u>w-50n26w6-m1</u>		
Investigator(s): ZCW, MGH	vestigator(s): ZCW, MGH Section, Township, Range: S6, T50N, R26W					
Landform (hillslope, terrace, etc.): Depression		Local Relief (concav	e, convex, none): CC	Slope (%): 0-2%		
Subregion (LRR or MLRA):	Latitude: 46	5.8432994047	Longitude: -93.67935642	Datum: NAD83		
Soil Map Unit Name: 292			NWI Cla	assification: N/A		
Are climatic/hydrologic conditions on the site	typical for this time of year	? (if no, explain in Re	emarks):	No		
Are Vegetation <u>No</u> , Soil <u>No</u> , or Hydrolog	y <u>No</u> significantly distur	bed? Are "Normal Ci	rcumstances" present? Yes	-		
Are Vegetation No , Soil No , or Hydrology	No naturally problemati	c2 (If pooded expla	in any answors in Pomarks)

VEGETATION - Use scientific names of plants.

SOIL

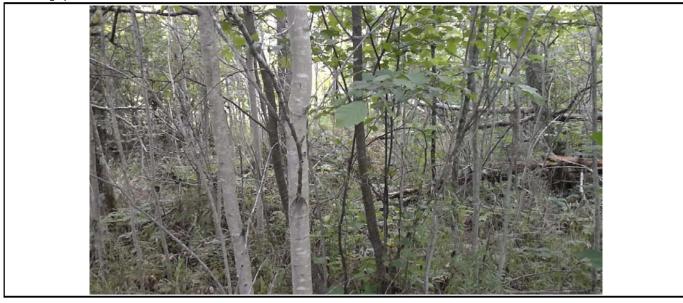
Site Photograph 1

Cowardin Classification: PFO

Circular 39: 7

Direction: West

Eggers & Reed: Hardwood Swamp/Coniferous Swamp

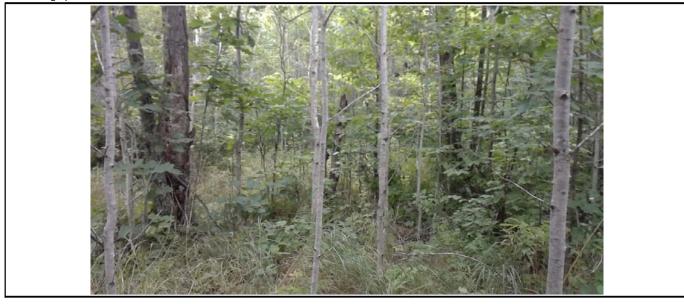
Site Photograph 2

Cowardin Classification: PFO

Direction: East

Circular 39: 7 Eggers & Reed: Hardwood Swamp/Coniferous Swamp
