**WETLAND DETERMINATION DATA FORM - North Central and Northeast Region**

Project/Site: SPP City/County: Aitkin Sampling Date: 2016-08-16  
 Applicant/Owner: Enbridge State: Minnesota Sampling Point: w-50n26w7-b1  
 Investigator(s): ZCW, MGH Section, Township, Range: S7, T50N, R26W  
 Landform (hillslope, terrace, etc.): Depression Local Relief (concave, convex, none): CC Slope (%): 0-2%  
 Subregion (LRR or MLRA): \_\_\_\_\_ Latitude: 46.8285898771... Longitude: -93.68123631... Datum: NAD83  
 Soil Map Unit Name: 204B NWI Classification: N/A  
 Are climatic/hydrologic conditions on the site typical for this time of year? (if no, explain in Remarks): No  
 Are Vegetation No, Soil No, or Hydrology No significantly disturbed? Are "Normal Circumstances" present? Yes  
 Are Vegetation No, Soil No, or Hydrology No naturally problematic? (If needed, explain any answers in Remarks)

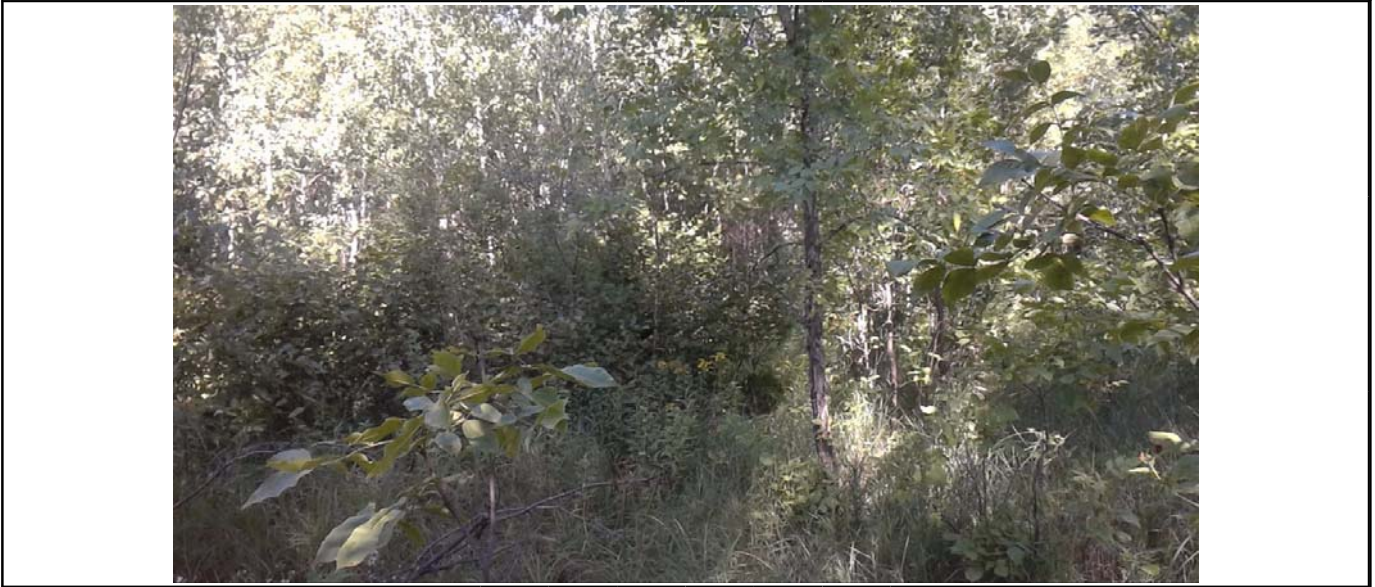
Site Photograph 1

Sampling Point: w-50n26w7-b1

Cowardin Classification: PFO

Direction: West

Eggers & Reed: Seasonally Flooded Basin

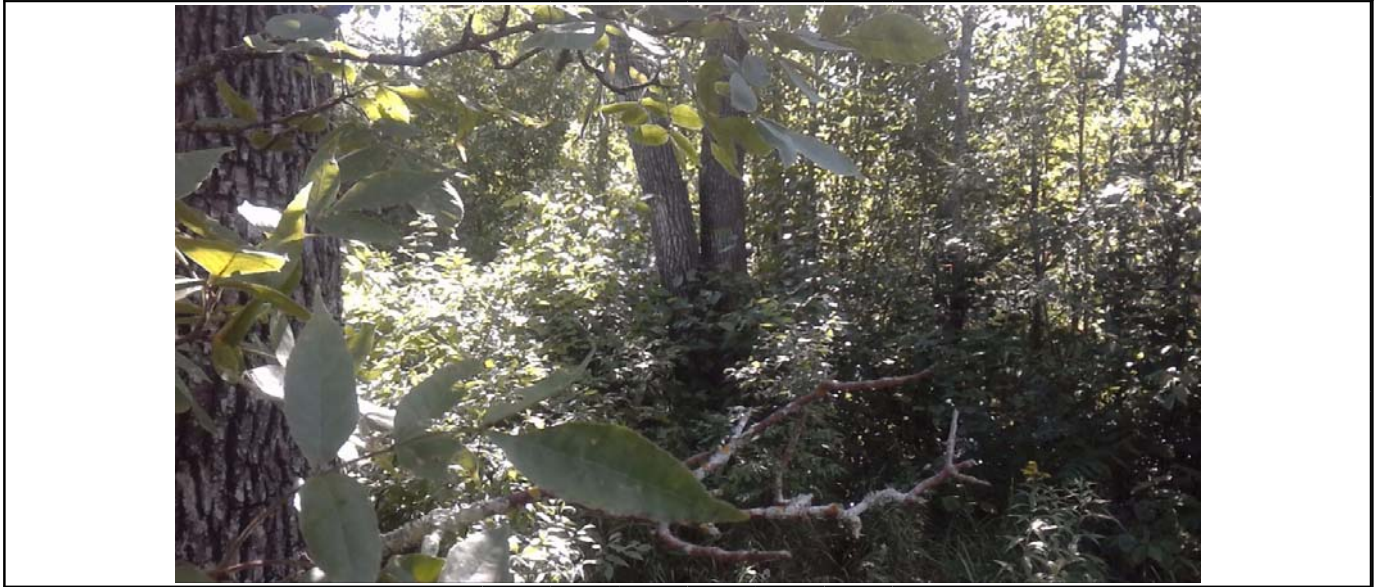
Site Photograph 2

Sampling Point: w-50n26w7-b1

Cowardin Classification: PFO

Direction: East

Eggers & Reed: Seasonally Flooded Basin
