WETLAND DETERMINATION DATA FORM - North Central and Northeast Region

Project/Site: SPP	City/County: Aitkin		Sampling Date: 2016-08-16		
Applicant/Owner: Enbridge		State: Minnesota	Sampling Point: w-50n26w7-c1		
Investigator(s): ZCW, MGH	Section, Townsh	ip, Range: <u>S7, T50N, R26W</u>			
Landform (hillslope, terrace, etc.): Depress	ion	Local Relief (concave, convex, r	none): CC Slope (%): 0-2%		
Subregion (LRR or MLRA):	Latitude: 4	5.8279459374 Longitude:	-93.68110816 Datum: NAD83		
Soil Map Unit Name: 204B			NWI Classification: N/A		
Are climatic/hydrologic conditions on the s	site typical for this time of year	? (if no, explain in Remarks):	No		
Are Vegetation No , Soil No , or Hydrology No significantly disturbed? Are "Normal Circumstances" present? Yes_					
Are Vegetation No , Soil No , or Hydrology No naturally problematic? (If needed, explain any answers in Remarks)					
SUMMARY OF FINDINGS - Attach site n	nap showing sampling point lo	ocations, transects, important fe	eatures, etc.

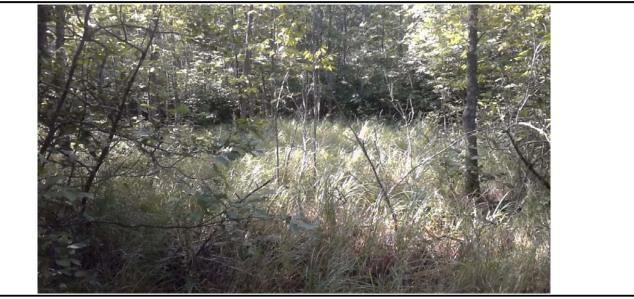
Site Photograph 1 Sampling Point: w-50n26w7-c1

The state of the s		
Latitude: 46.8279383099143	Cowardin Classification: PFO	
Longitude: -93.6810962577292	Circular 39: 1	
Direction: South	Eggers & Reed: Seasonally Flooded Basin	
Remarks:

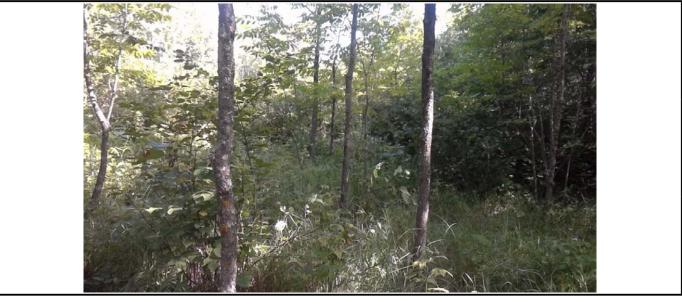
Site Photograph 2 Sampling Point: w-50n26w7-c1

Latitude: 46.8279380165477	Cowardin Classification: PFO
Longitude: -93.6810964253672	Circular 39: 1
Direction: North	Eggers & Reed: Seasonally Flooded Basin
Remarks:
