WETLAND DETERMINATION DATA FORM - North Central and Northeast Region

Project/Site: SPP	Cit	ty/County: Aitkin		Sampling Date: 2016-08-16		
Applicant/Owner: Enbridge			State: Minnesota	Samplir	ng Point: w-50n26w7-d1	
Investigator(s): ZCW,MGH		Section, Townshi	p, Range: <u>\$7, T50N, R26</u> V	N		
Landform (hillslope, terrace, etc.): Depress	sion		Local Relief (concave, co	onvex, none): CC	Slope (%): 0-2%	
Subregion (LRR or MLRA):		 Latitude: 46	5.8308480876 Lon	gitude: -93.68275361	Datum: NAD83	
Soil Map Unit Name: 204B				NWI Cla	ssification: N/A	
Are climatic/hydrologic conditions on the	site typica	al for this time of year	? (if no, explain in Remar		No	
Are Vegetation No , Soil No , or Hydrology No significantly disturbed? Are "Normal Circumstances" present? Yes						
Are Vegetation No_, Soil No_, or Hydrology No_ naturally problematic? (If needed, explain any answers in Remarks)						
SUMMARY OF FINDINGS - Attach site r	map show	ving sampling point lo	cations, transects, impo	rtant features, etc.

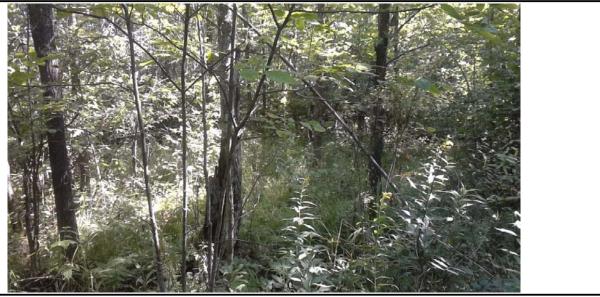
Site Photograph 1 Sampling Point: w-50n26w7-d1

Latitude: 46.8308455311198	Cowardin Classification: PFO			
Longitude: -93.6827493366726	Circular 39: 7			
Direction: South	Eggers & Reed: Hardwood Swamp/Coniferous Swamp			
Remarks:
