WETLAND DETERMINATION DATA FORM - North Central and Northeast Region

Project/Site: SPP City/County: Aitkin Sampling Date: 2016-08-16
 Applicant/Owner: Enbridge State: Minnesota Sampling Point: w-50n26w7-e1
 Investigator(s): ZCW, MGH Section, Township, Range: S7, T50N, R26W
 Landform (hillslope, terrace, etc.): Depression Local Relief (concave, convex, none): CC Slope (%): 0-2%
 Subregion (LRR or MLRA): _____ Latitude: 46.8307216465... Longitude: -93.68346657... Datum: NAD83
 Soil Map Unit Name: 292 NWI Classification: N/A
 Are climatic/hydrologic conditions on the site typical for this time of year? (if no, explain in Remarks): No
 Are Vegetation No, Soil No, or Hydrology No significantly disturbed? Are "Normal Circumstances" present? Yes
 Are Vegetation No, Soil No, or Hydrology No naturally problematic? (If needed, explain any answers in Remarks)

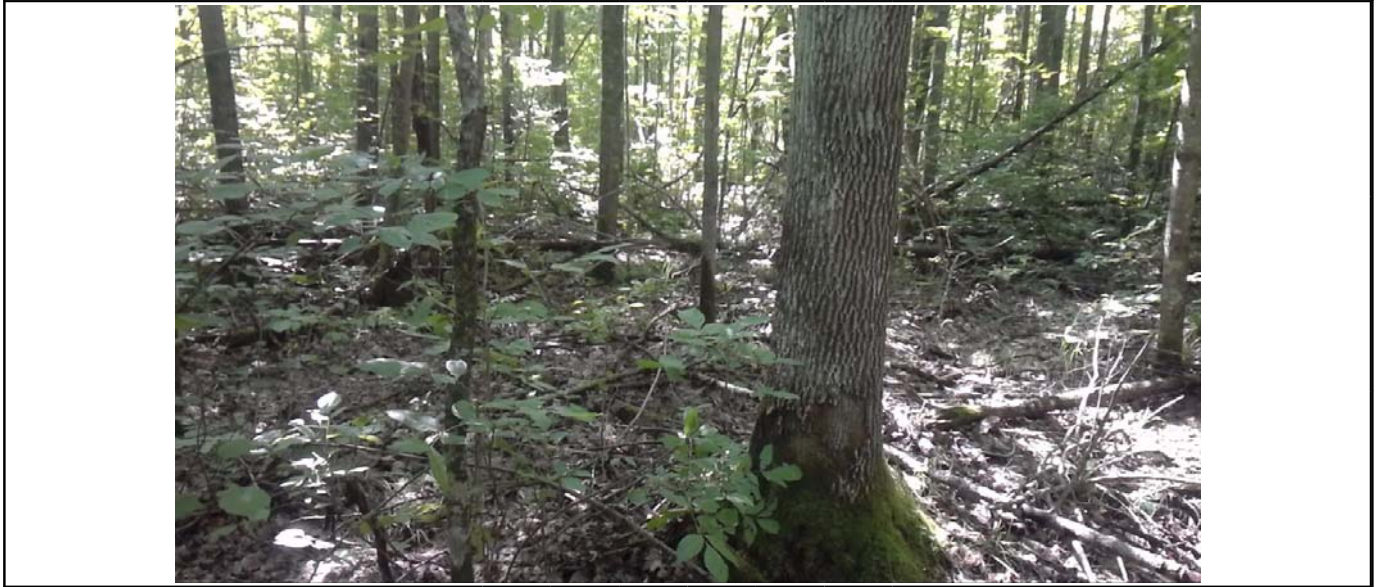
Site Photograph 1

Cowardin Classification: PFO

Circular 39: 1

Direction: Southeast

Eggers & Reed: Seasonally Flooded Basin

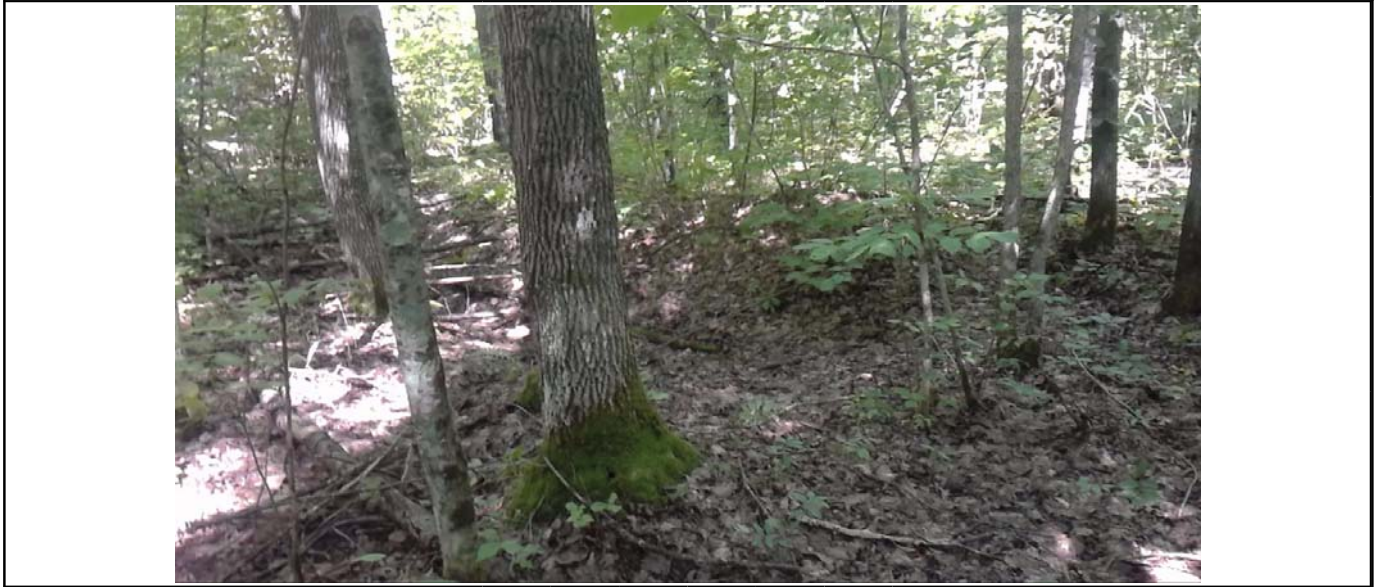
Site Photograph 2

Cowardin Classification: PFO

Circular 39: 1

Direction: Northwest

Eggers & Reed: Seasonally Flooded Basin
