ect/Site: SPP City/County: <u>Aitkin</u>				Sampling Date: 2016-08-16		
Enbridgo		<u> </u>	Ciata Minnosota	-	Consultan Data		
Applicant/Owner: Enbridge			State: <u>Minnesota</u>		Sampling Poin	t: w-50n26w7-i1	
Investigator(s): ZCW, MGH		Section, Townshi	ip, Range:				
Landform (hillslope, terrace, etc.): Depres	sion			ave, convex, none): <u>CC</u>		Slope (%): <u>0-2%</u>	
Subregion (LRR or MLRA):		Latitude: 46	5.8363680318	Longitude: -93.6820		atum: NAD83	
Soil Map Unit Name: 204B					NWI Classificat	tion: N/A	
Are climatic/hydrologic conditions on the	site typical	for this time of year	? (if no, explain in R	Remarks):		No	
Are Vegetation <u>No</u> , Soil <u>No</u> , or Hyd	Irology <u>No</u>	_ significantly distur	bed? Are "Normal C	Circumstances" preser	it? Yes		
Are Vegetation <u>No</u> , Soil <u>No</u> , or Hydro	ology <u>No</u> r	naturally problemation	c?(If needed, expl	ain any answers in Rer	narks)

SUMMARY OF FINDINGS - Attach site	map showi	ng sampling point lo	ocations, transects,	important features, e	tc.		
Hydrophytic Vegetation Present?	Y	es	Is the Sampled Area				
Hydric Soil Present?	Y	'es	within a Wetland? Yes				
Wetland Hydrology Present?	Y	es	If yes, optional We

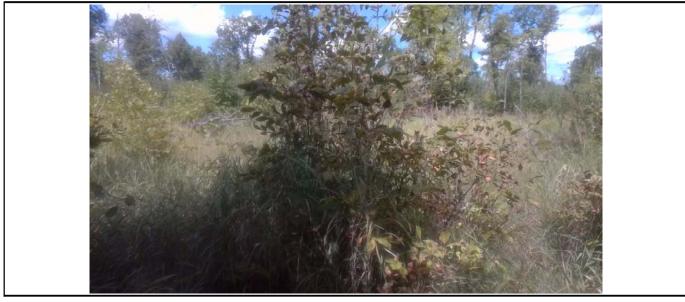
Latitude: 46.8363093585212

Longitude: -93.6821446661778

Cowardin Classification: PSS

Circular 39: 6

Direction: North

Eggers & Reed: Shrub-Carr/Alder Thicket

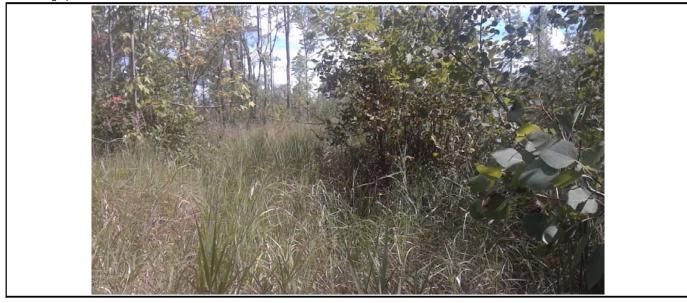
Site Photograph 2

Latitude: 46.8363129208301

Longitude: -93.6821604241558

Cowardin Classification: <u>PSS</u> Circular 39: <u>6</u>

Direction: East

Eggers & Reed: Shrub-Carr/Alder Thicket
