WETLAND DETERMINATION DATA FORM - North Central and Northeast Region

Site Photograph 1 Sampling Point: w-50n26w7-k1

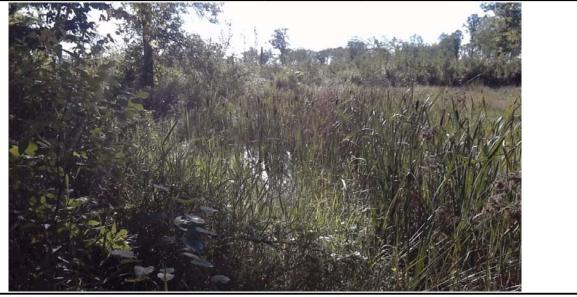
Latitude: 46.8401970947598	Cowardin Classification: PEM
Longitude: -93.6813447811582	Circular 39: 2
Direction: West	Eggers & Reed: Fresh (Wet) Meadow

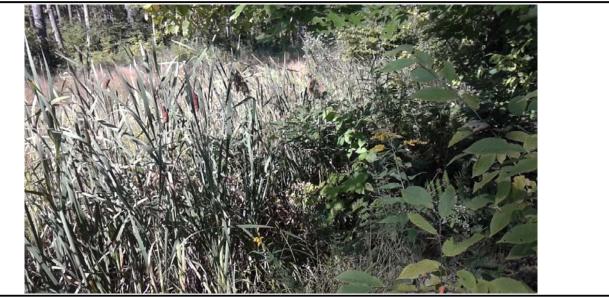
Site Photograph 2 Sampling Point: w-50n26w7-k1

Latitude: 46.8401973043073	Cowardin Classification: PEM
Longitude: -93.6813446135201	Circular 39: 2
Direction: West	Eggers & Reed: Fresh (Wet) Meadow
Remarks:
