## WETLAND DETERMINATION DATA FORM - North Central and Northeast Region

Project/Site: SPP	City/County: Aitkin		Sampling Date: 2016-08-17		
Applicant/Owner: Enbridge		State: Minnesota	Sampling Point: w-50n26w7-m1		
Investigator(s): ZCW, MGH Section, Township, Range: S7, T50N, R26W					
Landform (hillslope, terrace, etc.): Dep	oression	Local Relief (concave, conve	ex, none): CC Slope (%): 0-2%		
Subregion (LRR or MLRA):		,	ude: -93.67957460 Datum: NAD83		
Soil Map Unit Name: 292			NWI Classification: N/A

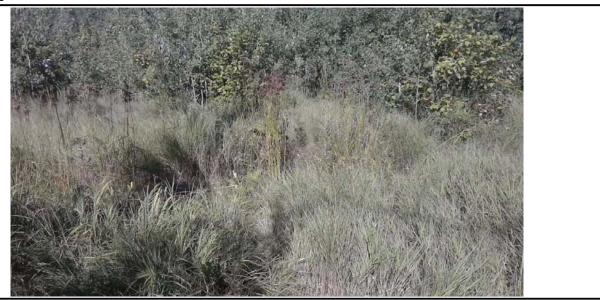
Site Photograph 1 Sampling Point: w-50n26w7-m1

Latitude: 46.8401377927948	Cowardin Classification: PEM
Longitude: -93.6795791332551	Circular 39: 1
Direction: West	Eggers & Reed: Seasonally Flooded Basin
Remarks:

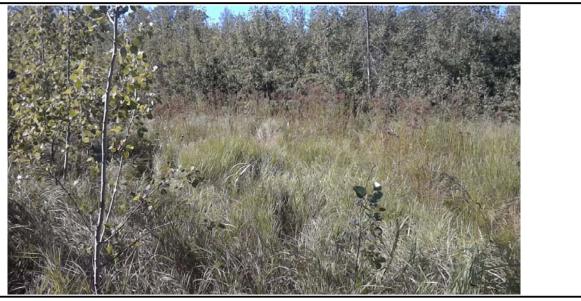
Site Photograph 2 Sampling Point: w-50n26w7-m1

Latitude: 46.8401374994282	Cowardin Classification: PEM	
Longitude: -93.6795803067215	Circular 39: 1	
Direction: South	Eggers & Reed: Seasonally Flooded Basin	
Remarks:
