WETLAND DETERMINATION DATA FORM - North Central and Northeast Region

Project/Site: SPP	Ci	ity/County: Aitkin		Sampling Date: 2016-08-17			
Applicant/Owner: Enbridge			State: Minnesota	Samplin	ng Point: w-50n26w7-q1		
Investigator(s): ZCW, MGH		Section, Township	p, Range: <u>S7, T50N, R26</u>	5W			
Landform (hillslope, terrace, etc.): Depres	ssion		Local Relief (concave, c	convex, none): CC	Slope (%): <u>0-2%</u>		
Subregion (LRR or MLRA):		Latitude: 46	i.8385563372 Loi	ngitude: -93.67964845	Datum: NAD83		
Soil Map Unit Name: 204B		_		NWI Cla	ssification: N/A		
Are climatic/hydrologic conditions on the	site typic	al for this time of year?	? (if no, explain in Rema	- rks):	No		
Are Vegetation No , Soil No , or Hyd	drology <u>No</u>	significantly disturb	ped? Are "Normal Circu	mstances" present? Yes			
Are Vegetation No_, Soil No_, or Hydrology No_ naturally problematic? (If needed, explain any answers in Remarks)							
SUMMARY OF FINDINGS - Attach site	map shov	ving sampling point lo	cations, transects, impo	ortant features, etc.

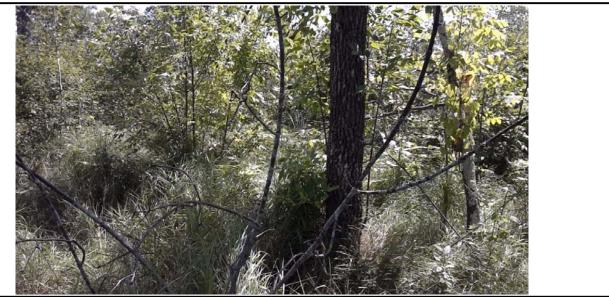
Site Photograph 2 Sampling Point: w-50n26w7-q1

ALTERNATION OF THE PROPERTY OF	
Latitude:	46.8385630008269	Cowardin Classification: PFO
Longitude:	-93.6795741041132	Circular 39: 1
Direction: East		Eggers & Reed: Seasonally Flooded Basin
Remarks:
