**WETLAND DETERMINATION DATA FORM - North Central and Northeast Region**

Project/Site: SPP City/County: Aitkin Sampling Date: 2016-08-17  
 Applicant/Owner: Enbridge State: Minnesota Sampling Point: w-50n26w7-r1  
 Investigator(s): ZCW, MGH Section, Township, Range: S7, T50N, R26W  
 Landform (hillslope, terrace, etc.): Depression Local Relief (concave, convex, none): CC Slope (%): 0-2%  
 Subregion (LRR or MLRA): \_\_\_\_\_ Latitude: 46.8379038479... Longitude: -93.67918350... Datum: NAD83  
 Soil Map Unit Name: 204B NWI Classification: N/A  
 Are climatic/hydrologic conditions on the site typical for this time of year? (if no, explain in Remarks): No  
 Are Vegetation No, Soil No, or Hydrology No significantly disturbed? Are "Normal Circumstances" present? Yes  
 Are Vegetation No, Soil No, or Hydrology No naturally problematic? (If needed, explain any answers in Remarks)

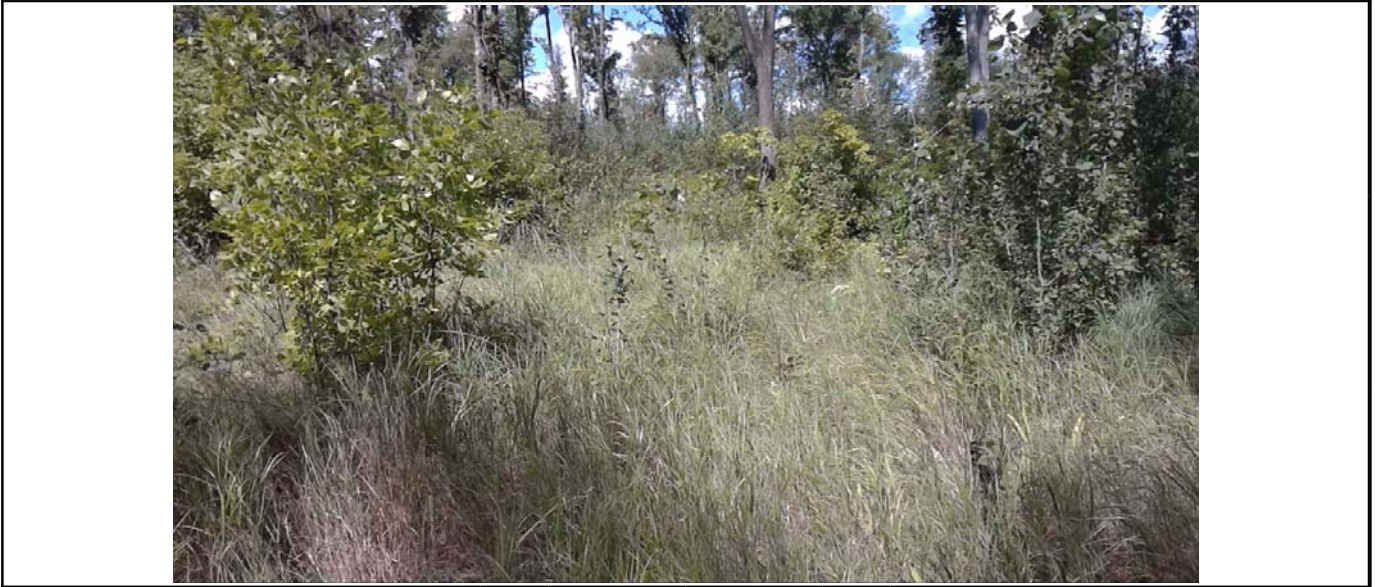
Site Photograph 1

Sampling Point: w-50n26w7-r1

Cowardin Classification: PEM

Direction: West

Eggers & Reed: Seasonally Flooded Basin

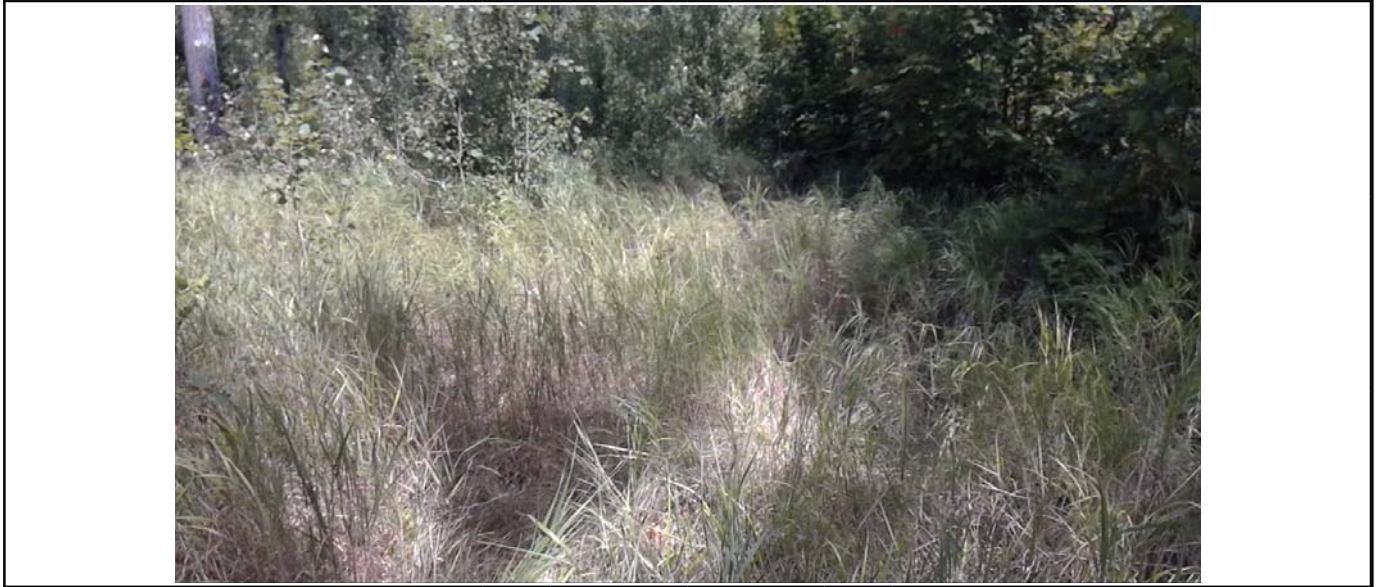
Site Photograph 2

Sampling Point: w-50n26w7-r1

Cowardin Classification: PEM

Direction: North

Eggers & Reed: Seasonally Flooded Basin
