WETLAND DETERMINATION DATA FORM - North Central and Northeast Region

Site Photograph 1 Sampling Point: w-50n26w7-s1

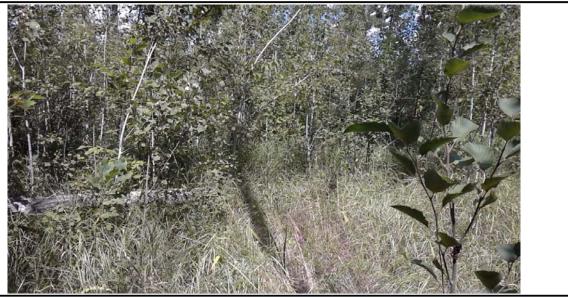
Latitude: 46.83	3881290727	Cowardin Classification: PSS		
Longitude: -93.67	784517672785	Circular 39: 1		
Direction: West		Eggers & Reed: Seasonally Flooded Basin		
Remarks:
