WETLAND DETERMINATION DATA FORM - North Central and Northeast Region

Project/Site: SPP	City,	/County: Aitkin		Sampling Date: 2016-08-17			
Applicant/Owner: Enbridge			State: Minnesota	Samplir	ng Point: <u>w-50n26w7-t1</u>		
Investigator(s): ZCW, MGH		_ Section, Township	p, Range: <u>S7, T50N, R26</u> V	N			
Landform (hillslope, terrace, etc.): Depre	ssion	_	Local Relief (concave, co	onvex, none): CC	Slope (%): 0-2%		
Subregion (LRR or MLRA):		 Latitude: 46	.8397018500 Lon	gitude: -93.67842804	Datum: NAD83		
Soil Map Unit Name: 292				NWI Cla	ssification: N/A		
Are climatic/hydrologic conditions on the	site typical t	for this time of year	? (if no. explain in Remar		No .		
. , .	• •	,		•			
Are Vegetation No_, Soil No_, or Hydrology No_ significantly disturbed? Are "Normal Circumstances" present? Yes_							
Are Vegetation No , Soil No , or Hydrology No naturally problematic? (If needed, explain any answers in Remarks)							
SUMMARY OF FINDINGS - Attach site	map showin	ng sampling point lo	cations, transects, impo	rtant features, etc.

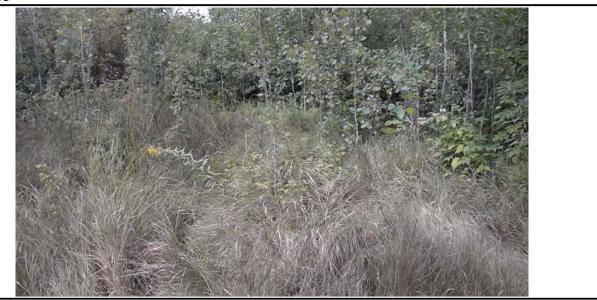
Site Photograph 2 Sampling Point: w-50n26w7-t1

A STATE OF THE RESIDENCE OF THE PROPERTY OF TH
Latitude: 46.8396947253932	Cowardin Classification: PFO
Longitude: -93.6784320698061	Circular 39: 1
Direction: West	Eggers & Reed: Seasonally Flooded Basin
Remarks:
