WETLAND DETERMINATION DATA FORM - North Central and Northeast Region

Project/Site: SPP	City/Coun	City/County: Carlton		Sampling Date: 2016-07-18			
Applicant/Owner: Enbridge		State: Minnesota			Sampling Point: u-47n18w2-ab1		
Investigator(s): ZCW	Sec	tion, Township	, Range: <u>S 2, T 49N</u>	I, R 18W			_
Landform (hillslope, terrace, etc.): Si	de Slope	ı	Local Relief (concav	ve, convex, none):	: VL	Slope (%	6): 8-15%
Subregion (LRR or MLRA):		Latitude: 46.	5820885403	Longitude: -92.5	 58301975	Datum: NAD	083
Soil Map Unit Name: 355C						fication: N/A	
Are climatic/hydrologic conditions o	n the site typical for thi	s time of year?	(if no. explain in Re	emarks):		Yes	
Are Vegetation No , Soil No , o	••	•		,	esent? Yes_		
Are Vegetation No_, Soil No_, or F	Hydrology <u>No</u> natural	ly problematic:	? (If needed, expla	nin any answers in	Remarks)		
SUMMARY OF FINDINGS - Attach	site map showing sam	pling point loc	ations, transects, i	mportant feature	es, etc.		
Hydrophytic Vegetation Present?	<u>No</u>		Is the Sampled Are	ea

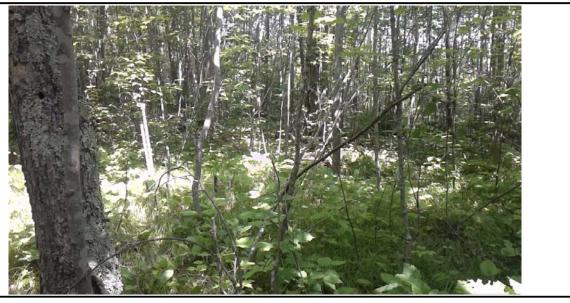
Site Photograph 1 Sampling Point: u-47n18w2-ab1

Latitude:	46.5821120096804	Cowardin Classification:	_
Longitude:	-92.5830372703193	Circular 39:	
Direction: Nor	th	Eggers & Reed:	
Remarks:

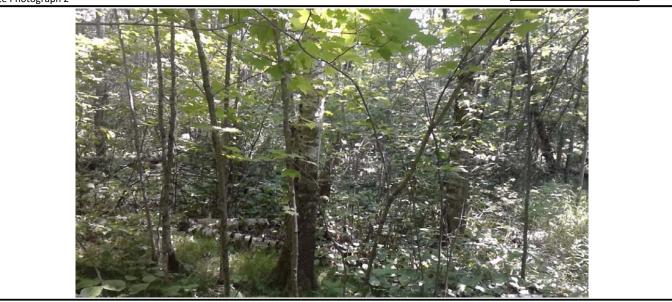
Site Photograph 2 Sampling Point: u-47n18w2-ab1

Latitude: 46.582112135409	Cowardin Classification:
Longitude: -92.5830371026812	Circular 39:
Direction: East	Eggers & Reed:
Remarks:
