WETLAND DETERMINATION DATA FORM - North Central and Northeast Region

Site Photograph 1 Sampling Point: u-47n18w2-ad1

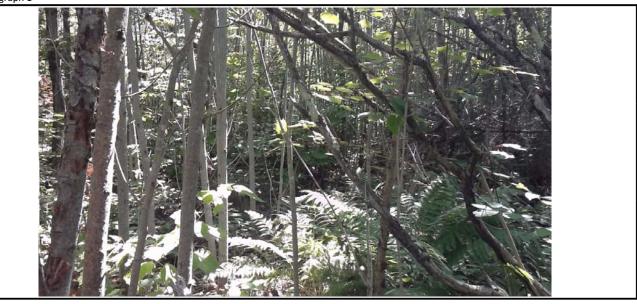
Latitude: 46.5778072318496	Cowardin Classification:
Longitude: -92.5877853670088	Circular 39:
Direction: South	Eggers & Reed:
Remarks:

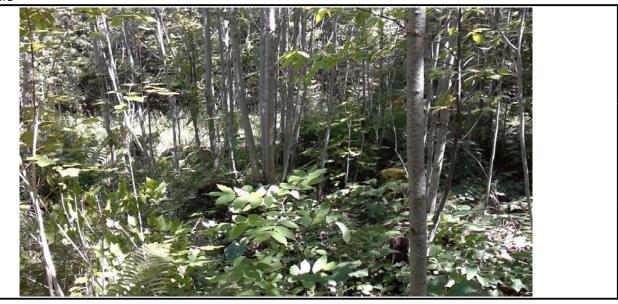
Site Photograph 2 Sampling Point: u-47n18w2-ad1

Latitude:	46.5778072737591	Cowardin Classification:					
Longitude:	-92.5877854508279	Circular 39:					
Direction: East	t .	Eggers & Reed:					
Remarks:
