WETLAND DETERMINATION DATA FORM - North Central and Northeast Region

Project/Site: SPP	City/County: Carlton			Sampling Date: 2016-07-19		
Applicant/Owner: Enbridge		State: Minnesota		Samplin	g Point: <u>u-47n18w2-ae1</u>	
Investigator(s): ZCW		Section, Townshi	p, Range: <u>S 2,T 47N, R 18</u>	3W		
Landform (hillslope, terrace, etc.): Side Sl	оре		Local Relief (concave, co	nvex, none): VL	Slope (%): <u>3-7%</u>	
Subregion (LRR or MLRA):		Latitude: 46	5.5822661528 Lon	gitude: -92.58864920	Datum: NAD83	
Soil Map Unit Name: 268B				NWI Clas	ssification: N/A	
Are climatic/hydrologic conditions on the	site typica	al for this time of year	? (if no, explain in Remarl	ks):	Yes	
Are Vegetation No_, Soil No_, or Hydrology No_ significantly disturbed? Are "Normal Circumstances" present? Yes						
Are Vegetation No_, Soil No_, or Hydro	ology <u>No</u>	_ naturally problemation	c? (If needed, explain an	y answers in Remarks)		
SUMMARY OF FINDINGS - Attach site	map shov	ving sampling point lo	ocations, transects, impor	rtant features, etc.

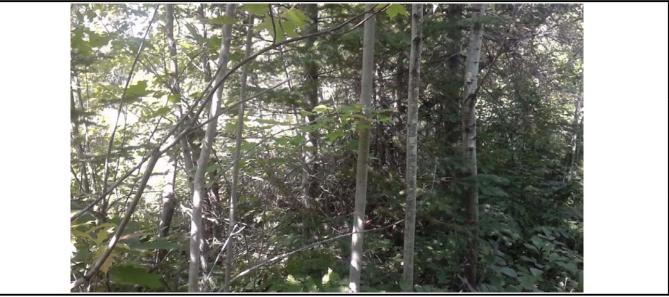
Site Photograph 1 Sampling Point: u-47n18w2-ae1

Latitude: 46.5822626324804	Cowardin Classification:			
Longitude: -92.5885963161407	Circular 39:			
Direction: North	Eggers & Reed:			
Remarks:

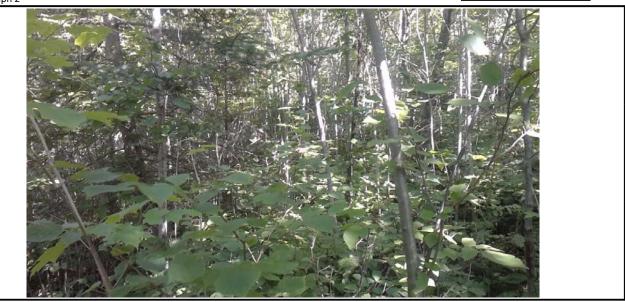
Site Photograph 2 Sampling Point: u-47n18w2-ae1

Latitude:	46.5822628001185	Cowardin Classification:
Longitude:	-92.5885963999597	Circular 39:
Direction: East		Eggers & Reed:
Remarks:
