WETLAND DETERMINATION DATA FORM - North Central and Northeast Region

Project/Site: SPP	City/County: Car	lton	Sampling Date: 2016-08-31				
Applicant/Owner: Enbridge		State: Minnesota	Sampling Pc	int: u-47n21w2-aa1			
Investigator(s): DPT, MGH							
Landform (hillslope, terrace, etc.): Ris		·	e, convex, none): VV	Slope (%): 3-7%			
Subregion (LRR or MLRA):	·	ude: 46.5919023659	· · · · · · · · · · · · · · · · · · ·	Datum: NAD83			
Soil Map Unit Name: 43B		<u> </u>	NWI Classific

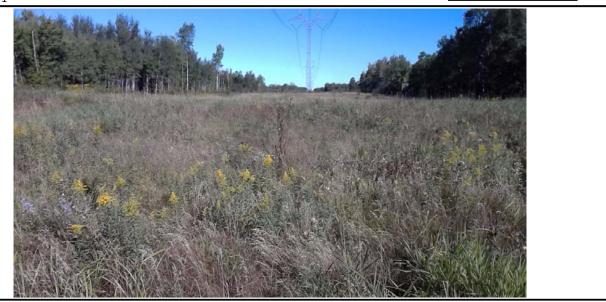
Site Photograph 1 Sampling Point: u-47n21w2-aa1

Latitude:	46.5919047547938	Cowardin Classification:
Longitude:	-92.9541515652956	Circular 39:
Direction: nort	h	Eggers & Reed:
Remarks:		
upland

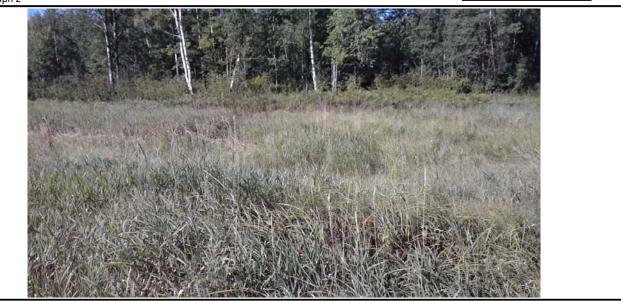
Site Photograph 2 Sampling Point: u-47n21w2-aa1

Latitude: 46.5919047547938	Cowardin Classification:		
Longitude: -92.9541515652956	Circular 39:		
Direction: west	Eggers & Reed:		
Remarks:			
upland
