WETLAND DETERMINATION DATA FORM - North Central and Northeast Region

Project/Site: SPP	City/0	City/County: Carlton		Sampling Date: 2016-09-01		
Applicant/Owner: Enbridge			State: Minnesota	S	ampling Point: <u>u-48</u> r	117w31-ab1
Investigator(s): DPT, MGH		Section, Townshi	p, Range: <u>S31, T48N</u>	I, R17W		
Landform (hillslope, terrace, etc.): Ri	ise		Local Relief (concav	ve, convex, none): VL	Slope	e (%): <u>0-2%</u>
Subregion (LRR or MLRA):		Latitude: 46	5.6045177169	Longitude: -92.54390	 0870 Datum: N	AD83
Soil Map Unit Name: 188C		_		N'	WI Classification: N/	 А
Are climatic/hydrologic conditions o	n the site typical for	or this time of year	? (if no, explain in R	emarks):	No	
Are Vegetation No , Soil No , o	r Hydrology <u>No</u>	significantly disturk	ped? Are "Normal C	ircumstances" present?	? <u>Yes</u>	
Are Vegetation No , Soil No , or H	Hydrology <u>No</u> na	turally problemation	c? (If needed, expla	ain any answers in Rema	arks)	
SUMMARY OF FINDINGS - Attach	site map showing	g sampling point lo	cations, transects, i	important features, etc	:

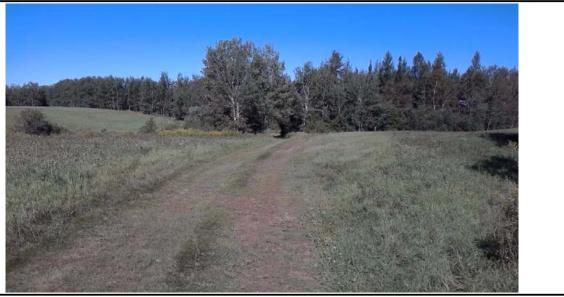
Site Photograph 1 Sampling Point: u-48n17w31-ab1

是一个人的人的人的人的人		
Latitude:	46.6045152862059	Cowardin Classification:	_
Longitude:	-92.5439068582771	Circular 39:	
Direction: Wes	st	Eggers & Reed:	
Remarks:			_
Upland			
1

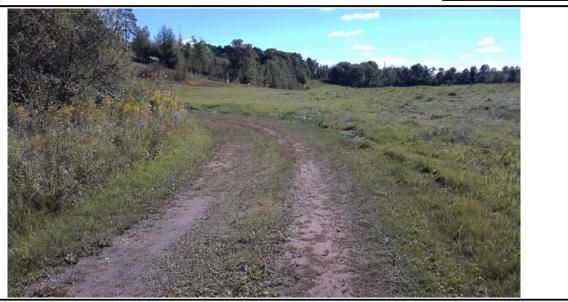
Site Photograph 2 Sampling Point: u-48n17w31-ab1

是一个一个一个一个一个一个一个一个一个一个一个一个一个一个一个一个一个一个一个
Latitude:	46.6045152862059	Cowardin Classification:
Longitude:	-92.5439068582771	Circular 39:
Direction: East		Eggers & Reed:
Remarks:		
Upland
