WETLAND DETERMINATION DATA FORM - North Central and Northeast Region

Site Photograph 1 Sampling Point: u-48n18w36-NWI1

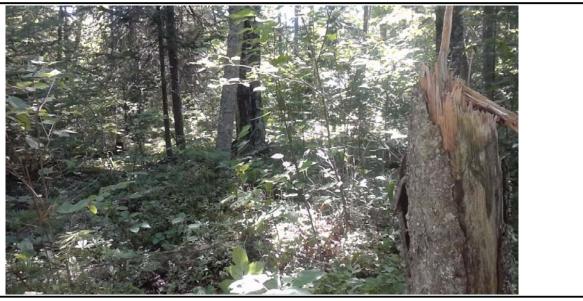
Latitude: 46.594696180007	Cowardin Classification:			
Longitude: -92.5693372172234	Circular 39:			
Direction: East	Eggers & Reed:			
Remarks:

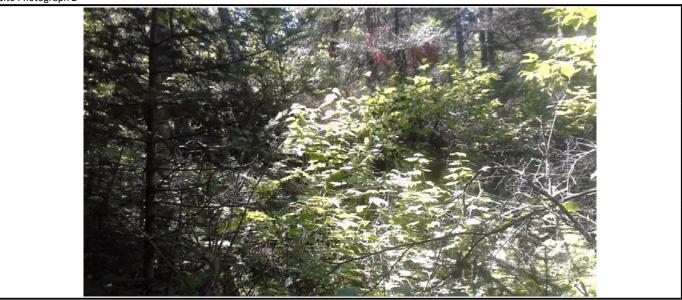
Site Photograph 2 Sampling Point: u-48n18w36-NWI1

Latitude:	46.5946963476451	Cowardin Classification:		
Longitude:	-92.5693371334044	Circular 39:		
Direction: Sou	th	Eggers & Reed:		
Remarks:
