## WETLAND DETERMINATION DATA FORM - North Central and Northeast Region

Project/Site: SPP	City/County: Carlton		Samplin	ng Date: 2016-07-18	
Applicant/Owner: Enbridge		State: Minnesota	Samplin	ng Point: w-47n18w2-ab1	
Investigator(s): ZCW	Section, Townsh	ip, Range:			
Landform (hillslope, terrace, etc.): Depression		Local Relief (concave, co	onvex, none): CC	Slope (%): <u>0-2%</u>	
Subregion (LRR or MLRA):	Latitude: 4	6.5820405539 Lon	gitude: -92.58296753	Datum: NAD83	
Soil Map Unit Name: 355C			NWI Clas	ssification: N/A	
Are climatic/hydrologic conditions on the site	typical for this time of year	r? (if no, explain in Remar	ks):	Yes	
Are Vegetation No_, Soil No_, or Hydrolog	y <u>No</u> significantly distur	bed? Are "Normal Circum	nstances" present? Yes		
Are Vegetation No_, Soil No_, or Hydrology	No naturally problemati	ic? (If needed, explain an	ny answers in Remarks)		
SUMMARY OF FINDINGS - Attach site map	showing sampling point le	ocations, transects, impo	rtant features, etc.

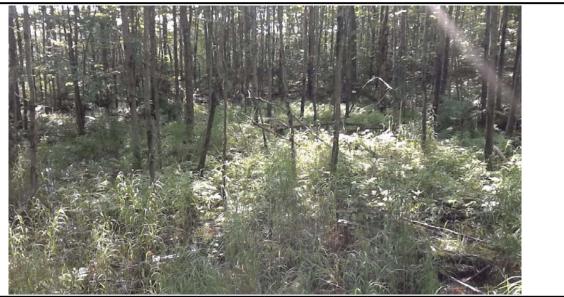
Site Photograph 1 Sampling Point: w-47n18w2-ab1

Latitude: 46.5820393385799	Cowardin Classification: PFO
Longitude: -92.5829530321924	Circular 39: 1
Direction: Southeast	Eggers & Reed: Seasonally Flooded Basin
Remarks:

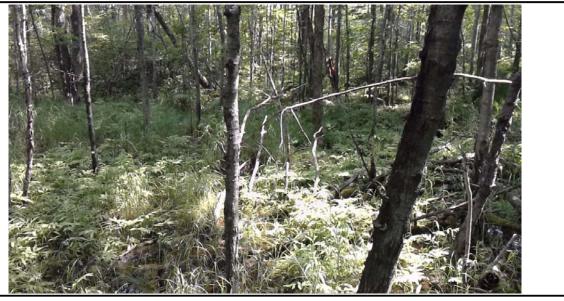
Site Photograph 2 Sampling Point: w-47n18w2-ab1

Latitude: 46.5820396738561	Cowardin Classification: PFO
Longitude: -92.582951942545	Circular 39: 1
Direction: Northeast	Eggers & Reed: Seasonally Flooded Basin
Remarks:
