WETLAND DETERMINATION DATA FORM - North Central and Northeast Region

Project/Site: SPP	City/County: Carlton		Sampling Date: 2016-07-19		
Applicant/Owner: Enbridge		State: Minnesota	Sampling Point: w-47n18w2-ad1		
Investigator(s): ZCW	Section, Townshi	p, Range: S 2, T 47N, R 18W			
Landform (hillslope, terrace, etc.): Depression		Local Relief (concave, conve	ex, none): CC Slope (%): 0-2%		
Subregion (LRR or MLRA):	 Latitude: 40	,	de: -92.58776600 Datum: NAD83		
Soil Map Unit Name: 504C	_		NWI Classification: N/A		
Are climatic/hydrologic conditions on the site t	pical for this time of year	? (if no. explain in Remarks):			
Are Vegetation No , Soil No , or Hydrolog	significantly distur	bed? Are "Normal Circumsta	nces" present? Yes		
Are Vegetation No , Soil No , or Hydrology	No naturally problemati	c? (If needed, explain any a	nswers in Remarks)		
SUMMARY OF FINDINGS - Attach site map	howing sampling point lo	cations, transects, importar	t features, etc.		
Hydrophytic Vegetation Present?	<u>Yes</u>	Is the Sampled Area

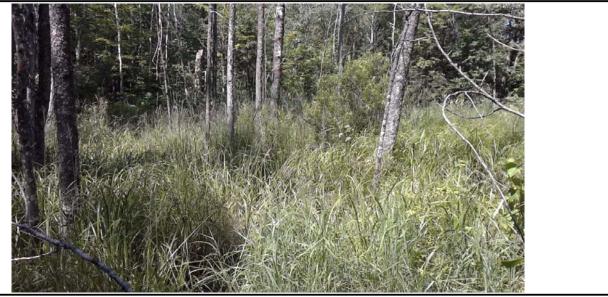
Site Photograph 1 Sampling Point: w-47n18w2-ad1

Latitude: 46.5778568527164	Cowardin Classification: PFO	
Longitude: -92.5877570361761	Circular 39: 7	
Direction: North	Eggers & Reed: Hardwood Swamp/Coniferous Swamp	
Remarks:

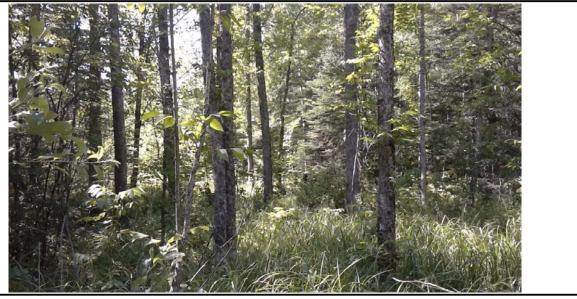
Site Photograph 2 Sampling Point: w-47n18w2-ad1

STATE OF THE STATE
Latitude: 46.5778541285978	Cowardin Classification: PFO
Longitude: -92.5877493248252	Circular 39: 7
Direction: West	Eggers & Reed: Hardwood Swamp/Coniferous Swamp
Remarks:
