WETLAND DETERMINATION DATA FORM - North Central and Northeast Region

Project/Site: SPP City/County: Carlton Sampling Date: 2016-07-19
 Applicant/Owner: Enbridge State: Minnesota Sampling Point: w-47n18w2-ae1
 Investigator(s): ZCW Section, Township, Range: S 2, T 47N, R 18
 Landform (hillslope, terrace, etc.): Depression Local Relief (concave, convex, none): CC Slope (%): 0-2%
 Subregion (LRR or MLRA): _____ Latitude: 46.5823797276... Longitude: -92.58864208... Datum: NAD83
 Soil Map Unit Name: 268B NWI Classification: N/A
 Are climatic/hydrologic conditions on the site typical for this time of year? (if no, explain in Remarks): Yes
 Are Vegetation No, Soil No, or Hydrology No significantly disturbed? Are "Normal Circumstances" present? Yes
 Are Vegetation No, Soil No, or Hydrology No naturally problematic? (If needed, explain any answers in Remarks)

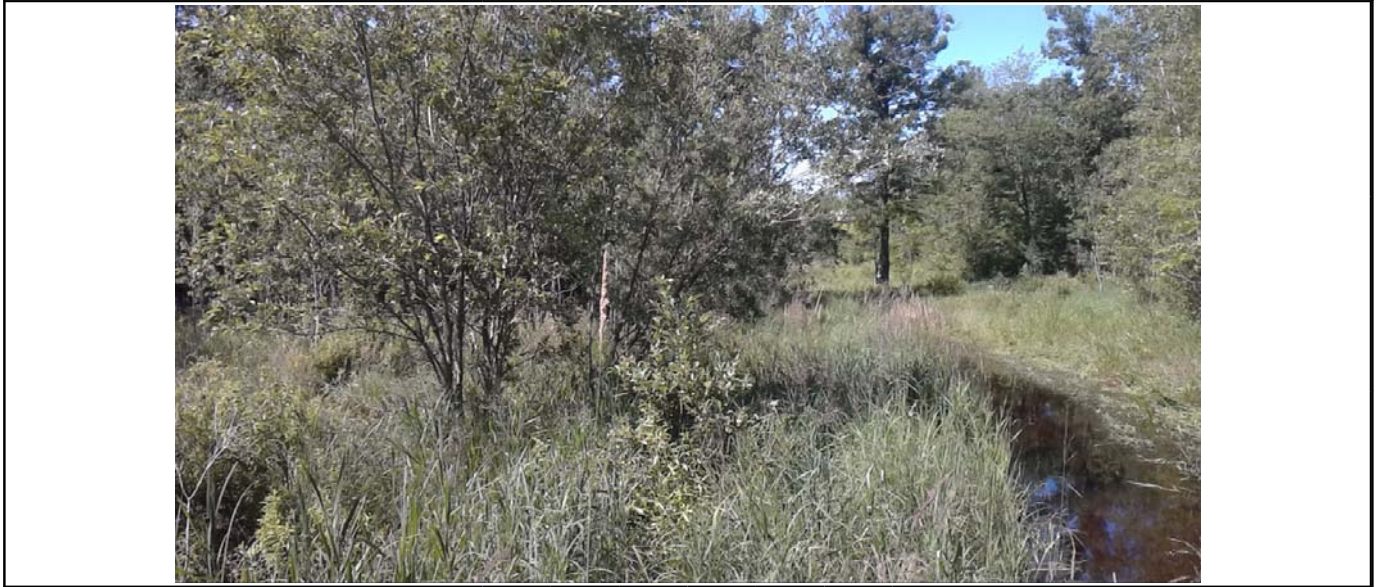
Site Photograph 1

Sampling Point: w-47n18w2-ae1

Cowardin Classification: PSS

Direction: North

Eggers & Reed: Shrub-Carr/Alder Thicket

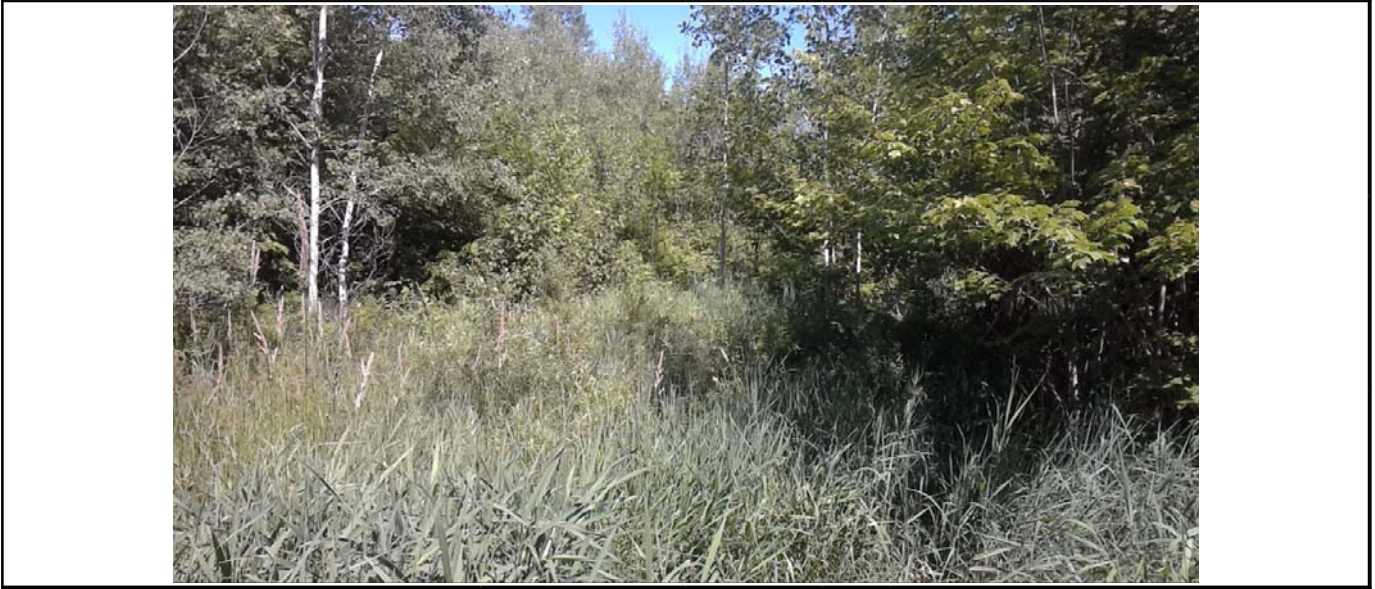
Site Photograph 2

Sampling Point: w-47n18w2-ae1

Cowardin Classification: PSS

Direction: East

Eggers & Reed: Shrub-Carr/Alder Thicket
