WETLAN	ID DETERMINATION DATA F	ORM - North Central ar	nd Northeast Region		
Project/Site: SPP	City/County: Carlton		Sampling	Date: 2016-09-01	
Applicant/Owner: Enbridge		State: Minnesota Sampling Point: w-47n19w3-aa1			
Investigator(s): DPT, MGH	Section, Townshi	p, Range: <u>S3, T47N, R19W</u>			
Landform (hillslope, terrace, etc.): Depress	sion	Local Relief (concave, con	vex, none): <u>CC</u>	Slope (%): <u>0-2%</u>	
Subregion (LRR or MLRA):	Latitude: 46	.5908339247 Longi	tude: -92.73167188	Datum: NAD83	
Soil Map Unit Name: V166			NWI Classi	fication: N/A	
Are climatic/hydrologic conditions on the s	site typical for this time of year	? (if no, explain in Remarks):	No	
Are Vegetation <u>No</u> , Soil <u>No</u> , or Hydr	ology <u>No</u> significantly disturb	oed? Are "Normal Circums	tances" present? Yes		
Are Vegetation <u>No</u> , Soil <u>No</u> , or Hydrole	ogy <u>No</u> naturally problematic	? (If needed, explain any	answers in Remarks)

SUMMARY OF FINDINGS - Attach site n	nap showing sampling point lo	cations, transects, import	ant features, etc.		
Hydrophytic Vegetation Present?	Yes	Is the Sampled Area			
Hydric Soil Present?	Yes	within a Wetland?	<u>Y</u>	Yes	
Wetland Hydrology

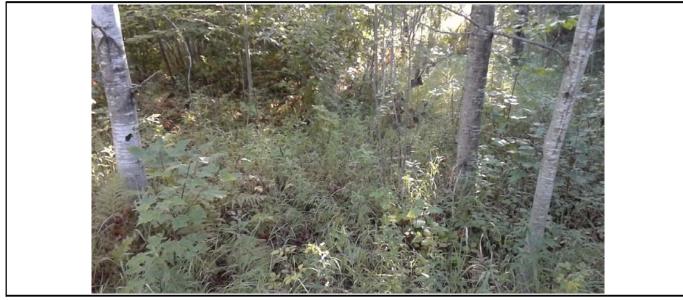
Site Photograph 1

Sampling Point: w-47n19w3-aa1

Cowardin Classification: PFO

Direction: east

Eggers & Reed: Hardwood Swamp/Coniferous Swamp

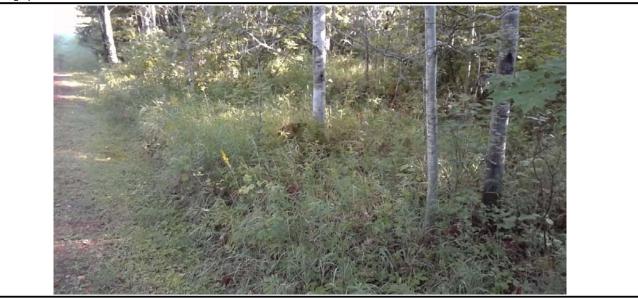
Site Photograph 2

Sampling Point: w-47n19w3-aa1

Cowardin Classification: PFO

Direction: north Remarks: Circular 39: 7

Eggers & Reed: Hardwood Swamp/Coniferous Swamp
