WETLAND DETERMINATION DATA FORM - North Central and Northeast Region

Project/Site: SPP	City/County: Carlto	n	Sampling Date: 2016-09-01			
Applicant/Owner: Enbridge		State: Minnesota	Samplii	ng Point: w-47n19w3-ab1		
Investigator(s): DPT, MGH	Section, Tow	nship, Range: S3, T47N, R19	 9W			
Landform (hillslope, terrace, etc.): Depr		Local Relief (concave, c		Slope (%): 0-2%		
Subregion (LRR or MLRA):		•	ngitude: -92.73161966	,		
Soil Map Unit Name: V166				ssification: N/A		
Are climatic/hydrologic conditions on the	ne site typical for this time of	vear? (if no explain in Rema	-	No		
				····		
Are Vegetation No_, Soil No_, or H	ydrology No significantly dis	sturbed? Are "Normal Circu	mstances" present? Yes	,		
Are Vegetation No_, Soil No_, or Hyd	rology No naturally probler	natic? (If needed, explain a	ny answers in Remarks)			
·	- · · · · · · · · · · · · · · · · · · ·	, , ,				
SUMMARY OF FINDINGS - Attach sit	e map showing sampling poi	nt locations, transects, impo	ortant features, etc.

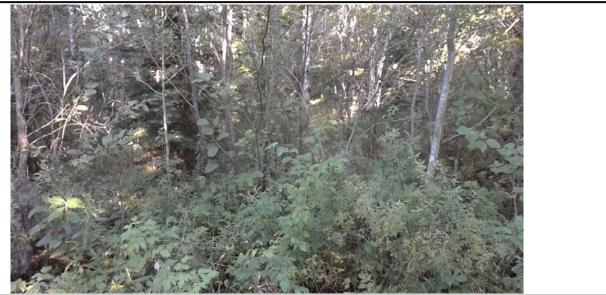
Site Photograph 1 Sampling Point: w-47n19w3-ab1

Latitude: 46.5908337571161	Cowardin Classification: PFO	
Longitude: -92.731654280883	Circular 39: 7	
Direction: west	Eggers & Reed: Hardwood Swamp/Coniferous Swamp	
Remarks:

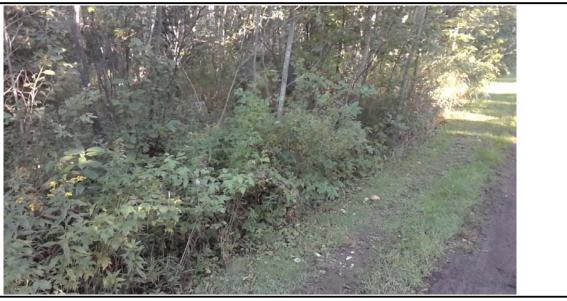
Site Photograph 2 Sampling Point: w-47n19w3-ab1

Latitude: 46.5908337571161	Cowardin Classification: PFO
Longitude: -92.731654280883	Circular 39: 7
Direction: north	Eggers & Reed: Hardwood Swamp/Coniferous Swamp
