WETLAND DETERMINATION DATA FORM - North Central and Northeast Region

Project/Site: SPP	Cit	ty/County: Carlton		Sampl	ing Date: 2016-08-31	
Applicant/Owner: Enbridge			State: Minnesota	Sampli	ing Point: <u>w-47n21w2-aa1</u>	
Investigator(s): DPT, MGH		Section, Township	p, Range: S2, T47N, R21V	V		
Landform (hillslope, terrace, etc.): De	epression		Local Relief (concave, co	nvex, none): CC	Slope (%): 0-2%	
Subregion (LRR or MLRA):		 Latitude: 46	5.5917263459 Long	gitude: -92.95409381	. Datum: NAD83	
Soil Map Unit Name: 43B				NWI Cl	assification: N/A	
Are climatic/hydrologic conditions o	n the site typica	al for this time of year	? (if no, explain in Remarl	ks):	No	
Are Vegetation No , Soil No , o	r Hydrology <u>No</u>	significantly disturb	ped? Are "Normal Circum	nstances" present? Yes	-	
Are Vegetation No_, Soil No_, or H	lydrology No	naturally problemation	c? (If needed, explain an	y answers in Remarks)		
SUMMARY OF FINDINGS - Attach	site map show	ing sampling point lo	cations, transects, impor	rtant features, etc.

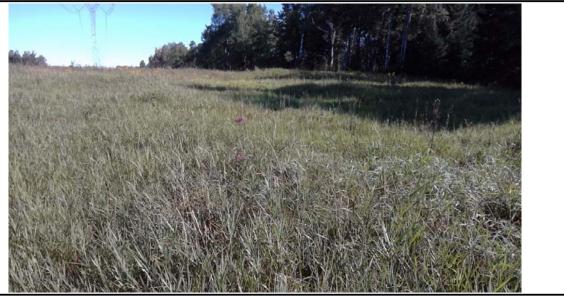
Site Photograph 1 Sampling Point: w-47n21w2-aa1

Latitude: 46.5917328838693	Cowardin Classification: PEM
Longitude: -92.9540869408222	Circular 39: 2
Direction: north	Eggers & Reed: Fresh (Wet) Meadow

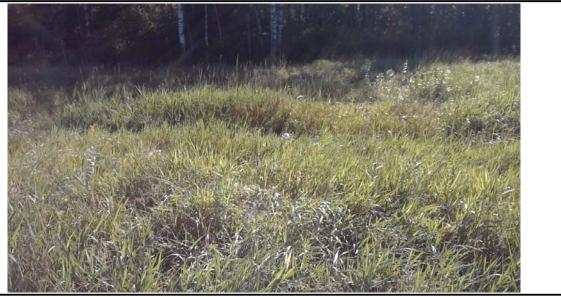
Site Photograph 2 Sampling Point: w-47n21w2-aa1

Latitude: 46.5917330095978	Cowardin Classification: PEM
Longitude: -92.9540871084602	Circular 39: 2
Direction: east	Eggers & Reed: Fresh (Wet) Meadow
