## WETLAND DETERMINATION DATA FORM - North Central and Northeast Region

| Project/Site: SPP | Ci | City/County: Carlton | | Sampling Date: 2016-08-31 | | |
| Applicant/Owner: Enbridge | | | State: Minnesota | Sampl | ing Point: w-47n21w2-aa2 | |

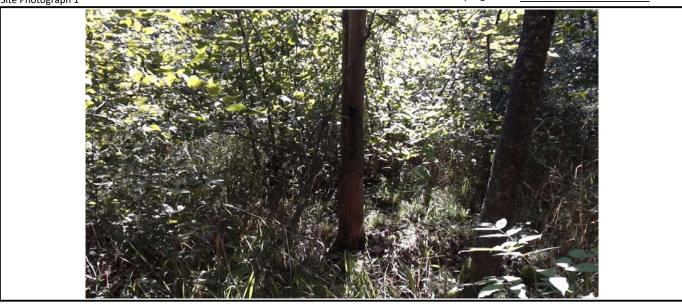
Site Photograph 1 Sampling Point: w-47n21w2-aa2

| Latitude: 46.5918644797491 | Cowardin Classification: PFO |
| Longitude: -92.9534144607307 | Circular 39: 7 |
| Direction: east | Eggers & Reed: Hardwood Swamp/Coniferous Swamp |

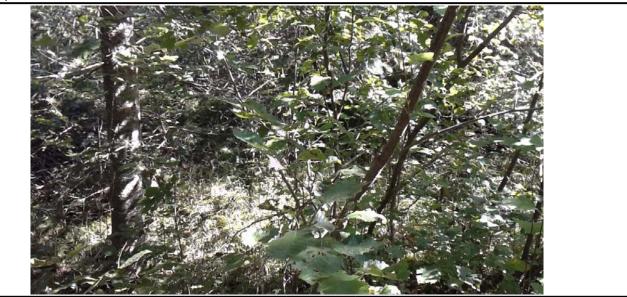
Site Photograph 2 Sampling Point: w-47n21w2-aa2

| Latitude: 46.5918644797491 | Cowardin Classification: PFO |
| Longitude: -92.9534144607307 | Circular 39: 7 |
| Direction: north | Eggers & Reed: Hardwood Swamp/Coniferous Swamp |
