WETLAND DETERMINATION DATA FORM - North Central and Northeast Region

Project/Site: SPP	City/County: Carlton			Sampling Date: 2016-08-01		
Applicant/Owner: Enbridge			State: Minnesota	Samplii	ng Point: <u>w-48n15w31-aa1</u>	
Investigator(s): DPT, MGH		Section, Townshi	p, Range: <u>S31, T48N,</u> I	R15W		
Landform (hillslope, terrace, etc.): Depr	ession		Local Relief (concave	, convex, none): CL	Slope (%): 0-2%	
Subregion (LRR or MLRA):		Latitude: 46	5.5970848128 լ	Longitude: -92.29199068	Datum: NAD83	
Soil Map Unit Name: 303				NWI Cla	assification: N/A	
Are climatic/hydrologic conditions on the	he site typical for	this time of year	? (if no, explain in Ren		Yes	
Are Vegetation No , Soil No , or Hydrology No significantly disturbed? Are "Normal Circumstances" present? Yes						
Are Vegetation No_, Soil No_, or Hydrology No_ naturally problematic? (If needed, explain any answers in Remarks)						
SUMMARY OF FINDINGS - Attach sit	te map showing	sampling point lo	cations, transects, im	portant features, etc.

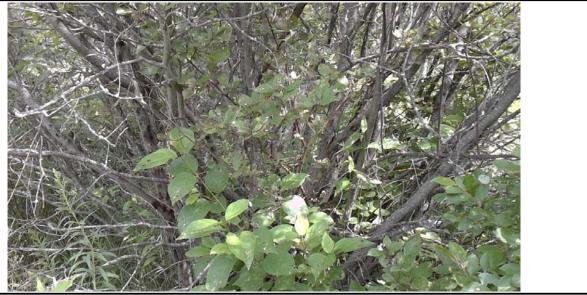
Site Photograph 1 Sampling Point: w-48n15w31-aa1

NACORE TO A STATE OF THE STATE	A CANADA
Latitude: 46.5970853157775	Cowardin Classification: PSS
Longitude: -92.2919687257076	Circular 39: 6
Direction: south	Eggers & Reed: Shrub-Carr/Alder Thicket
Remarks:

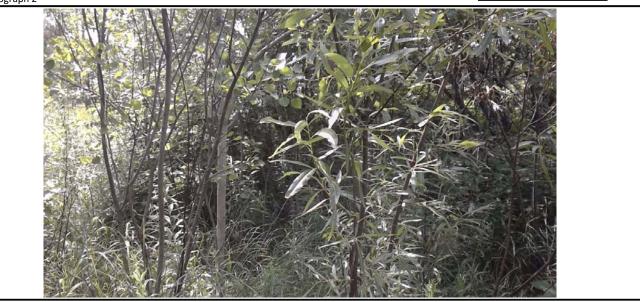
Site Photograph 2 Sampling Point: w-48n15w31-aa1

Latitude: 46.5970857348727	Cowardin Classification: PSS		
Longitude: -92.2919691448028	Circular 39: <u>6</u>		
Direction: north	Eggers & Reed: Shrub-Carr/Alder Thicket		
Remarks:
