WETLAND DETERMINATION DATA FORM - North Central and Northeast Region

Site Photograph 1 Sampling Point: w-48n17w21-ab1

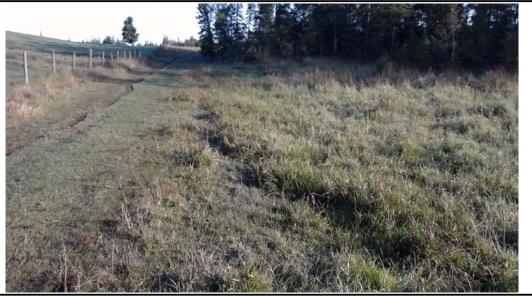
Site Photograph 2 Sampling Point: w-48n17w21-ab1

Latitude: 46.620718762322	Cowardin Classification: PEM	
Longitude: -92.4933187198755	Circular 39: 2	
Direction: north	Eggers & Reed: Fresh (Wet) Meadow	
Remarks:
