## WETLAND DETERMINATION DATA FORM - North Central and Northeast Region

Project/Site: SPP	City/County: Carlton		Sampling Date: 2016-09-01			
Applicant/Owner: Enbridge		State: Minnesota	Sampling Point: w-48n17w31-aa1			
Investigator(s): DPT, MGH						
Landform (hillslope, terrace, etc.): Depression	<u> </u>	Local Relief (concave, conv	ex, none): CL Slope (%): 0-2%			
Subregion (LRR or MLRA):	 Latitude: 4	,	ude: -92.54562162 Datum: NAD83			
Soil Map Unit Name: 533		201.8.0	NWI Classification: PFOB

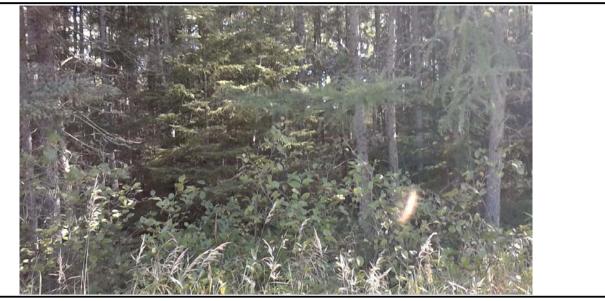
Site Photograph 1 Sampling Point: w-48n17w31-aa1

Latitude: 46.6053424543204	Cowardin Classification: PFO		
Longitude: -92.5456222985802	Circular 39: 7		
Direction: north	Eggers & Reed: Hardwood Swamp/Coniferous Swamp		
Remarks:

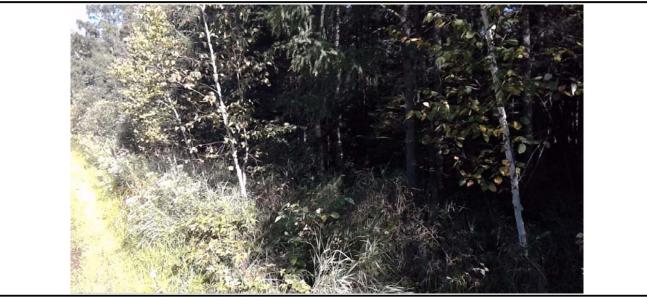
Site Photograph 2 Sampling Point: w-48n17w31-aa1

Latitude: 46.6053422028633	Cowardin Classification: PFO		
Longitude: -92.5456225500373	Circular 39: 7		
Direction: west	Eggers & Reed: Hardwood Swamp/Coniferous Swamp		
Remarks:
