## WETLAND DETERMINATION DATA FORM - North Central and Northeast Region

Project/Site: SPP	City/County: Carlton		Sampling Date: 2016-09-01		
Applicant/Owner: Enbridge		State: Minnesota	Sampling Point: w-48n17w31-al	b1	
Investigator(s): DPT, MGH					
Landform (hillslope, terrace, etc.): Depression		Local Relief (concave, conv	vex, none): CC Slope (%): 0-2%		
Subregion (LRR or MLRA):	Latitude: 4	•	tude: -92.54361080 Datum: NAD83		
Soil Map Unit Name: 188C	_		NWI Classification: PSSB		
Are climatic/hydrologic conditions on the site	typical for this time of year	r? (if no. explain in Remarks

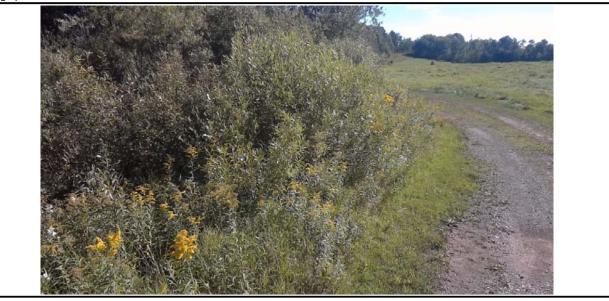
Site Photograph 1 Sampling Point: w-48n17w31-ab1

Latitude: 46.6045048507364	Cowardin Classification: PSS
Longitude: -92.5436065346864	Circular 39: 6
Direction: east	Eggers & Reed: Shrub-Carr/Alder Thicket
