# Focused Remedial Investigation Report

## *Freeway Landfill and Freeway Dump*

Prepared for  
Minnesota Pollution Control Agency

June 2019

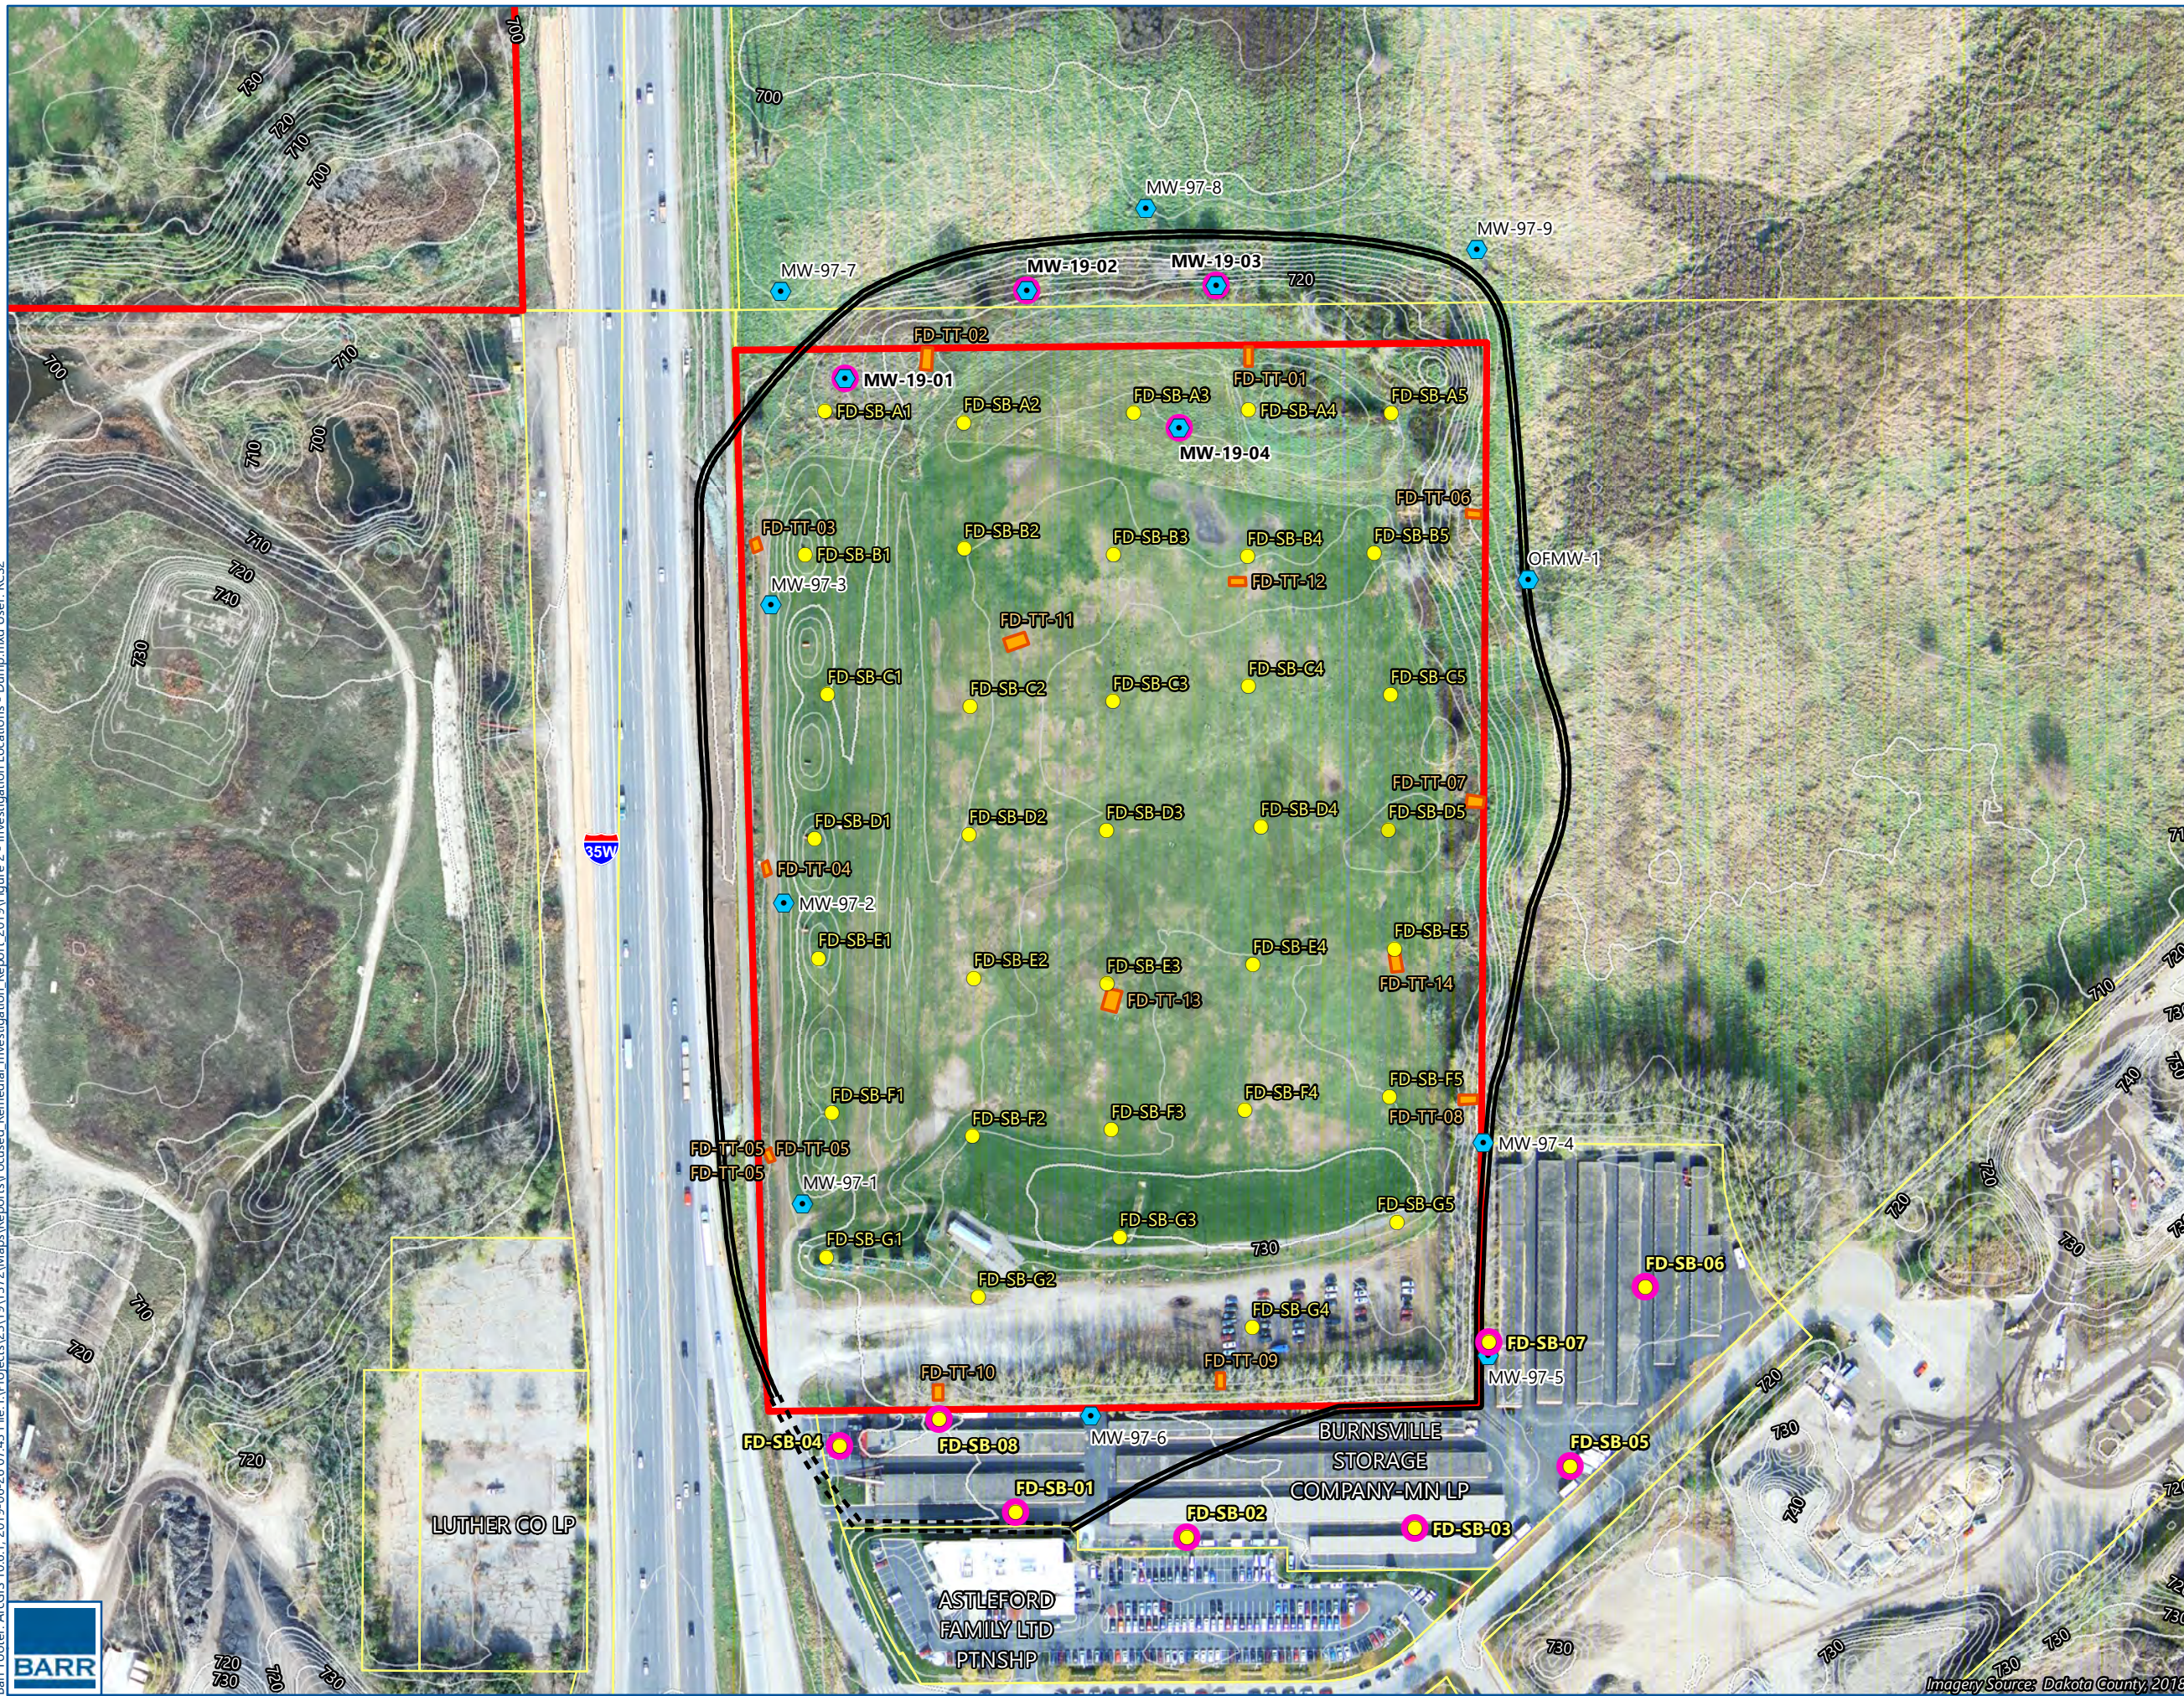
FIGURE 2

*Dump* – Eight soil borings were completed at the Burnsville Storage property located south of the Dump. The borings were generally spaced across the Burnsville Storage property for the purpose of identifying the extent of waste material south of the Dump. Two of the boring locations were placed near buildings that are used as residences, and soil-gas samples were collected for laboratory analysis from these locations. Locations of the soil borings at the Burnsville Storage property are shown on [Figure 2](#).

**INVESTIGATION LOCATIONS**  
**Freeway Dump**  
 Focused Remedial  
 Investigation Report  
 Freeway Landfill and Dump  
 Burnsville, Minnesota

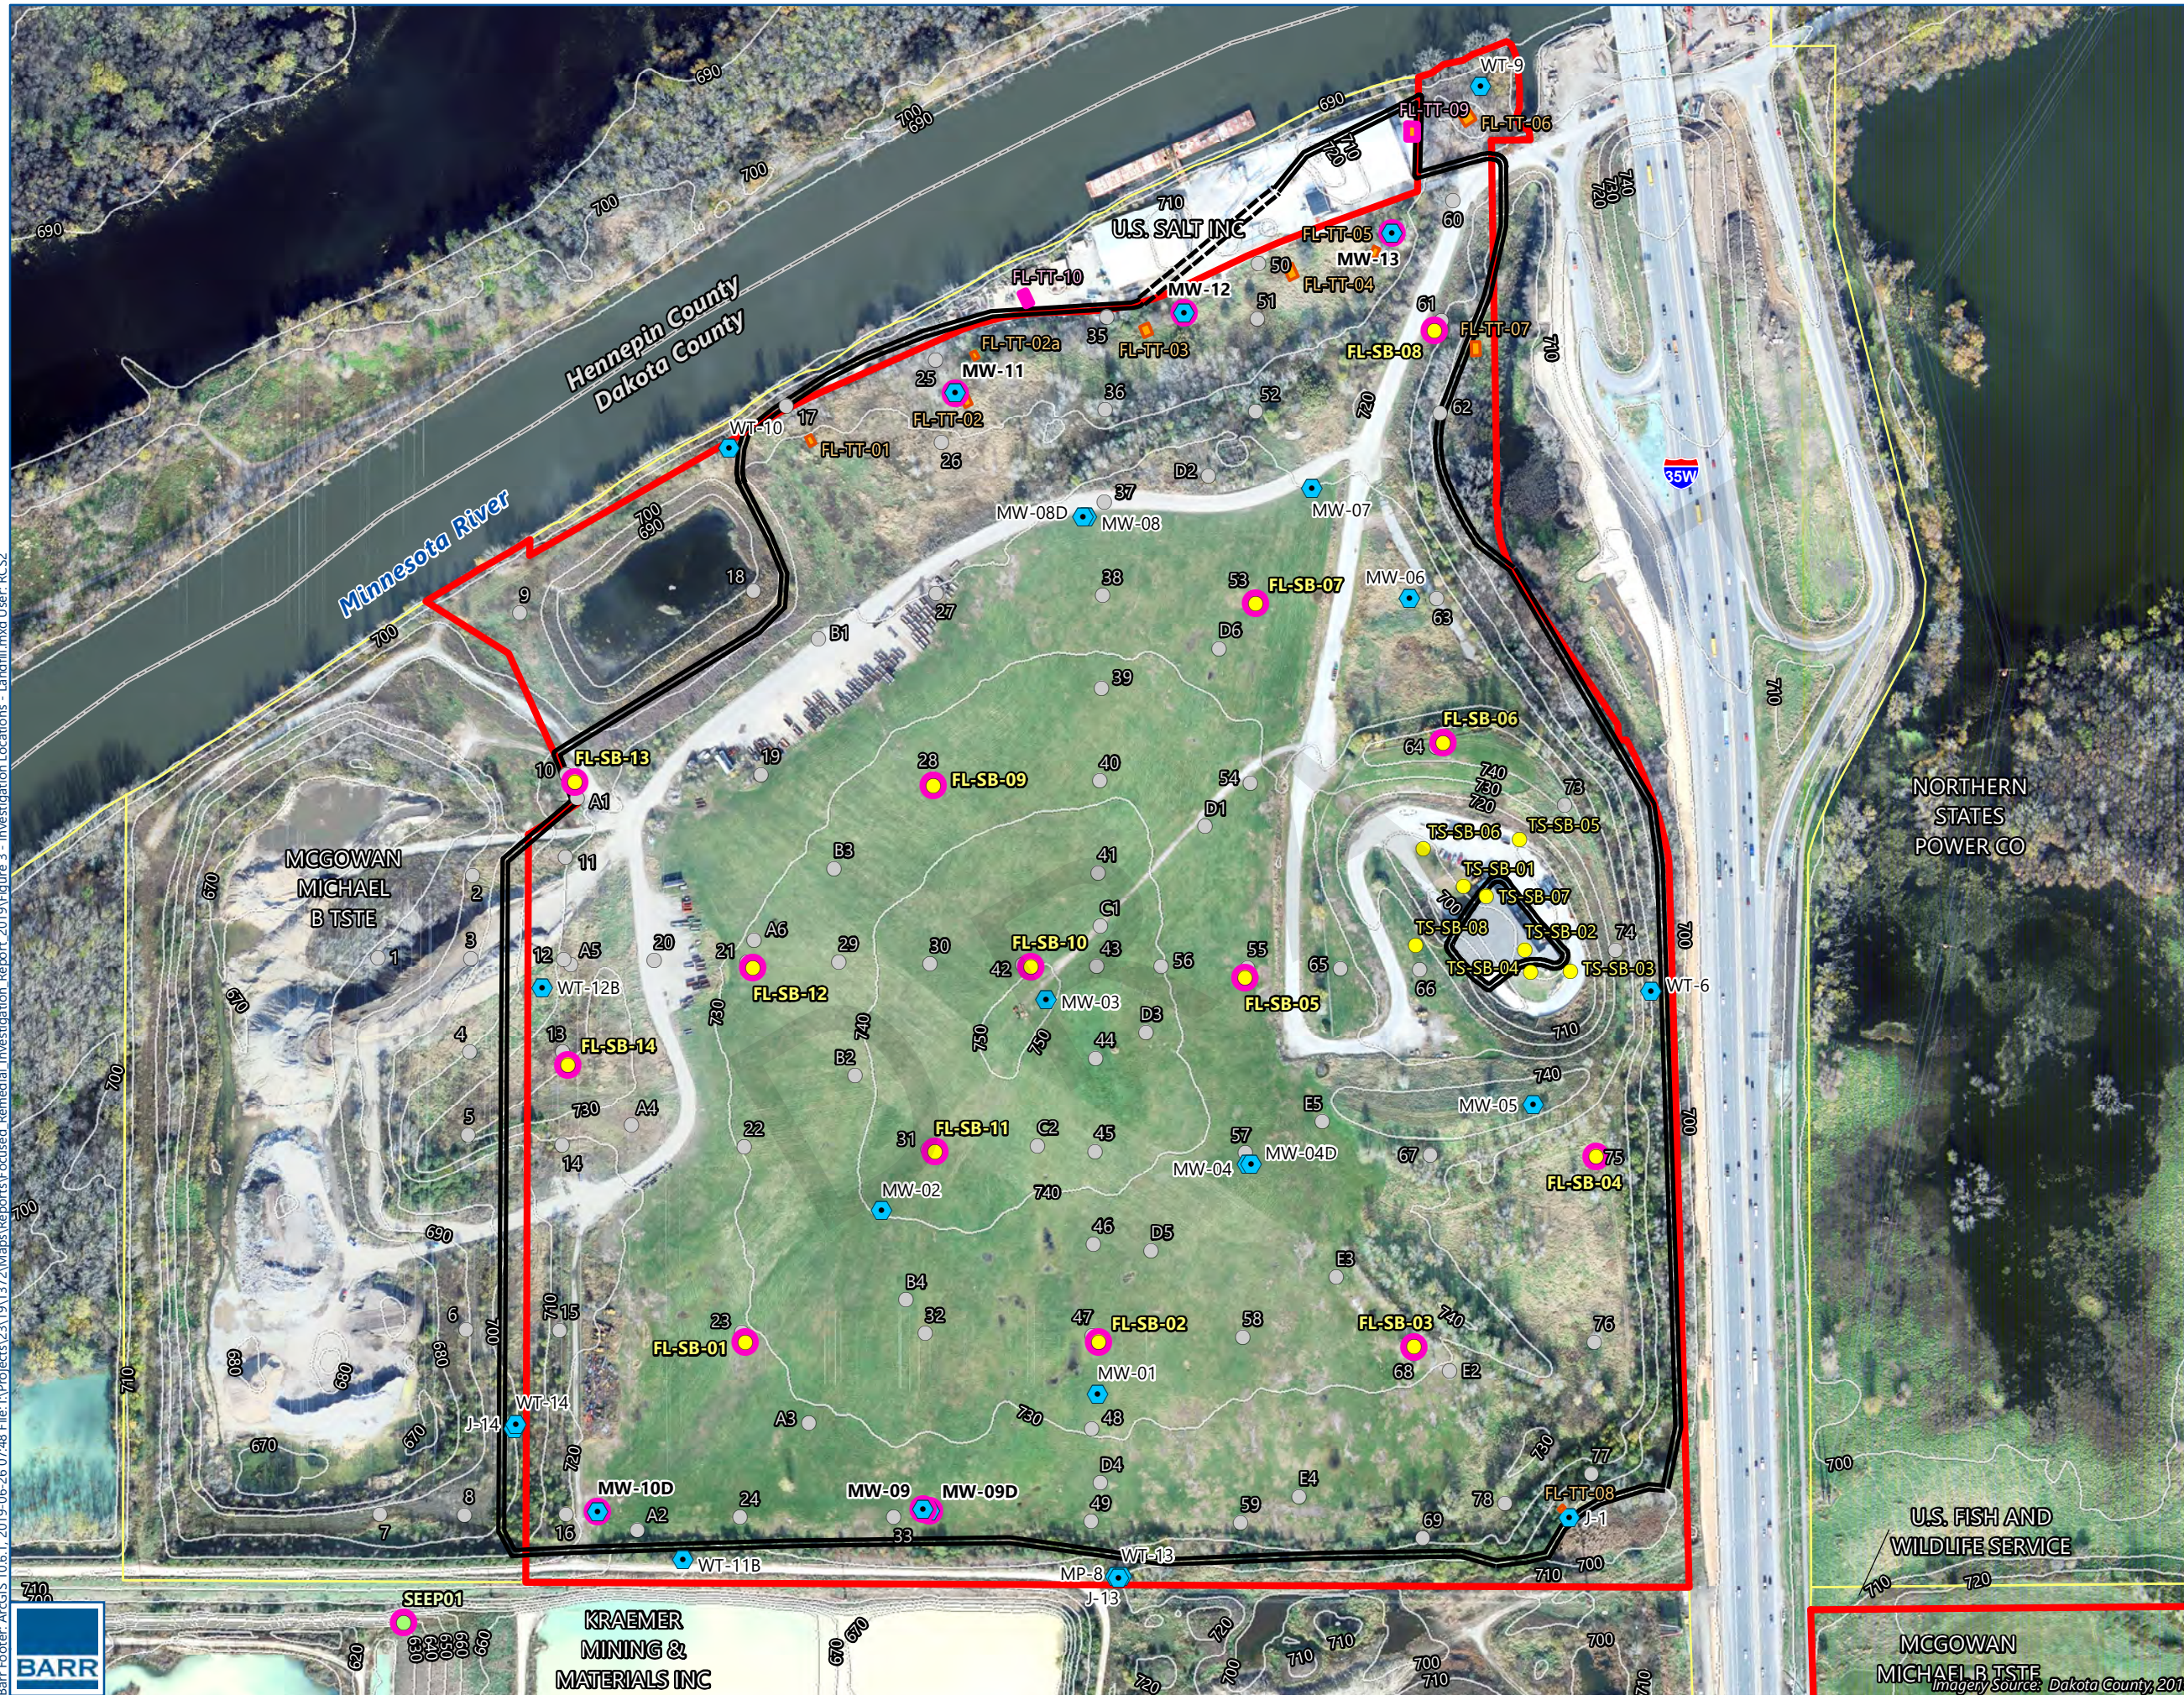
**INVESTIGATION LOCATIONS**  
**Freeway Landfill**  
 Focused Remedial  
 Investigation Report  
 Freeway Landfill and Dump  
 Burnsville, Minnesota

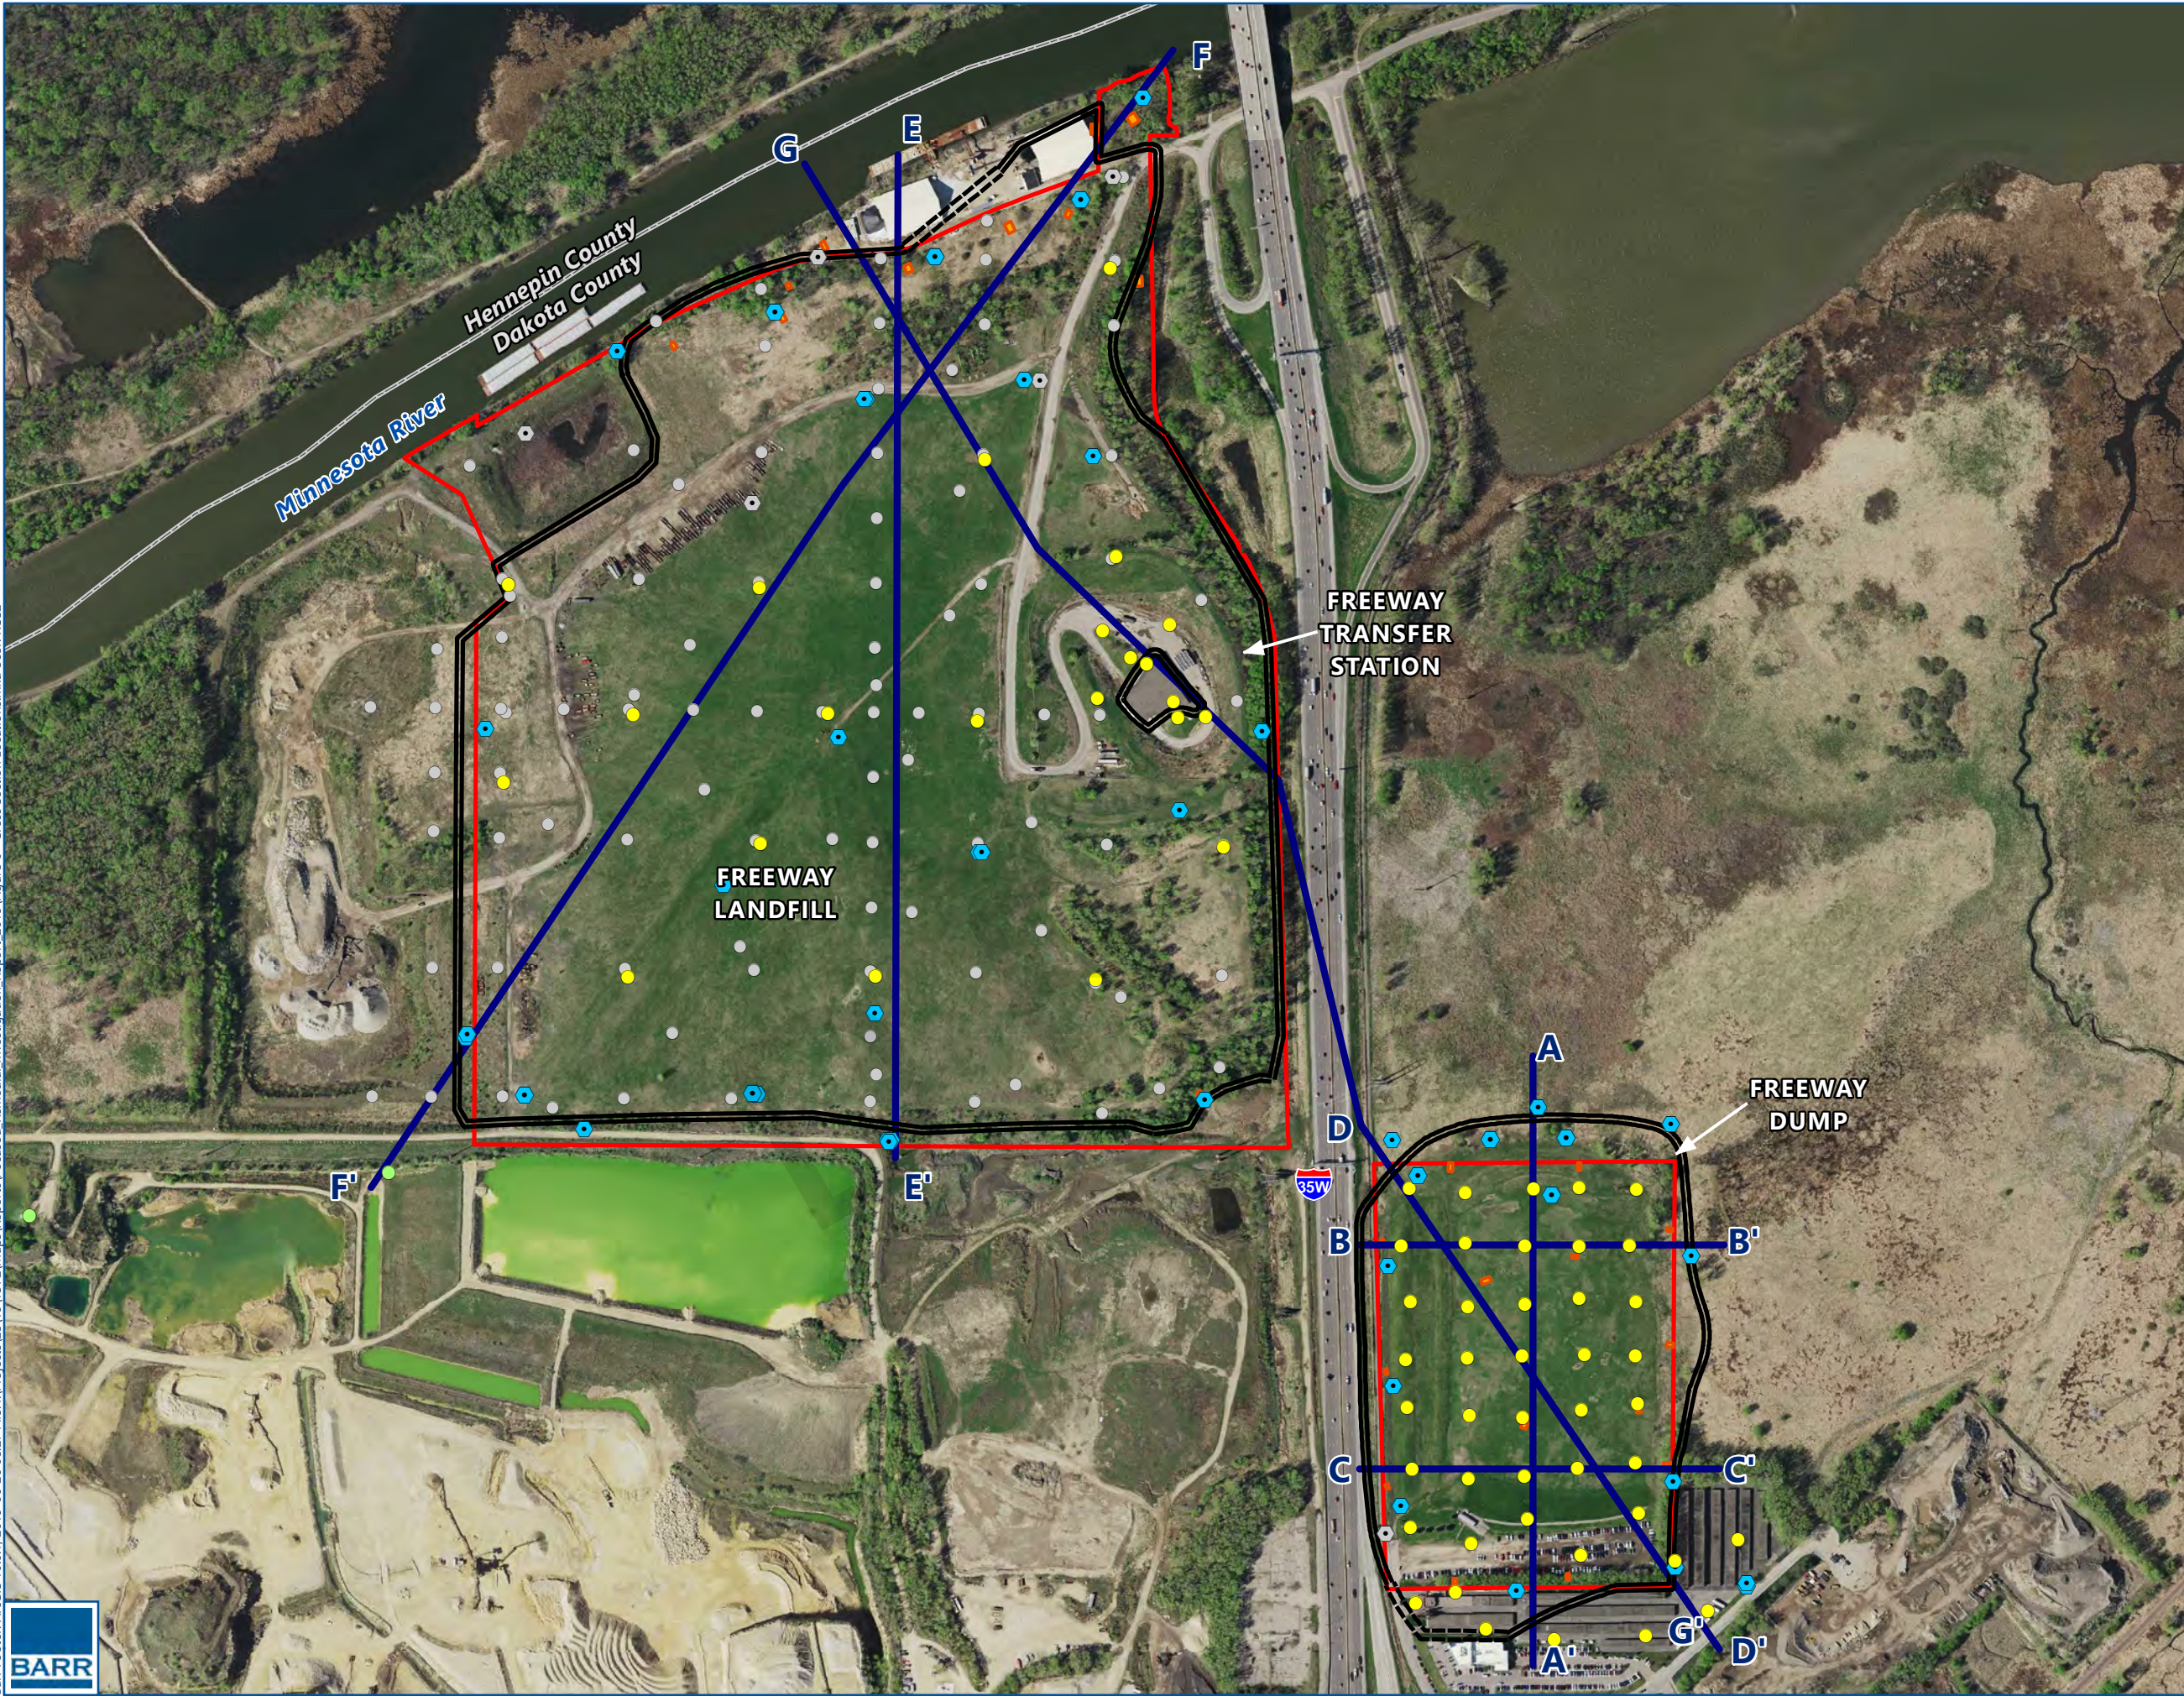
**CROSS SECTION LOCATIONS**  
Focused Remedial Investigation Report  
Freeway Landfill and Dump  
Burnsville, Minnesota

- Cross Section Location
- Monitoring Wells
- Borings
- Seep Sample
- Abandoned Monitoring Wells
- Historical Borings
- Test Trenches
- Inferred Waste Extent
- Project Areas

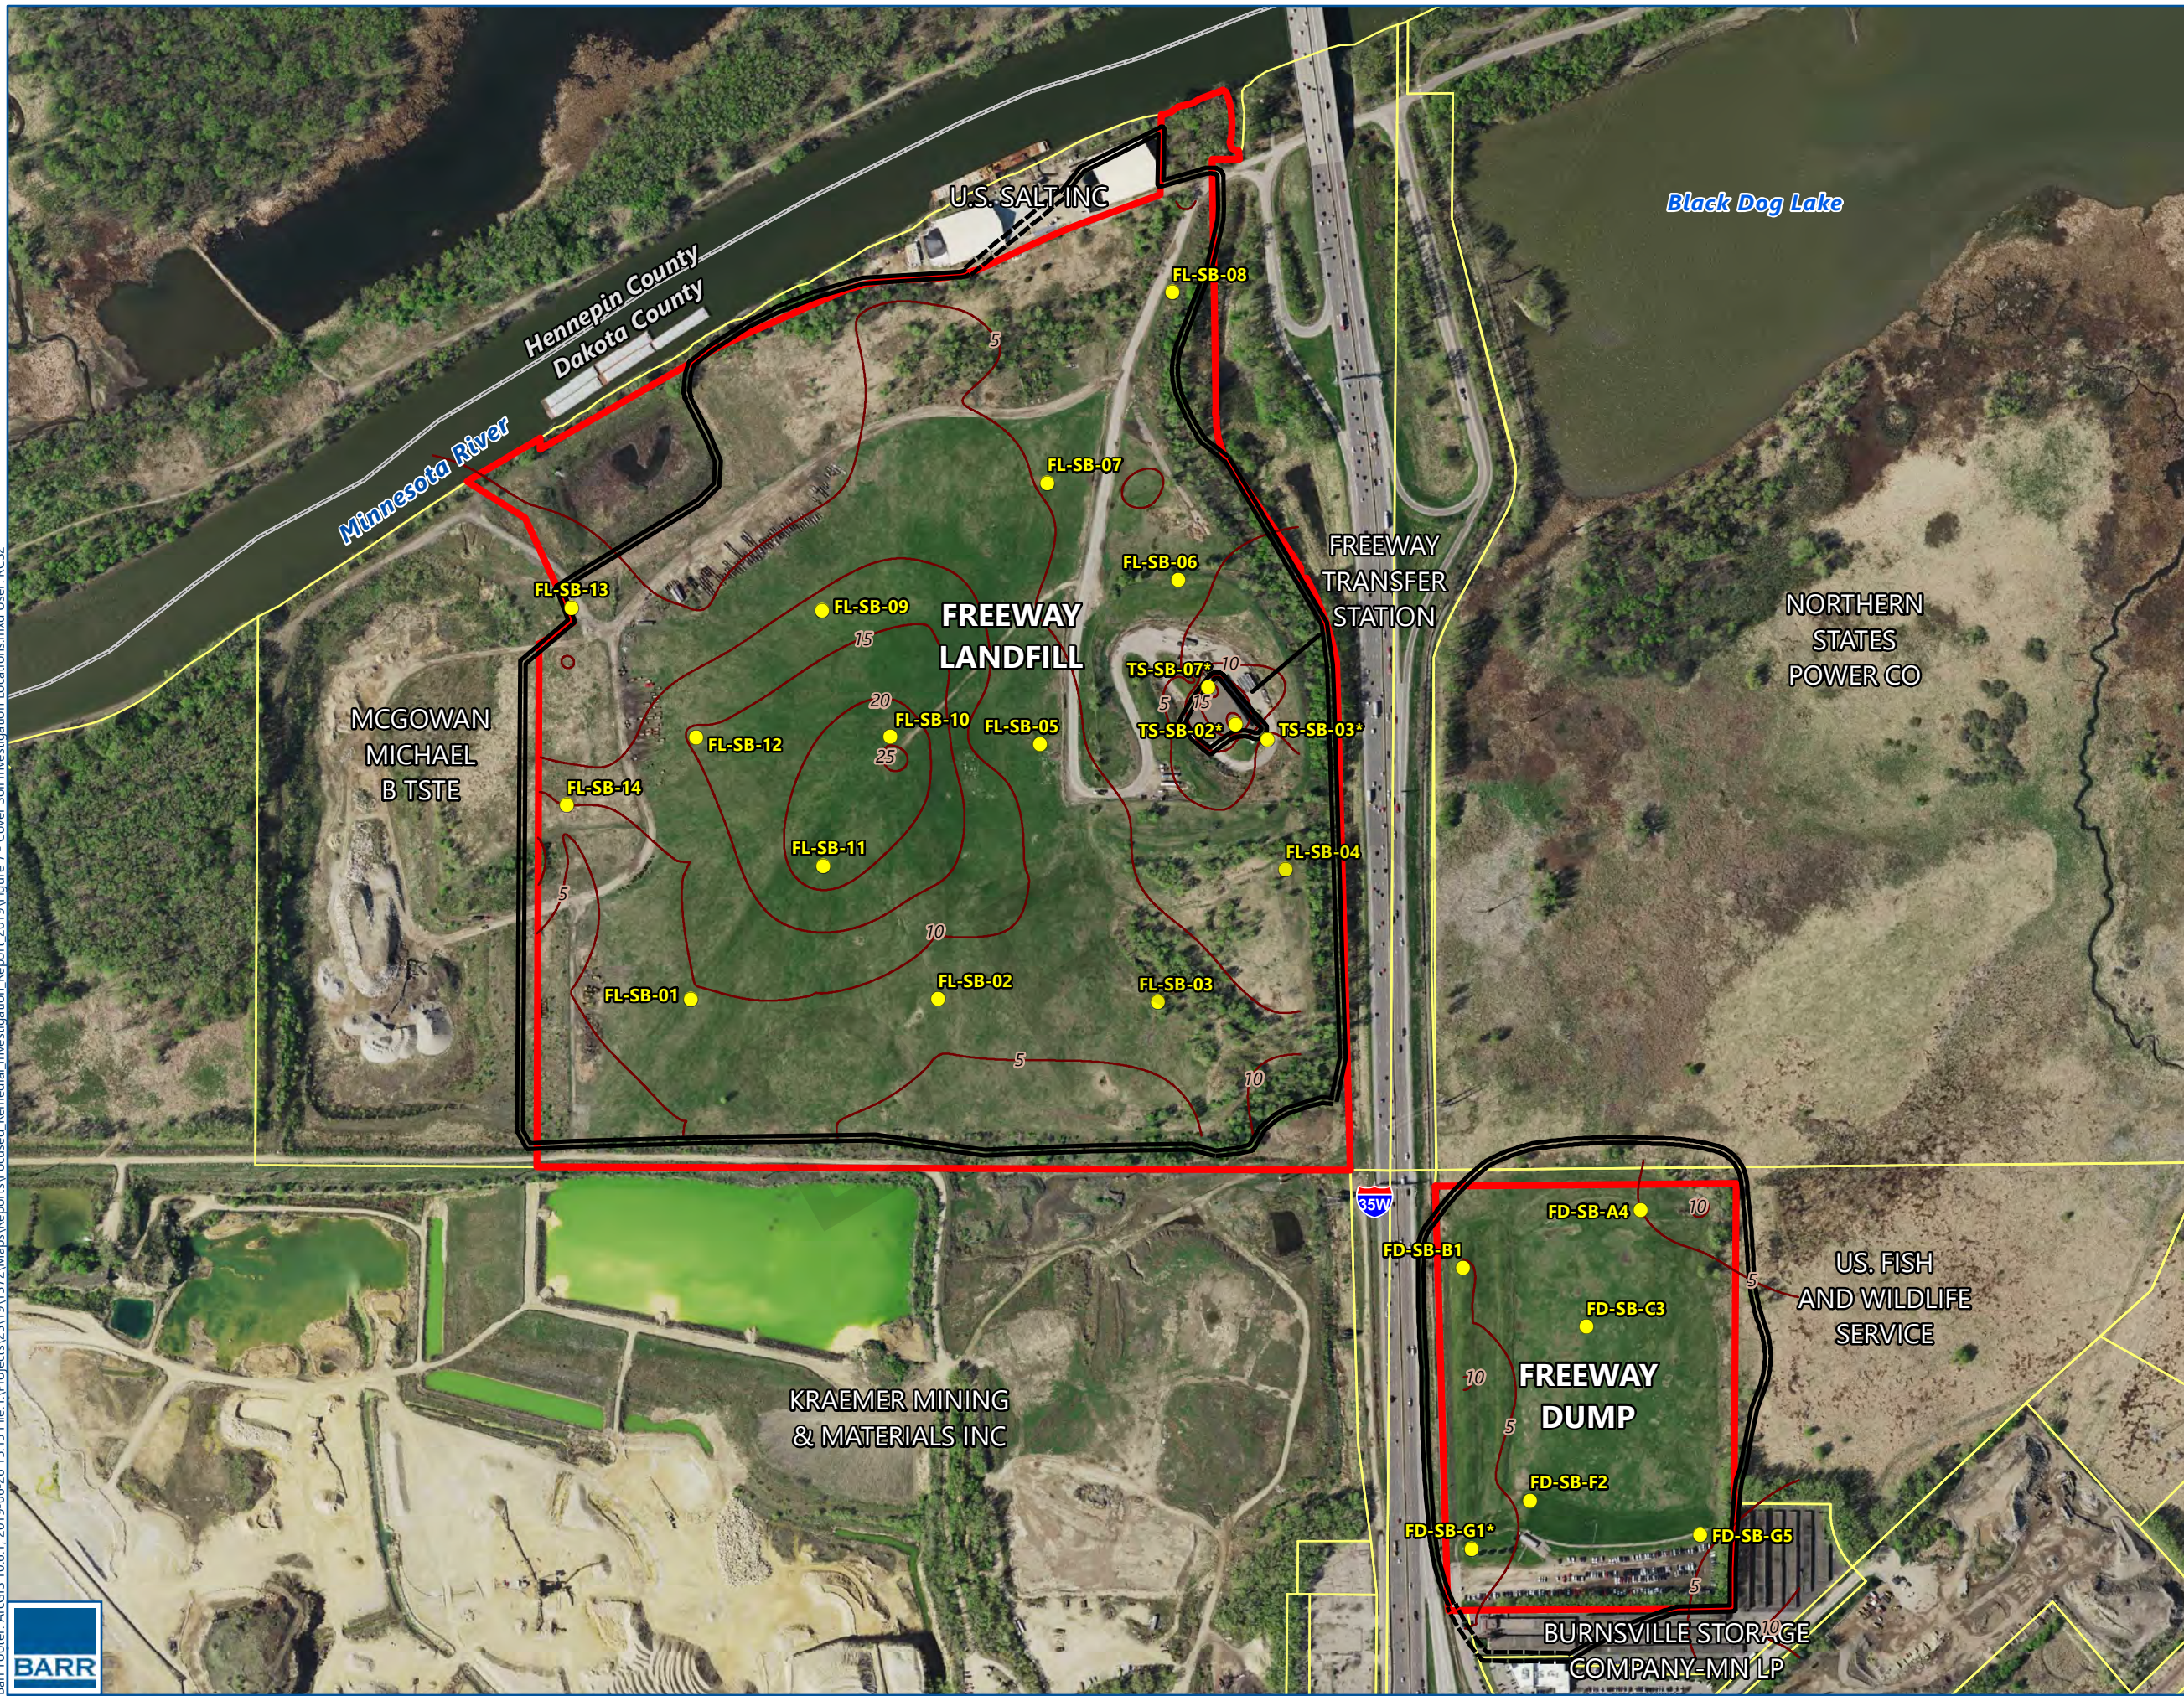
**COVER SOIL INVESTIGATION LOCATIONS**  
 Focused Remedial Investigation Report  
 Freeway Landfill and Dump  
 Burnsville, Minnesota  
 FIGURE 7

- Cover Soil Investigation Location
- Inferred Waste Extent
- Cover Soil Thickness Contours (5ft)\*\*
- Project Areas
- Parcel Boundary
- County Boundary

\* Phase A Investigation Location  
 \*\* Cover soil thickness contours created using boring log data from all recent and historical investigation locations

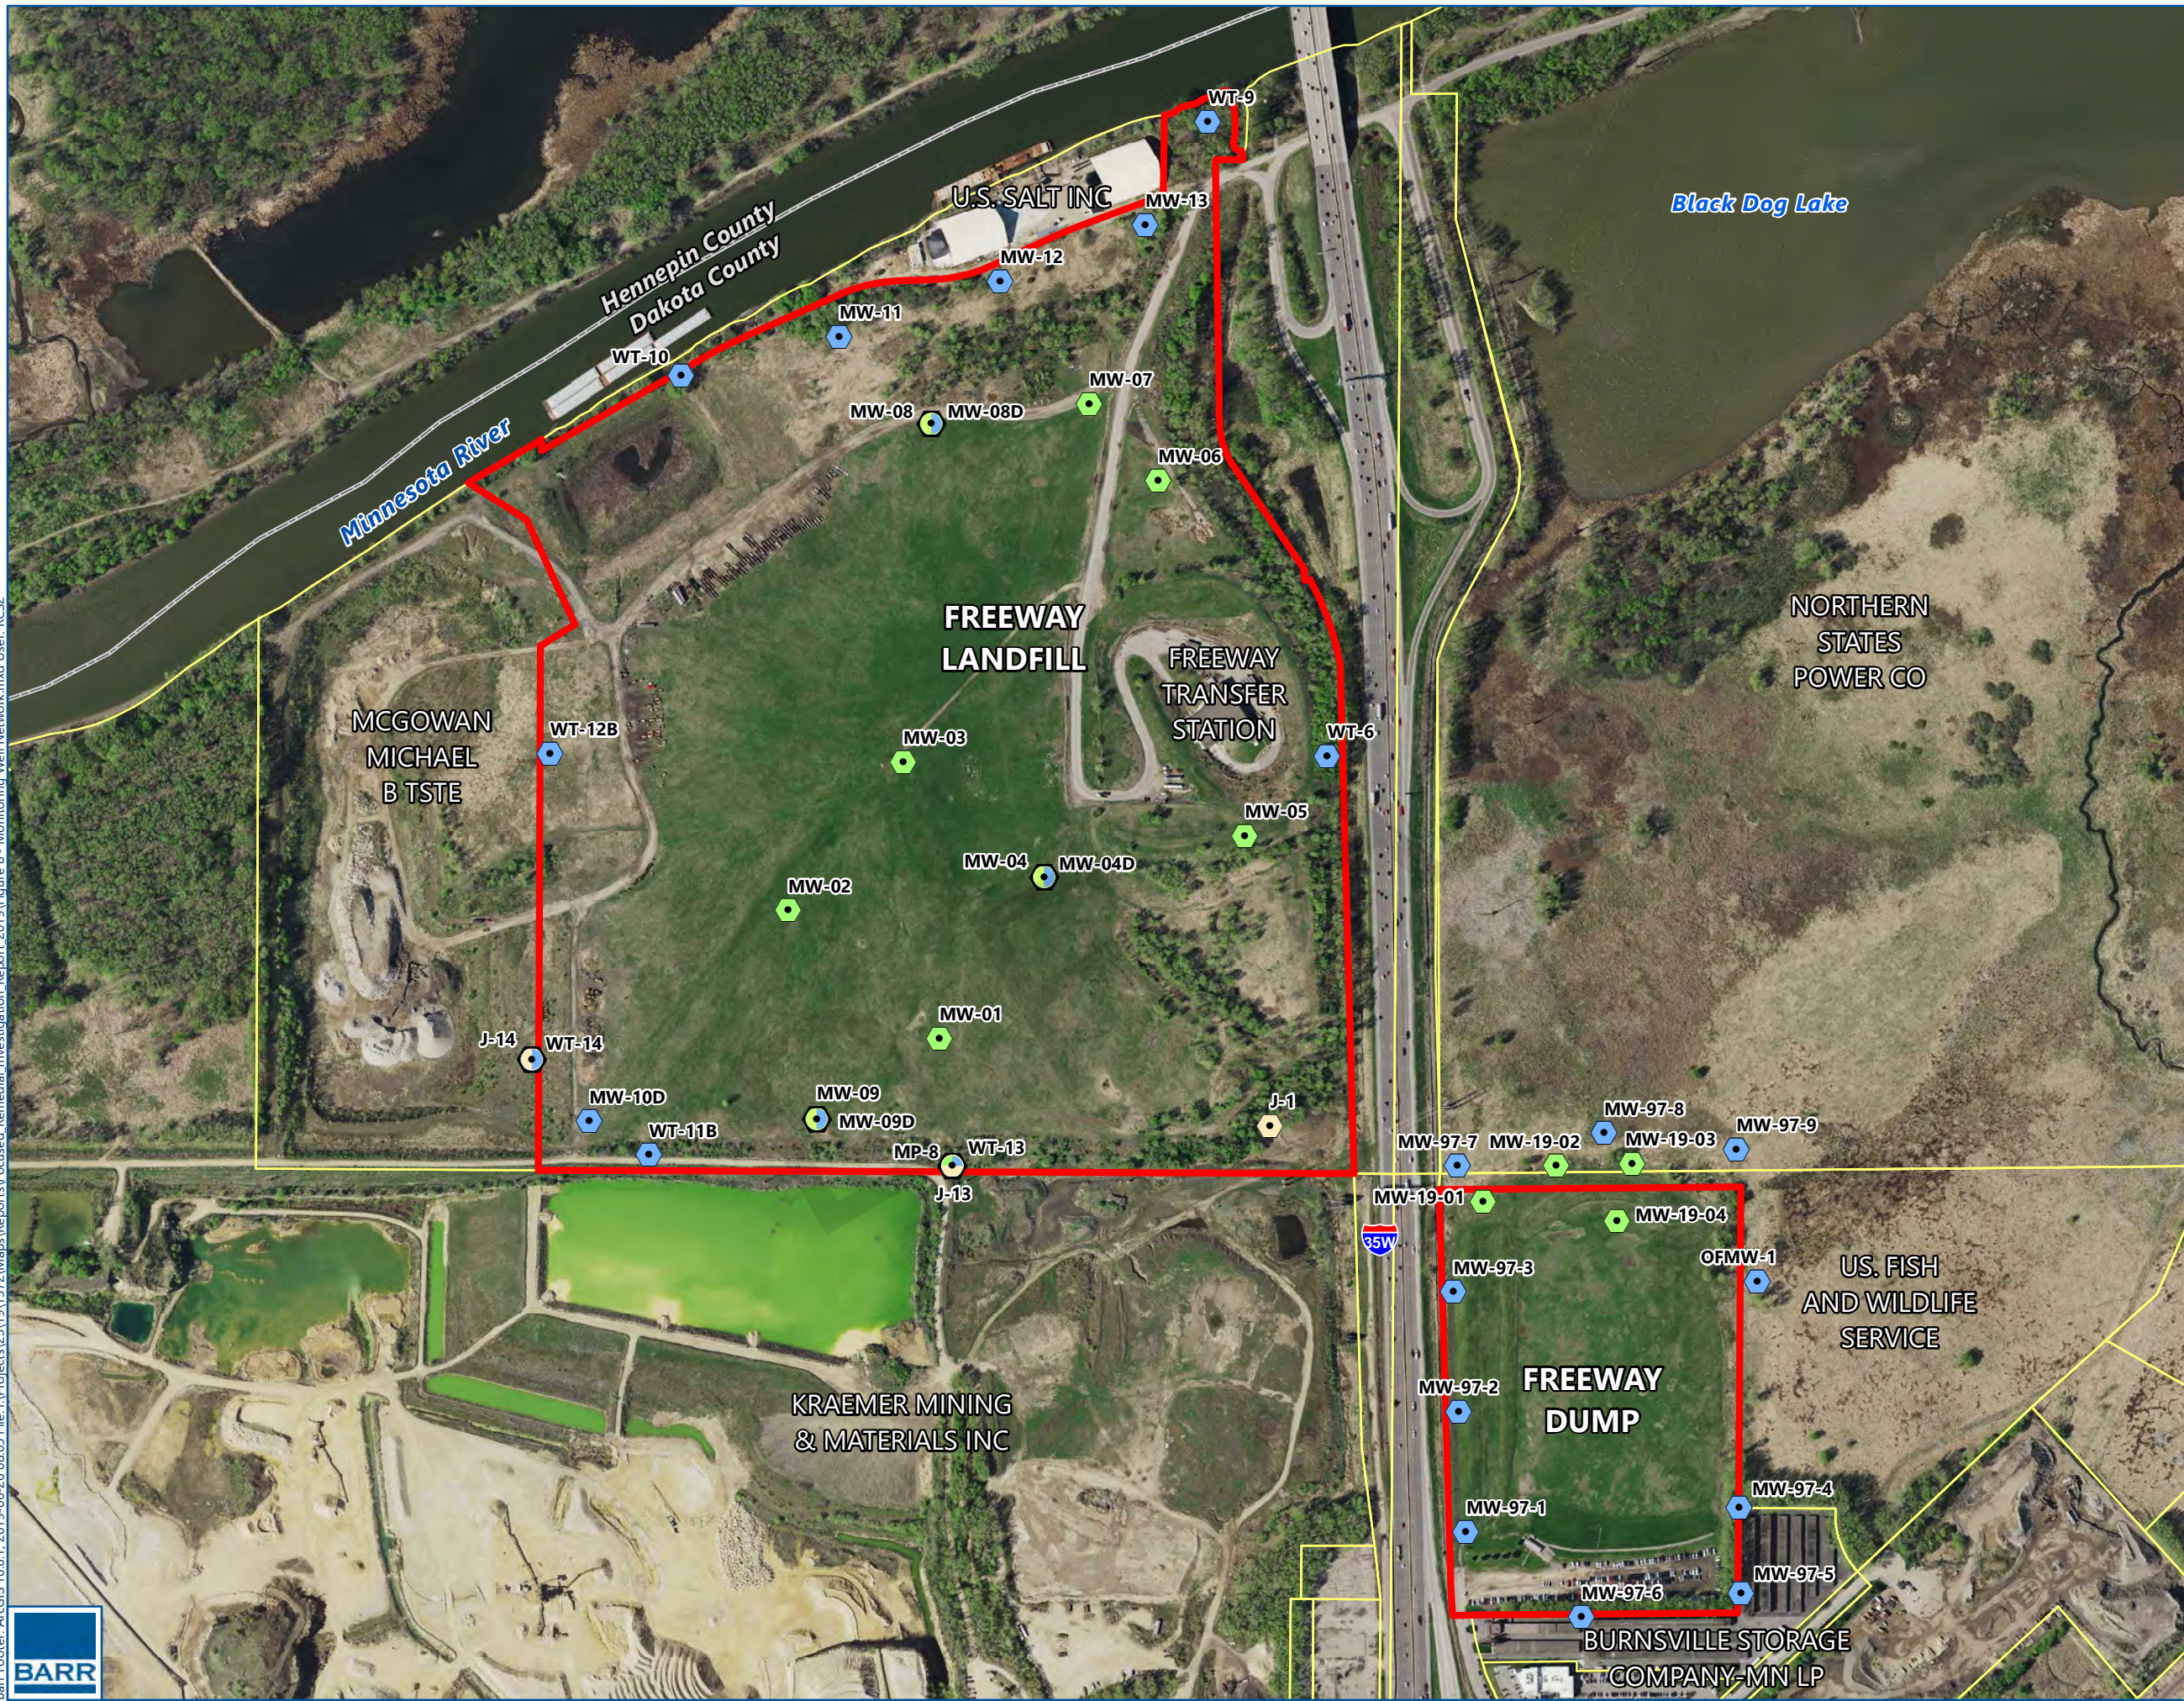
**Jordan** – Wells that are constructed as open borehole bedrock monitoring wells in the Jordan formation which underlies the Prairie du Chien. The open-hole sections of these wells are generally at depths of approximately 160 to 220 feet below ground surface.

**MONITORING WELL NETWORK**  
 Focused Remedial Investigation Report  
 Freeway Landfill and Dump  
 Burnsville, Minnesota
