# Focused Remedial Investigation Report

## *Freeway Landfill and Freeway Dump*

Prepared for  
Minnesota Pollution Control Agency

June 2019

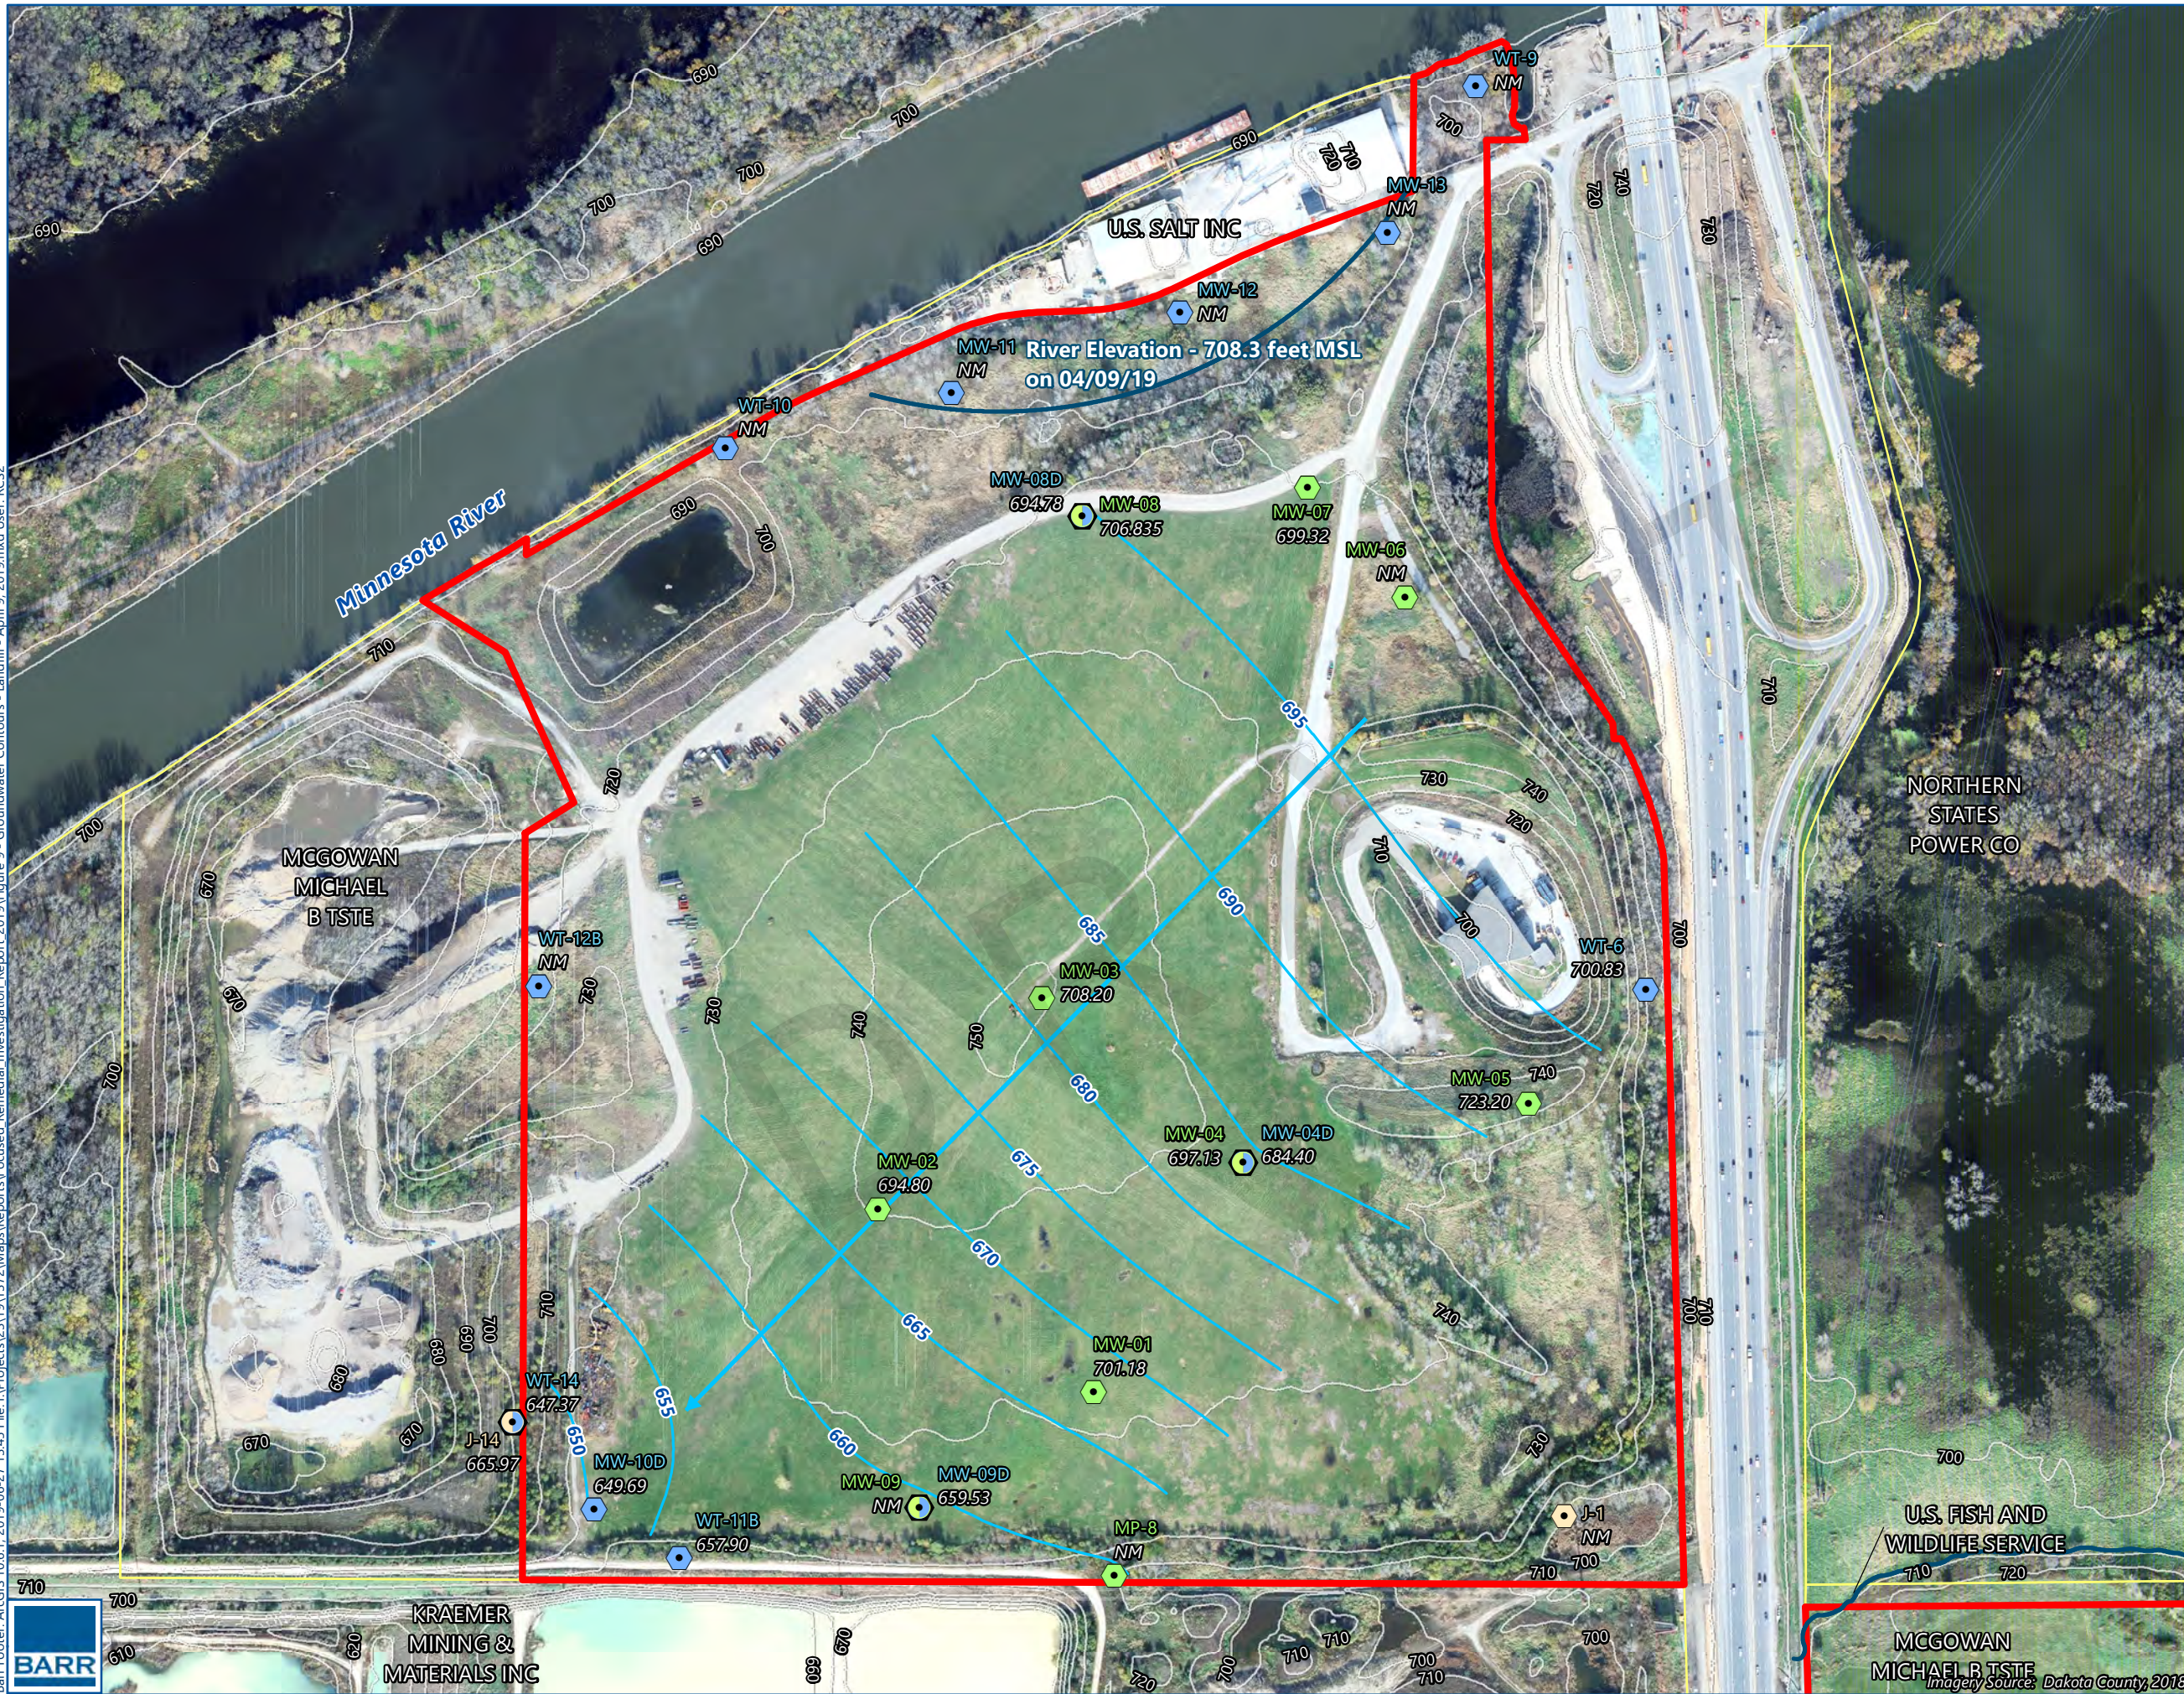
FIGURE 9

- Perched Monitoring Well
- Water Table Monitoring Well
- Jordan Well
- Perched and Water Table
- Water Table and Jordan
- Groundwater Elevation Contour\*  
Contour Interval = 5 ft (MSL)
- Estimated Flow Direction
- Contours, Dakota County, 2011**
- 10-Foot Contour
- Project Areas
- Parcel Boundary

\* Groundwater Elevation from Water Table Monitoring Wells

Groundwater levels were measured in monitoring wells during the spring of 2019. A summary of groundwater level measurements is provided in [Tables 9a](#) and [9b](#). Two synoptic rounds of groundwater level measurements were conducted on April 9, 2019 and June 17, 2019. The Minnesota River stage (at Savage MN, approximately 1 mile upstream) was approximately 708 feet MSL which is between the minor flood stage (702 feet MSL) and moderate flood stage (710 feet MSL) during the April 9 measurement and therefore a number of wells were inaccessible. During the June 17 measurement, the Minnesota River Stage at Savage, MN was approximately 699 feet MSL which is between the action stage (697 feet MSL) and the minor flood stage. Only one well (J-1) was inaccessible on June 17. Groundwater levels were also recorded by Pace when samples were collected for laboratory analysis. Groundwater levels from the synoptic measurements are presented on the groundwater contour figures ([Figures 9 to 11](#))

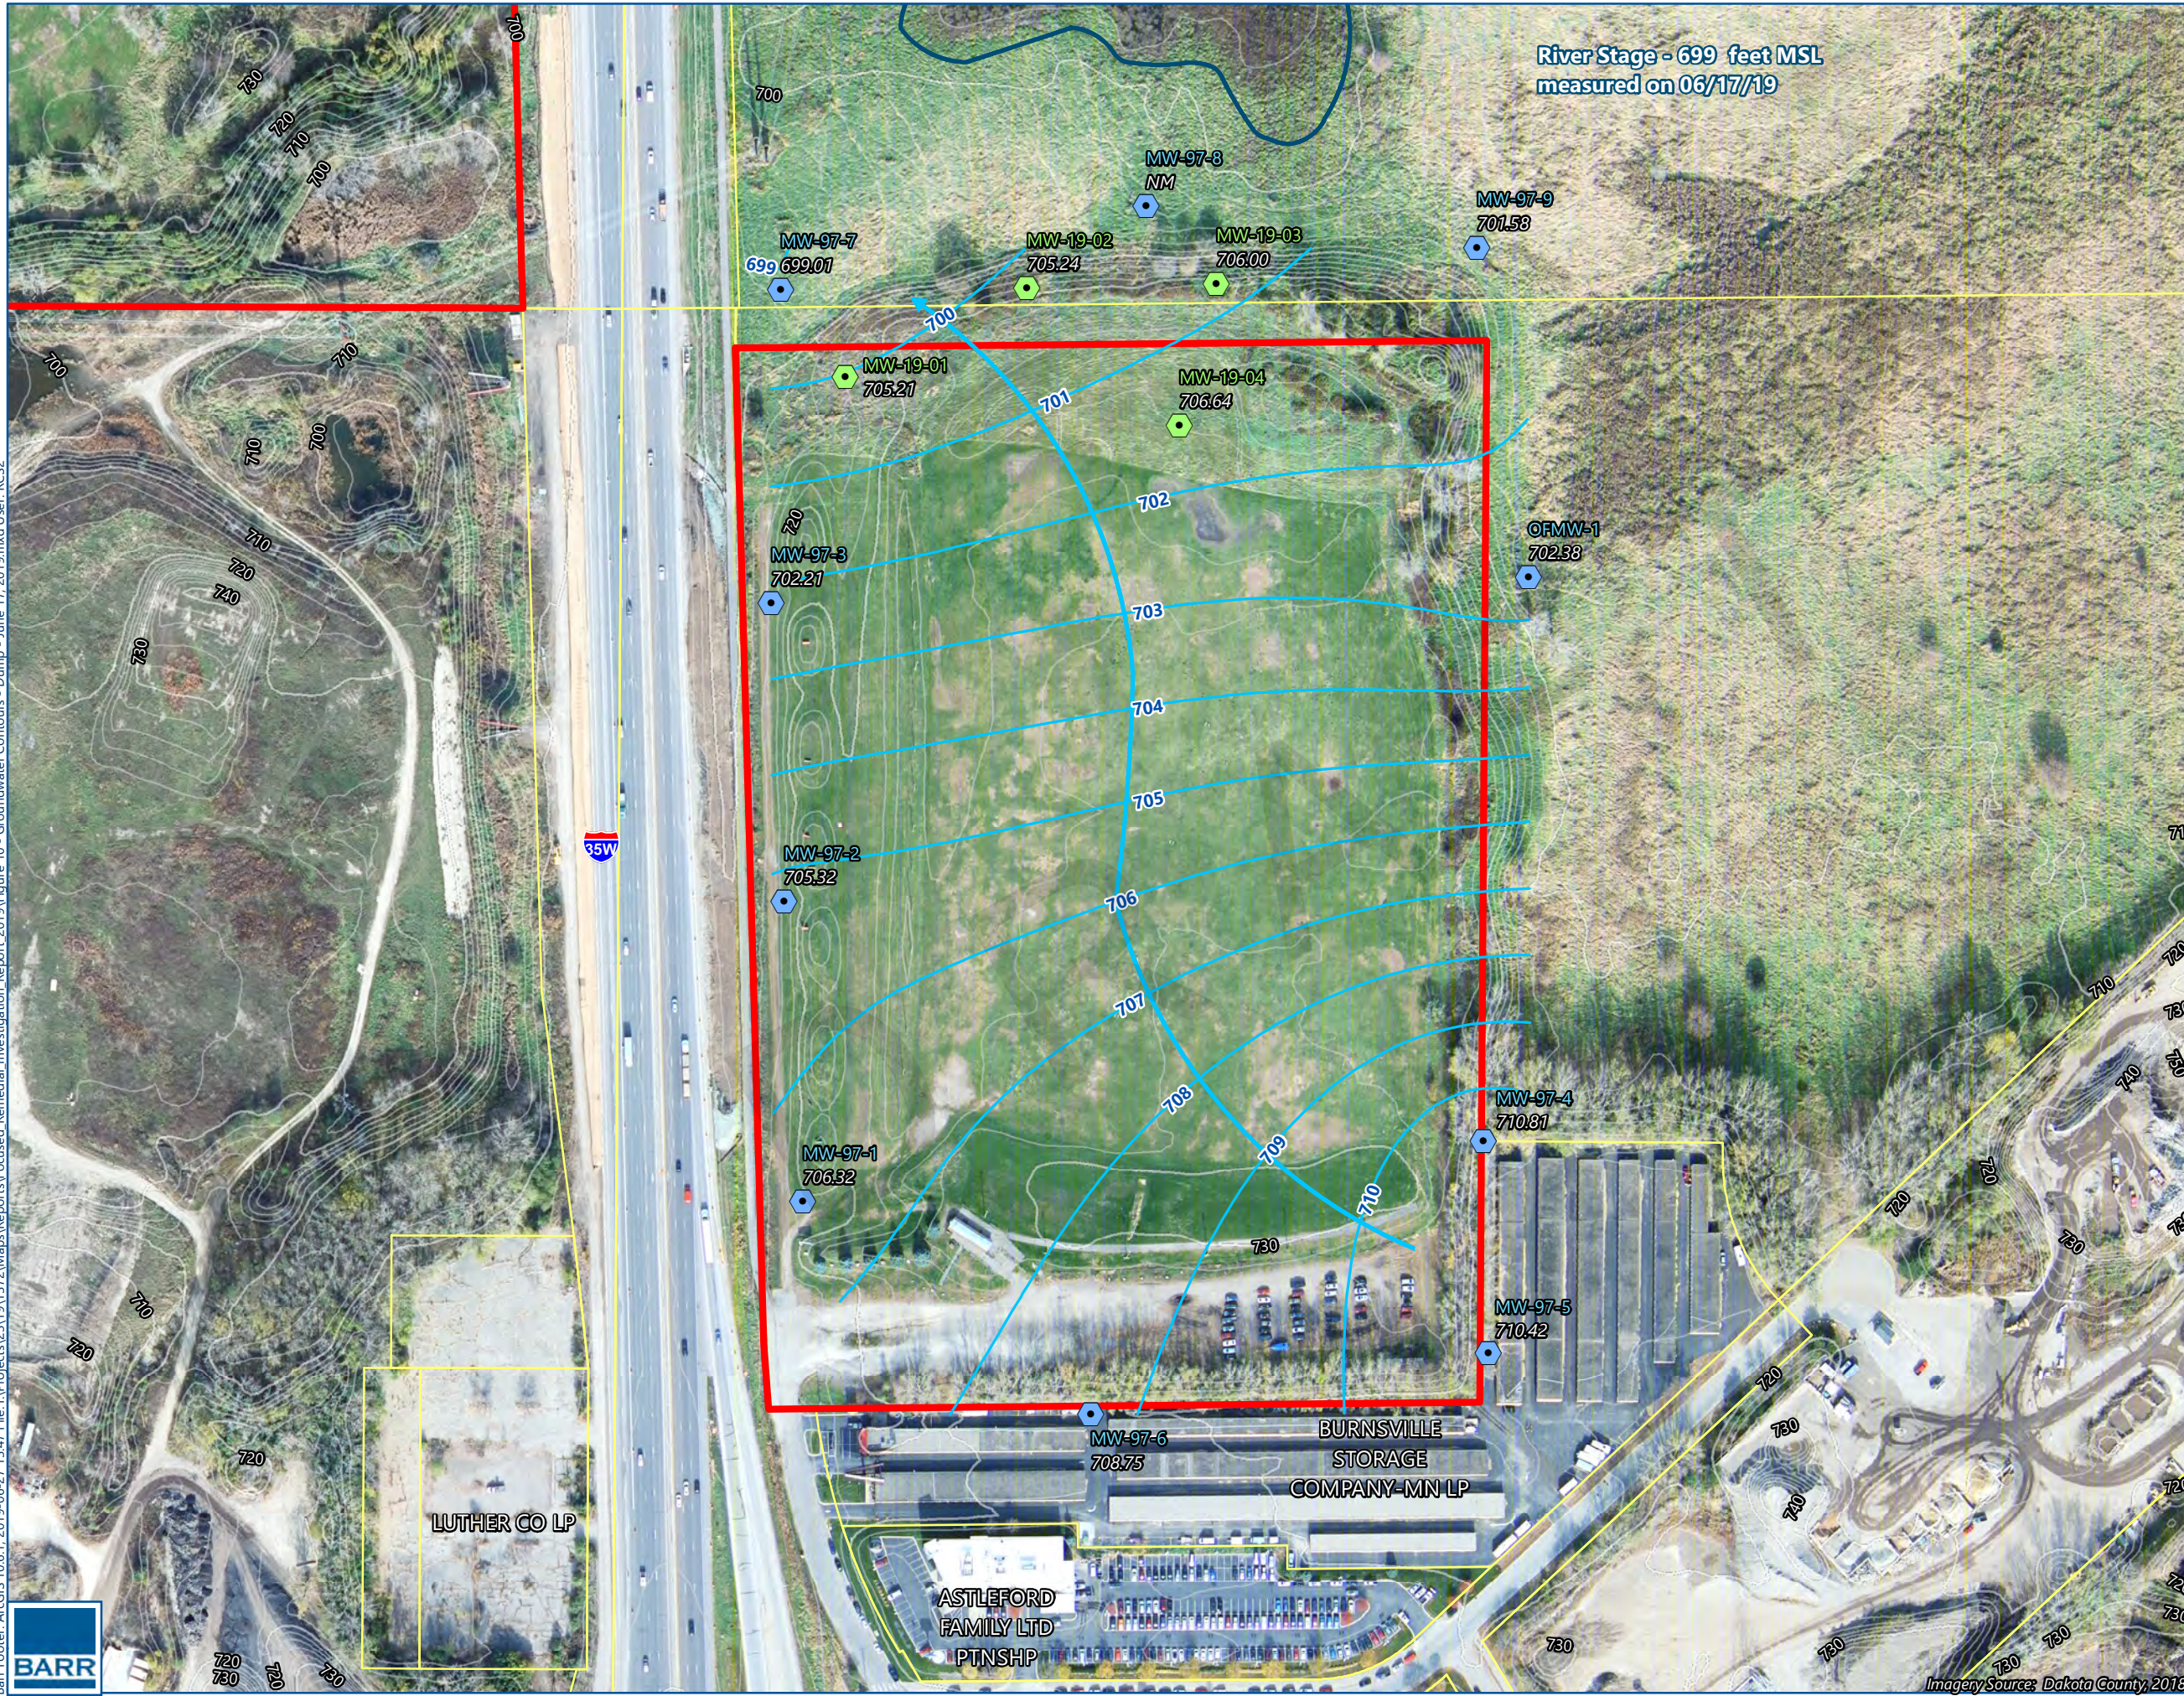
River Stage - 699 feet MSL  
measured on 06/17/19

- Perched Monitoring Well
- Water Table Monitoring Well
- Groundwater Elevation Contour\*  
Contour Interval = 1 ft (MSL)
- Estimated Flow Direction
- Contours, Dakota County, 2011**
- 10-Foot Contour
- 2-Foot Contour
- Project Areas
- Parcel Boundary

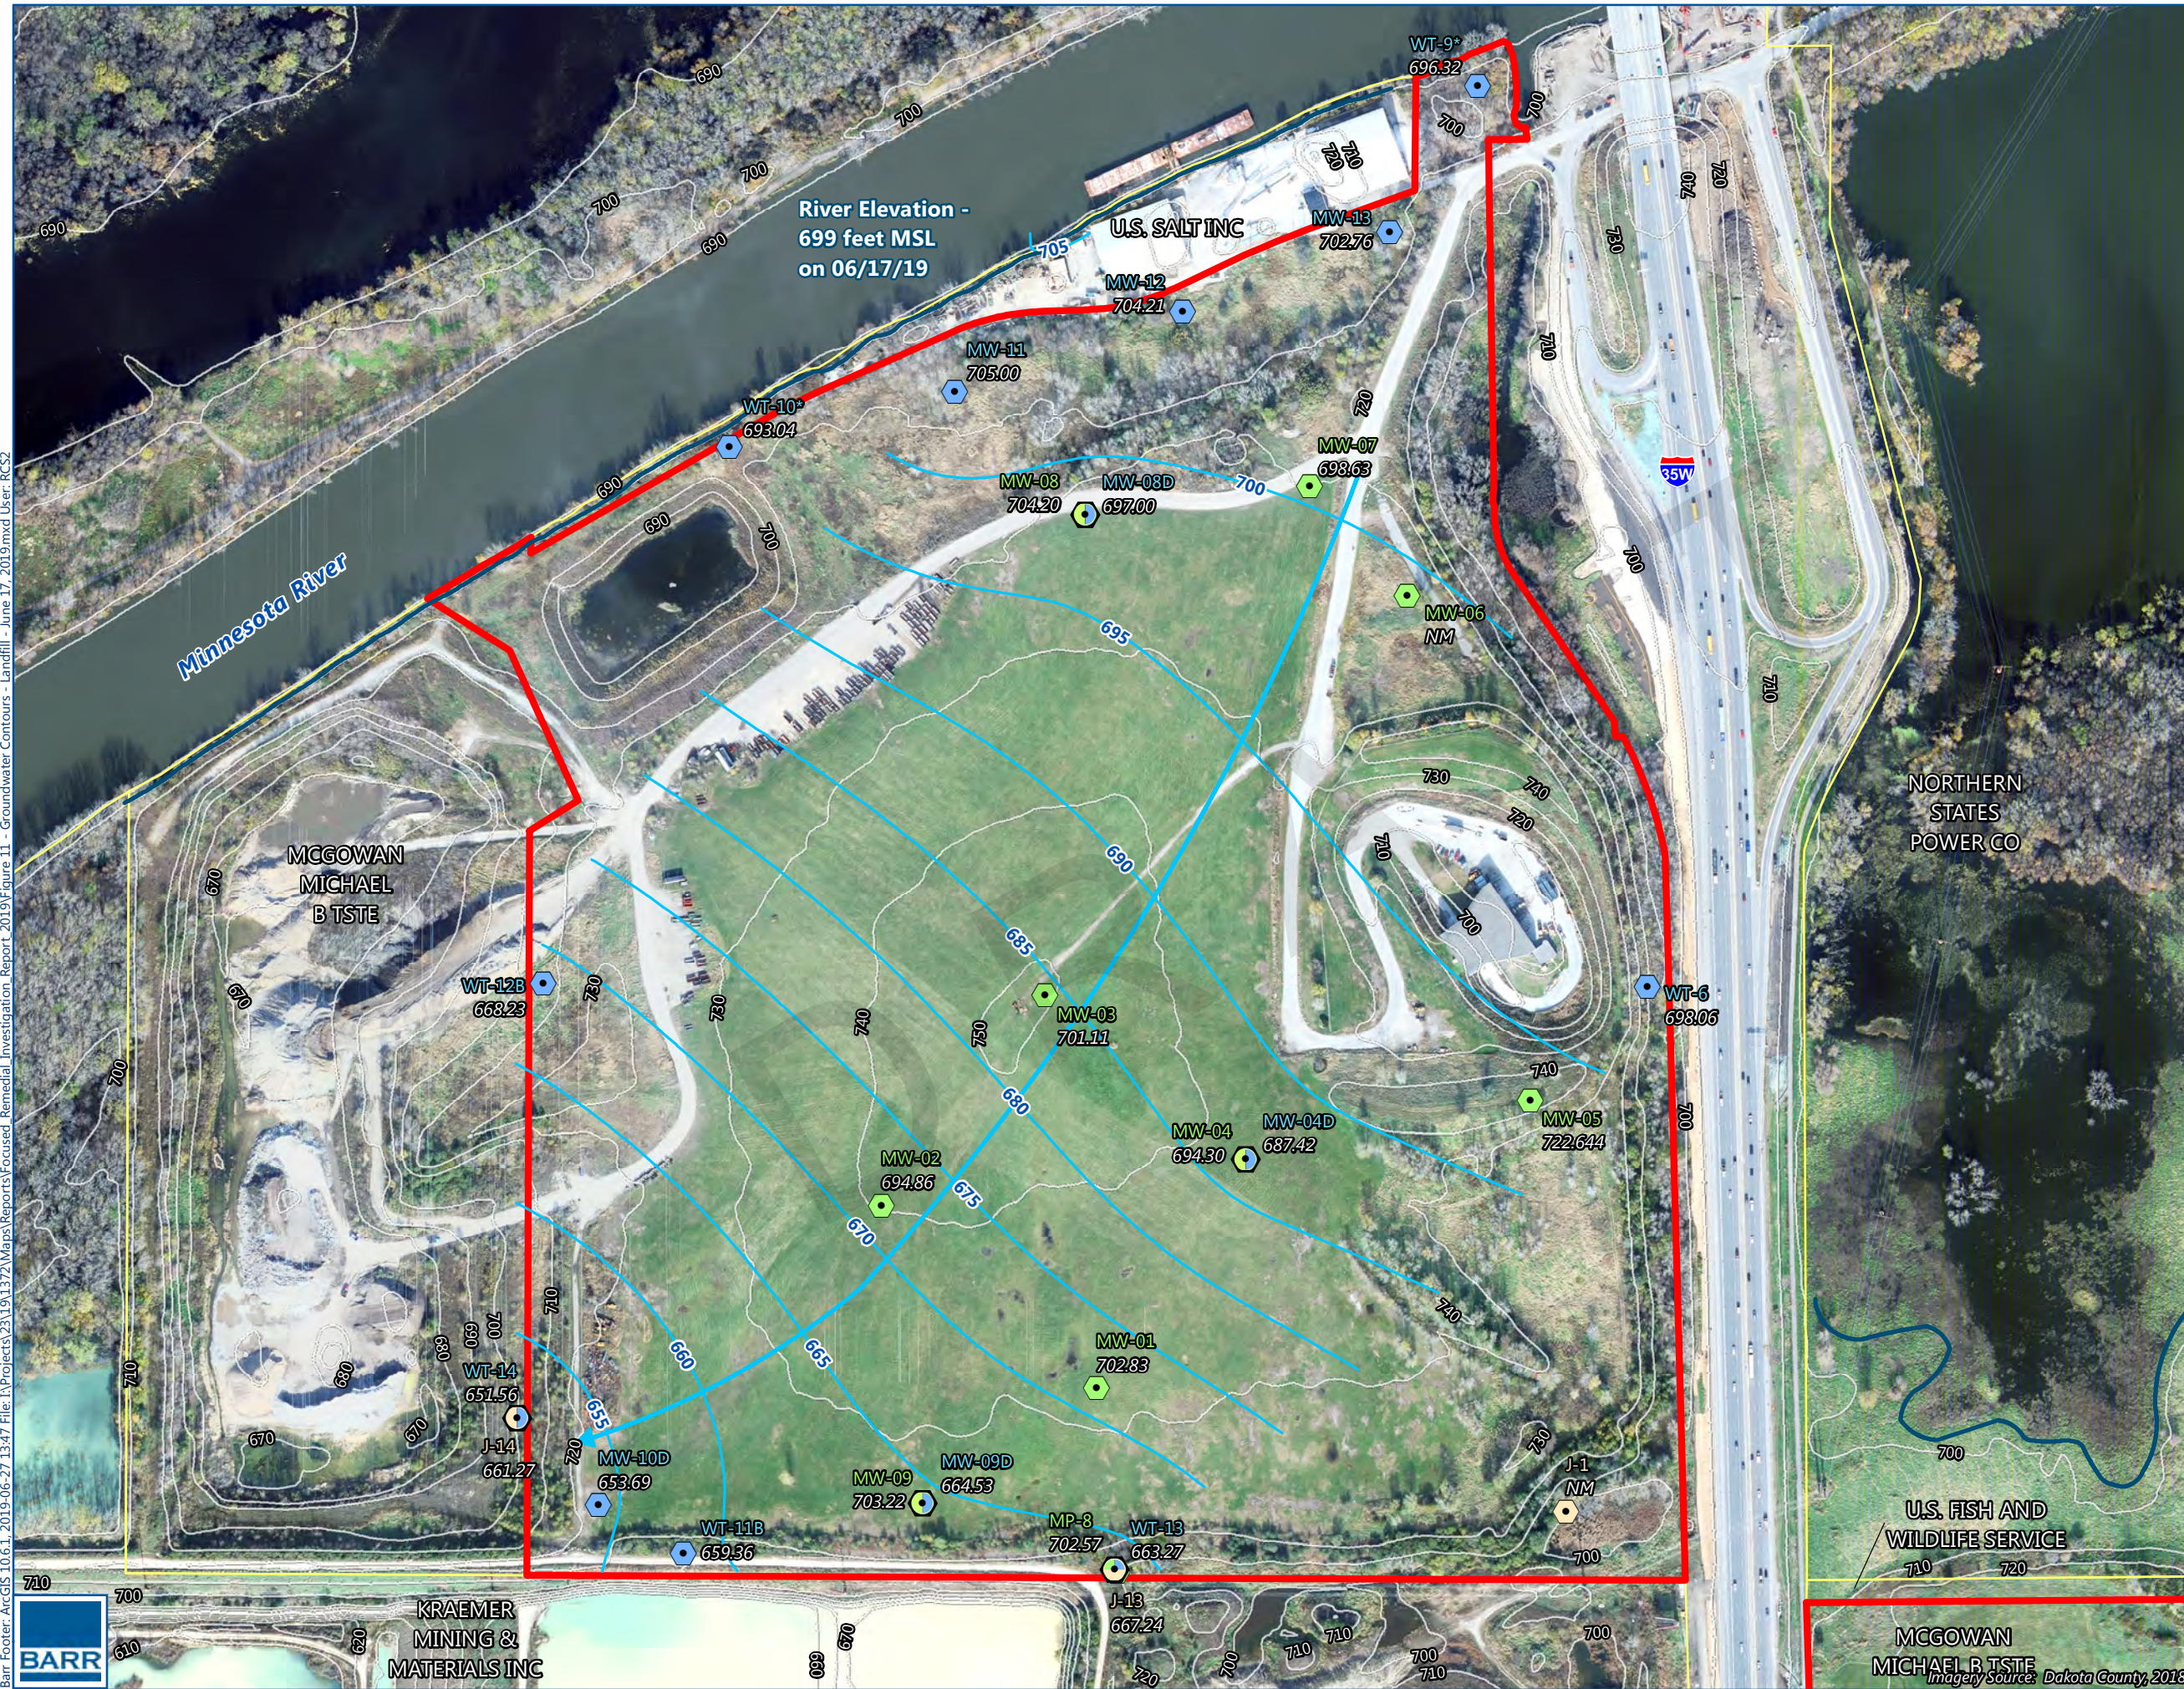
**FIGURE 11**

- Perched Monitoring Well
  - Water Table Monitoring Well
  - Jordan Well
  - Perched and Water Table
  - Water Table and Jordan
  - Perched, Water Table, and Jordan
  - Groundwater Elevation Contour\*  
Contour Interval = 5 ft (MSL)
  - Estimated Flow Direction
  - Contours, Dakota County, 2011**
  - 10-Foot Contour
  - Project Areas
  - Parcel Boundary
- \* Groundwater Elevation from Water Table Monitoring Wells (except WT-9 and WT-10)
- NM - Not Measured

**GROUNDWATER CONTOURS**  
 June 17, 2019  
 Freeway Landfill  
 Focused Remedial  
 Investigation Report  
 Freeway Landfill and Dump  
 Burnsville, Minnesota

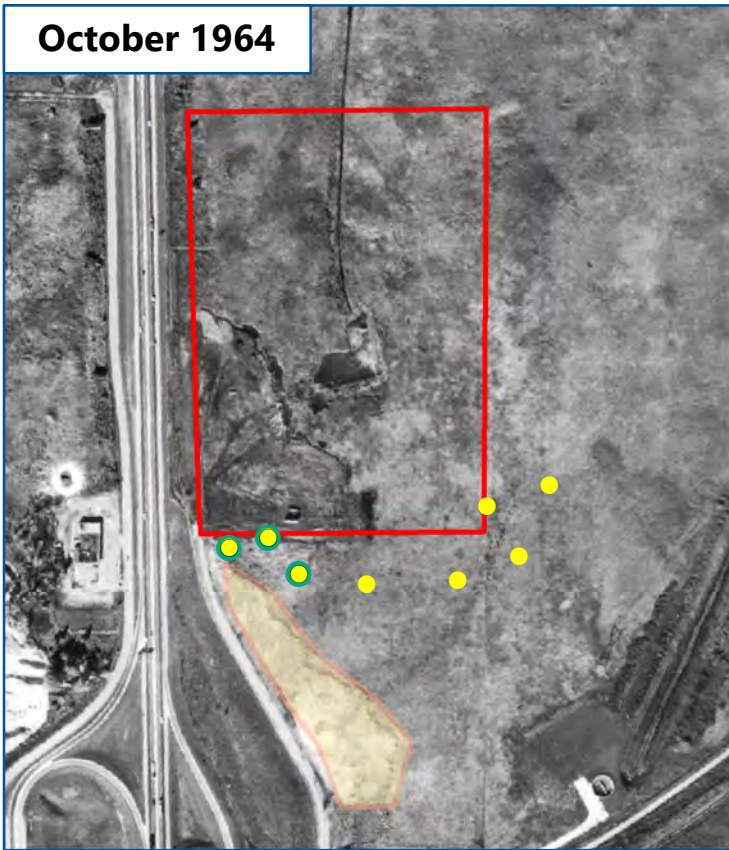
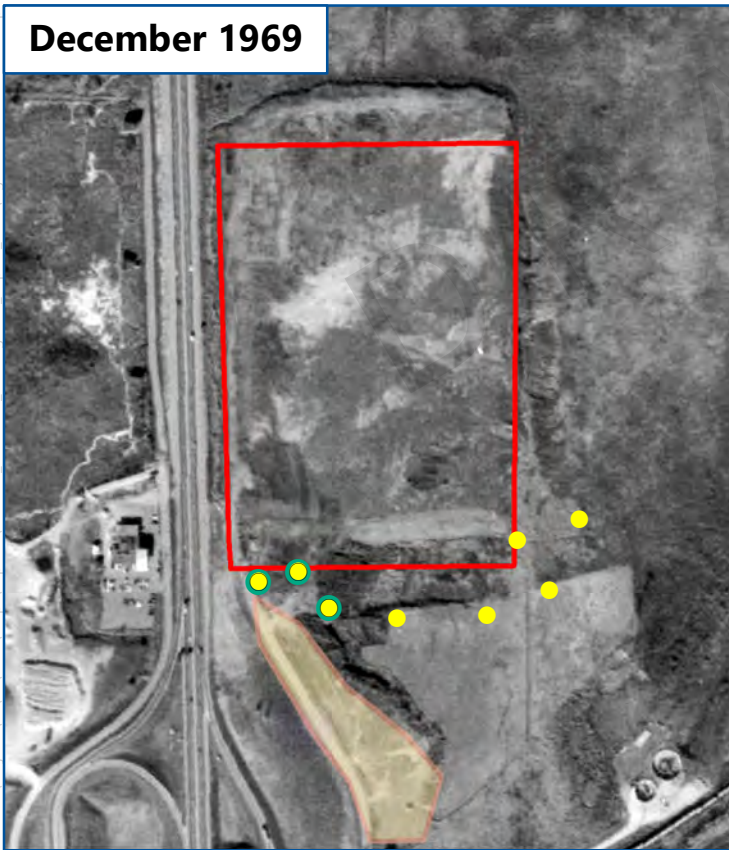
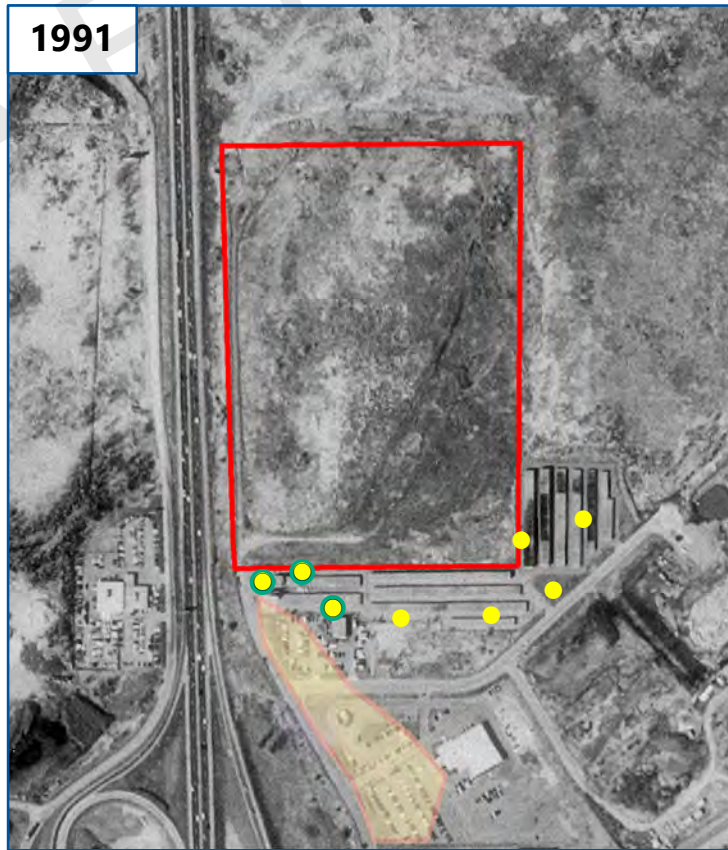
- Waste Extent Boring Location
- Waste Observed
- Approximate Location of Astleford Dump
- Project Areas

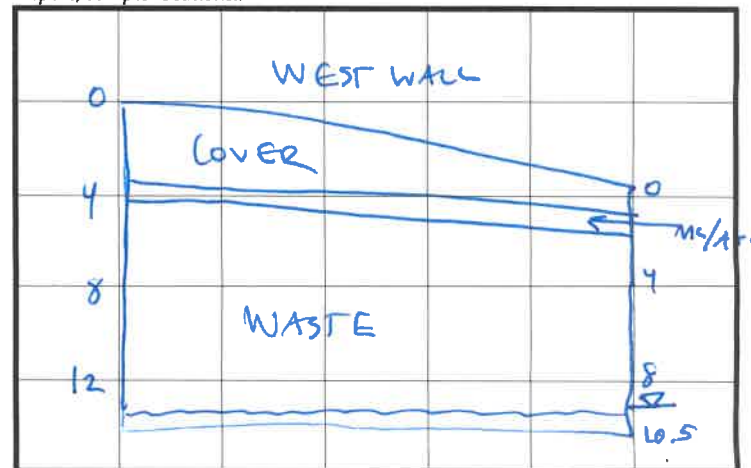
2.5-10.5 WASTE MATERIAL: wood, bricks, bottles, rubber hose: tires, Cinder blocks: construction material, wet @ 10' bgs

CROSS SECTION SKETCH: identify scale and direction, excavation extents and depths, sample locations..
