## 4.0 Investigation Results

This section describes the results of the investigation conducted in the spring of 2018 (Phase A). Included in this discussion of results is the description of the different solid media encountered and their distribution across the Site. Additionally, solid media and water quality results are presented in comparison to relevant health-based risk criteria.

## **4.2 Freeway Dump**

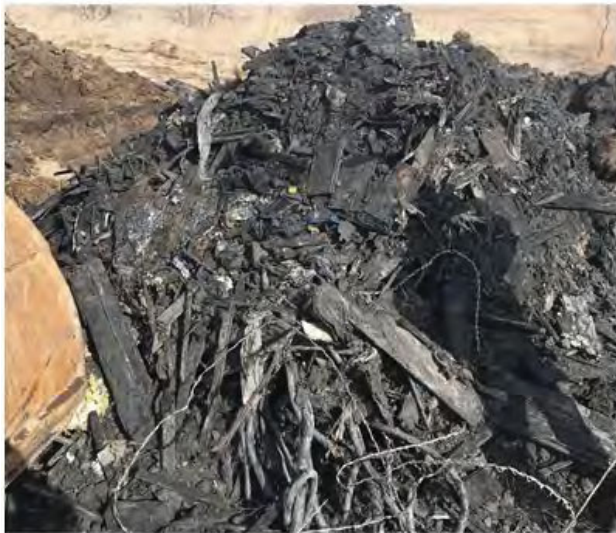
MSW/CD stockpile at FD-TT-01

MSW/CD was encountered across most of the site. Municipal solid waste consisted of paper, plastics, glass, wood, metal, and rubber and was sometimes mixed with fill material. Construction debris varied,

typically including bricks, concrete, wood, shingles, and insulation. The level of decomposition varied as well, with some areas appearing relatively dry and containing readable lines of newspaper, whereas other pockets of waste material were well degraded and had a noticeable odor of decomposition.

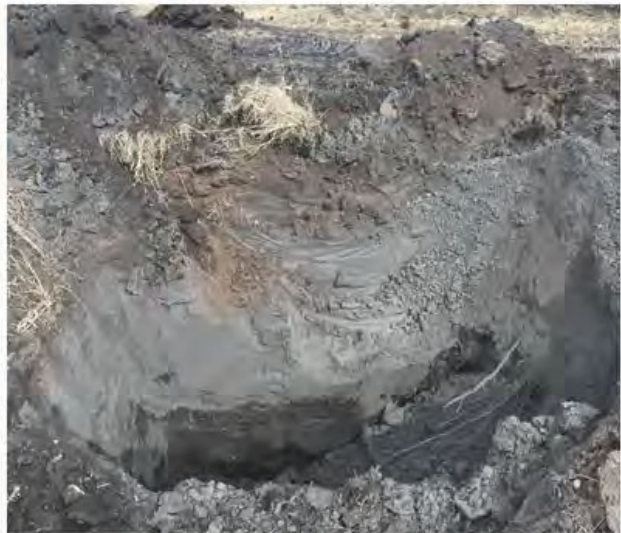
Ash sidewall at FD-TT-03

Ash was observed only at investigation locations at the Dump. Ash is generally described as gray, or black, non-plastic, silt to fine grained sand-size material and was differentiated from native sediments by strength and texture comparisons. The ash encountered at the Dump was mostly fine-grained and non-cemented, making it appear as a possible native gray silt except that it often was intermixed with waste material. The ash was generally observed either above and/or below the waste material.
