**Subject: Limited Site Investigation Report for Leak 15,656 at Former Alex Exhaust;
AECOM Project 04660027**

Investigation Report Form

Leak Site Name: **Former Alex Exhaust**

Leak Site Address: **905 - 3rd Avenue East**

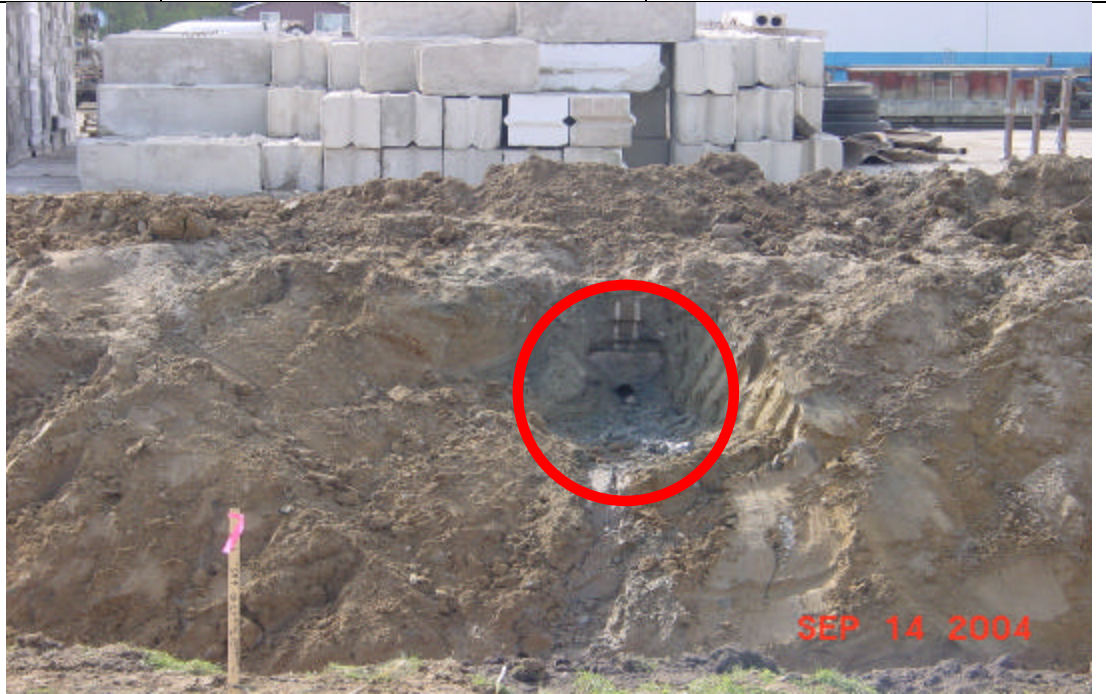
| Description: Four inch drain pipe identified during reconstruction activities in Area 5. Contaminated soil was identified around the pipe. | |

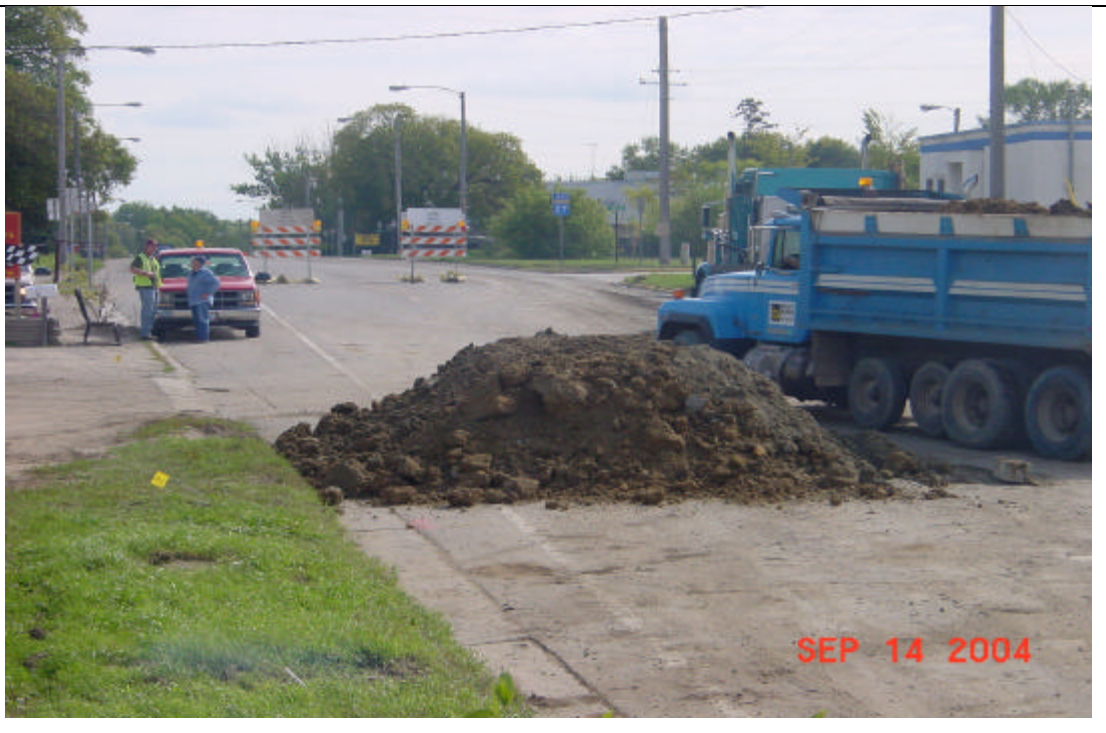
| Photo No. 6 | Date: 9/14/04 |

| Description: Temporary stockpile of contaminated soil excavated from Area 5 around 4 inch drain pipe. | |

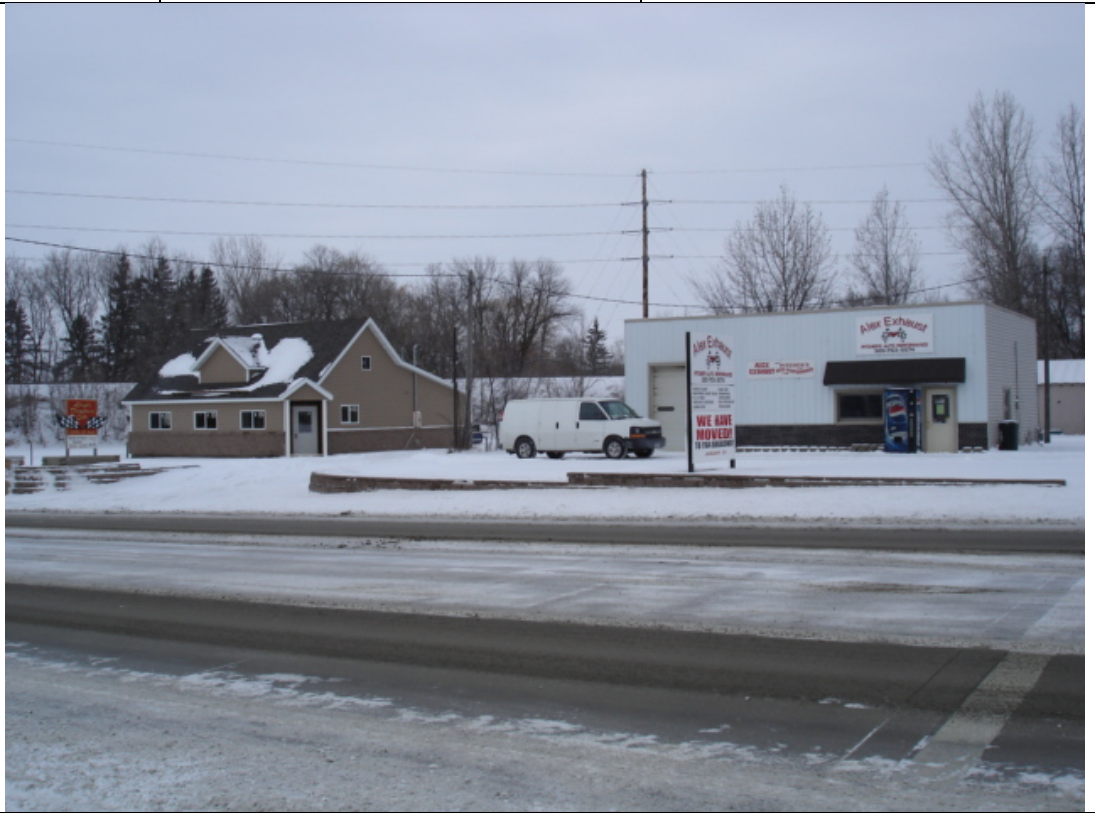
This photograph shows the site configuration in February, 2007. The white building on the right of the photo is the Alex Exhaust building.

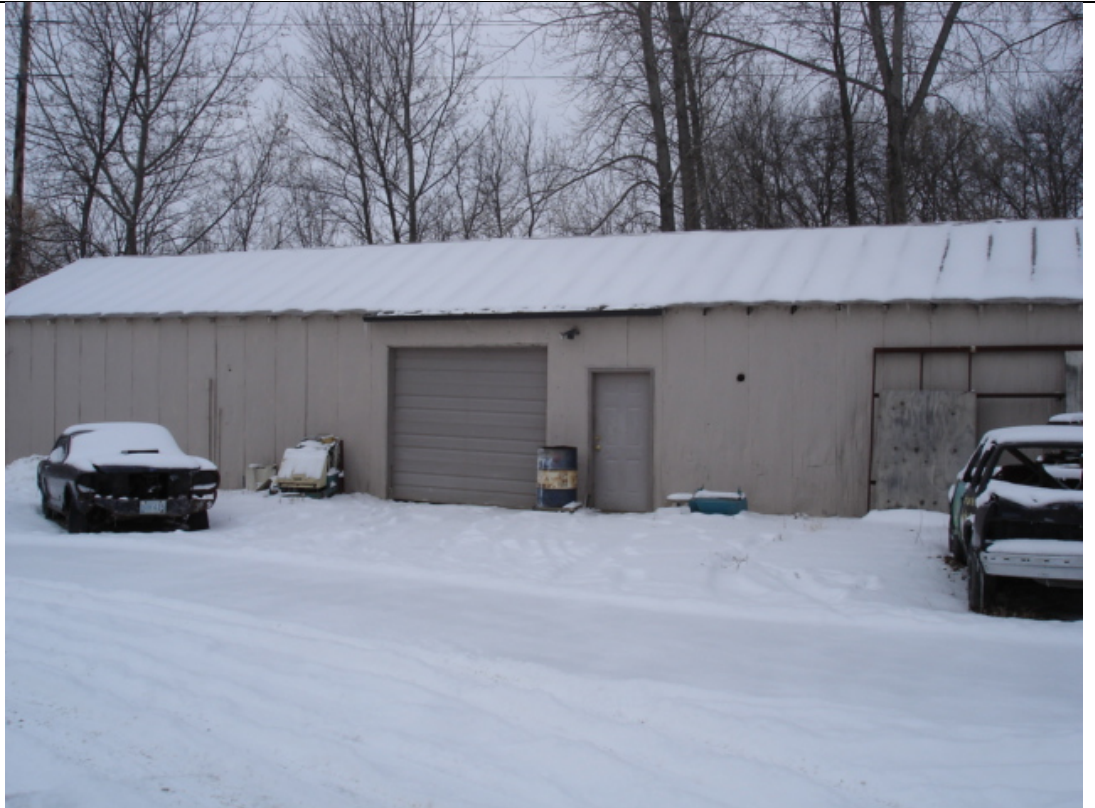
This photograph shows the large shed/garage building north of the Alex Exhaust building.
