Corrective Action Report

Junction Food-N-Fuel Site
5493 Miller Trunk Hwy
Hermantown, Minnesota

MSA Project No. 00625001
MPCA Leak No. 3534

September 2013

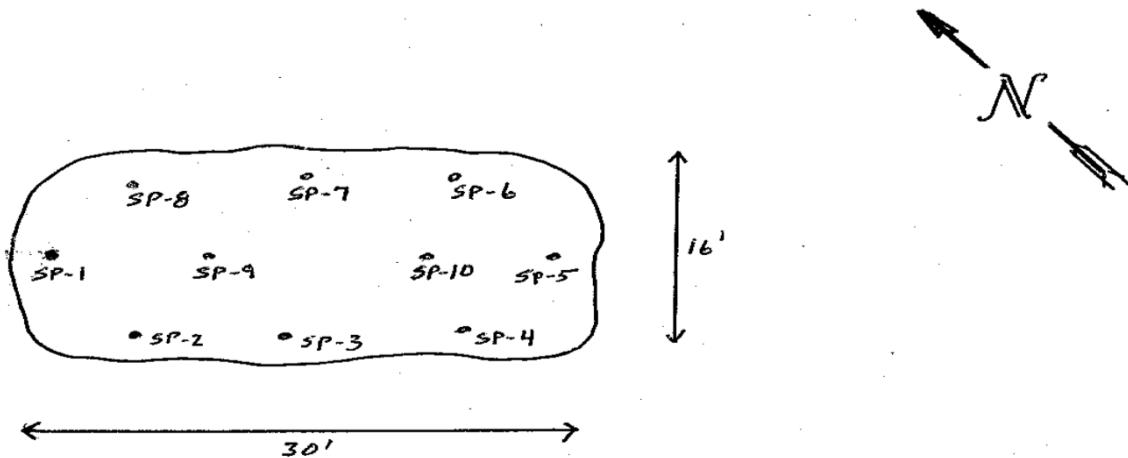
DETAIL OF
 STOCKPILE
 FROM FIGURES 2, 3, 4

Table 1
Stockpile Sample Field Screening Results
Junction Food-N-Fuel Site
June 20th, 2013

Soil Sample Number		Field Screening Reading
Stockpile Samples	SP-1	0.6
	SP-2	0.7
	SP-3	0.4
	SP-4	0.7
	SP-5	0.5
	SP-6	0.3
	SP-7	0.5
	SP-8	0.8
	SP-9	1.7
	SP-10	0.6
